# **2010 PARCEL 22 MONITORING REPORT**

**BAILEY'S BRANCH AND PLEASANT RUN REMOVAL ACTION  
BEDFORD, INDIANA**

**Prepared For:**  
**General Motors LLC**

**FEBRUARY 2011**

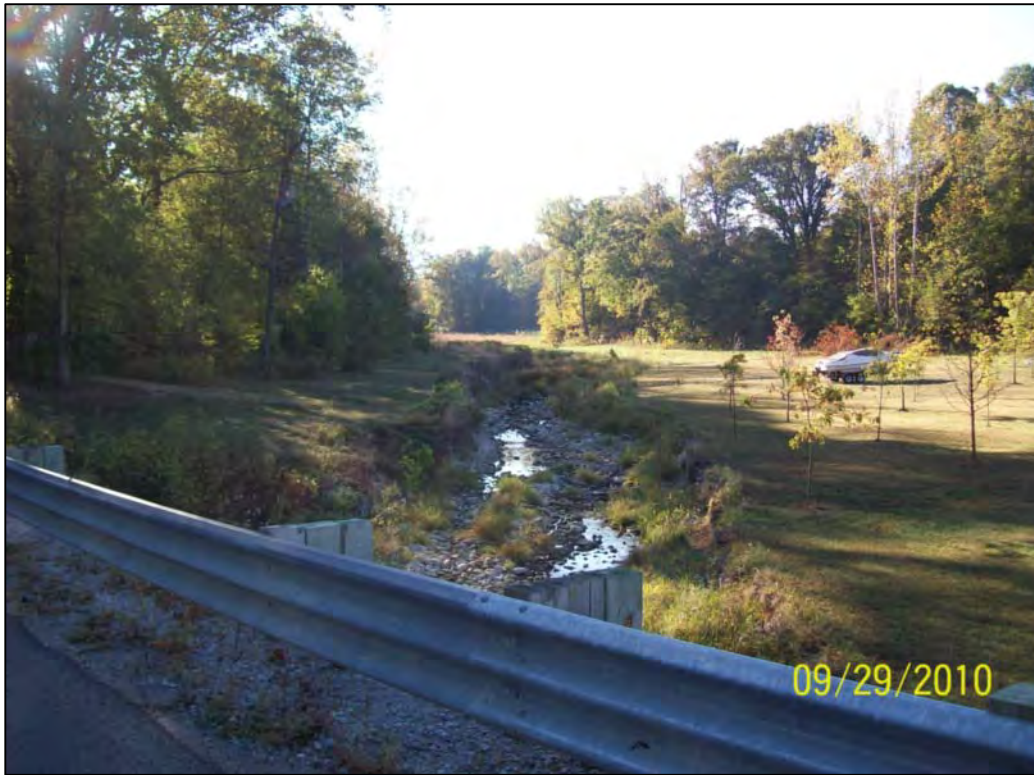
FIGURE 1.0 - PARCEL 22, LOCATION 1, LOOKING UPSTREAM

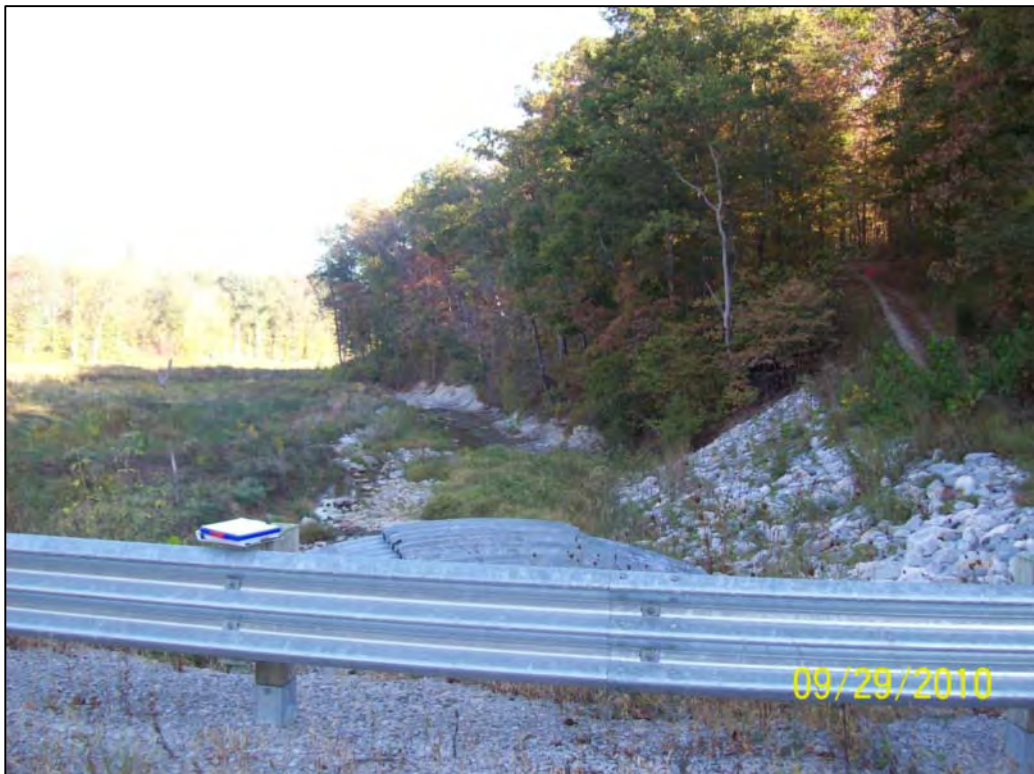
FIGURE 1.1 - PARCEL 22, LOCATION 1, LOOKING DOWNSTREAM

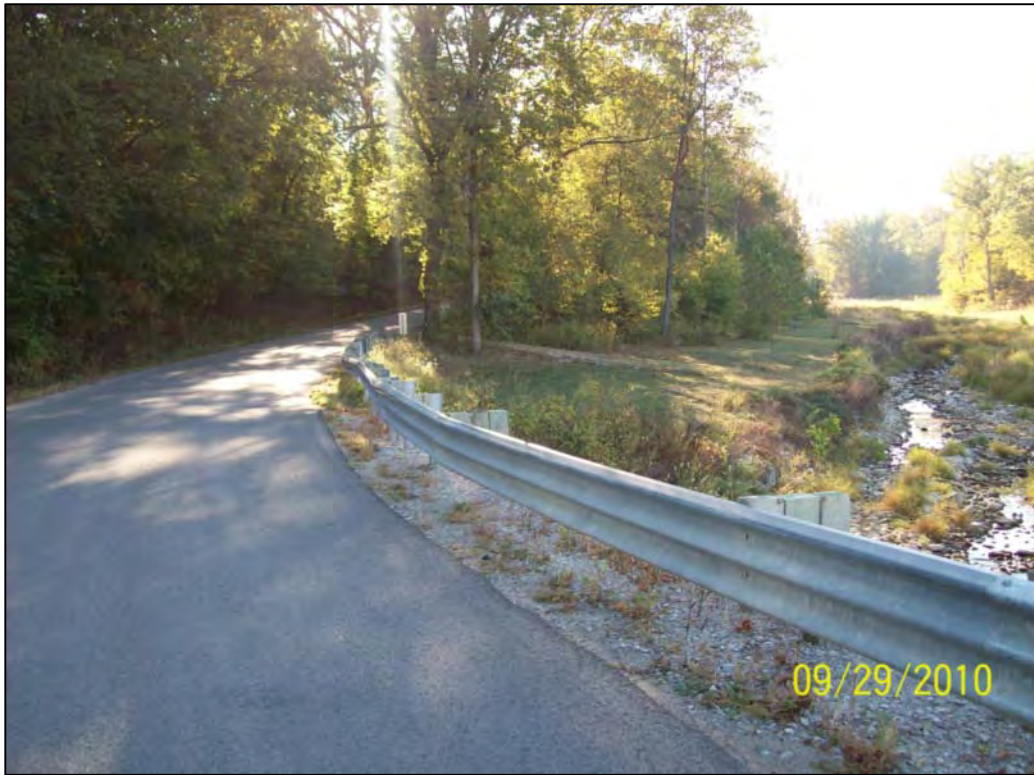
FIGURE 1.2 - PARCEL 22, LOCATION 1, LOOKING NORTH-EAST

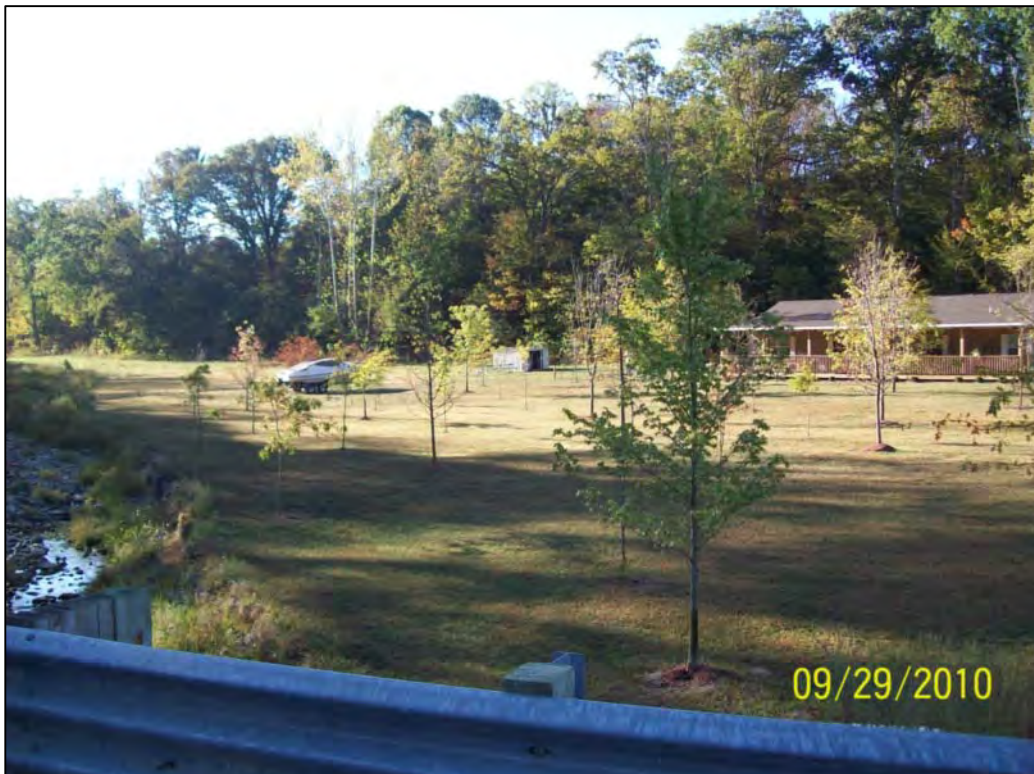
FIGURE 1.3 - PARCEL 22, LOCATION 1, LOOKING SOUTH-EAST

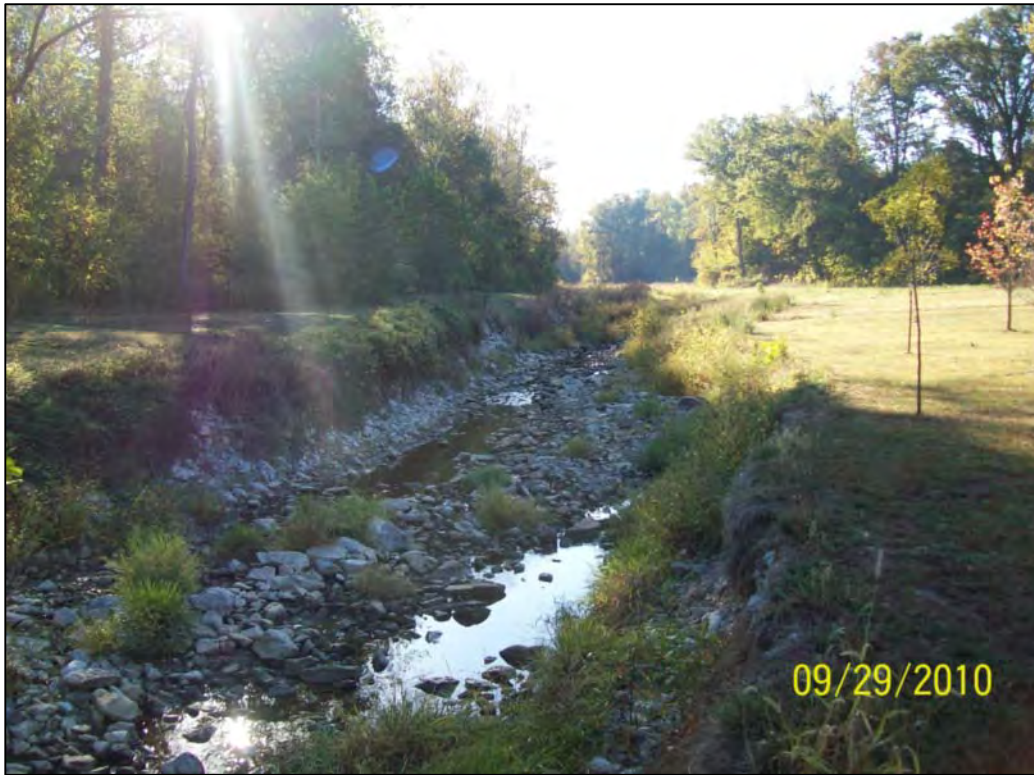
FIGURE 2.0 - PARCEL 22, LOCATION 2, LOOKING UPSTREAM

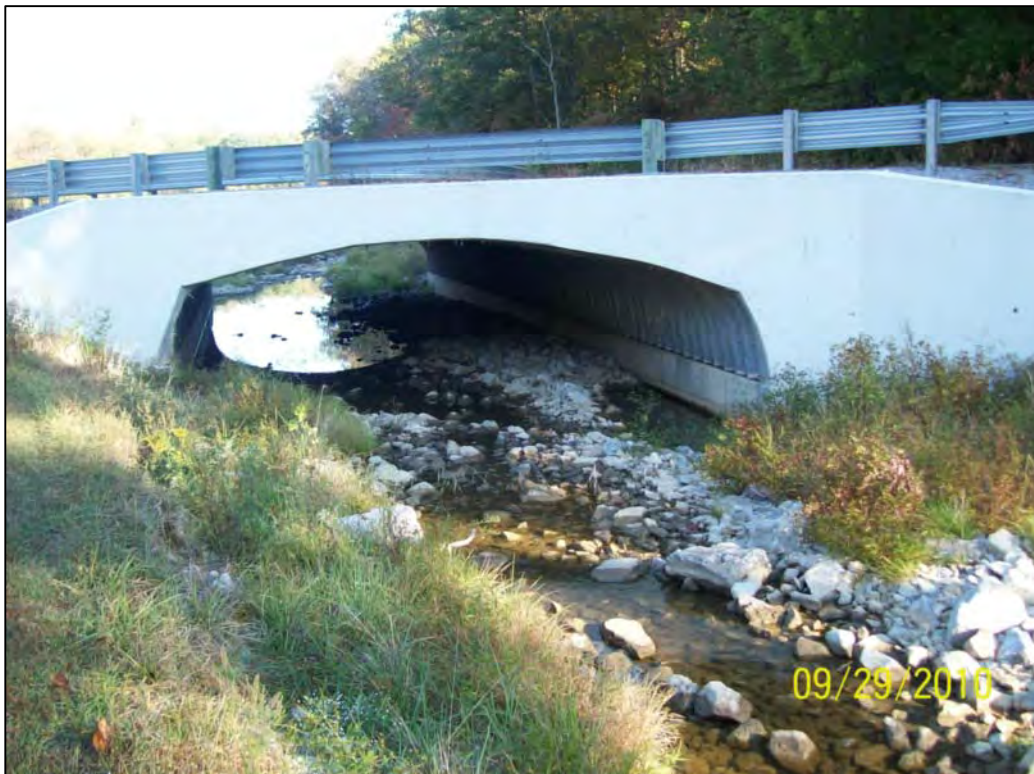
FIGURE 2.1 - PARCEL 22, LOCATION 2, LOOKING DOWNSTREAM

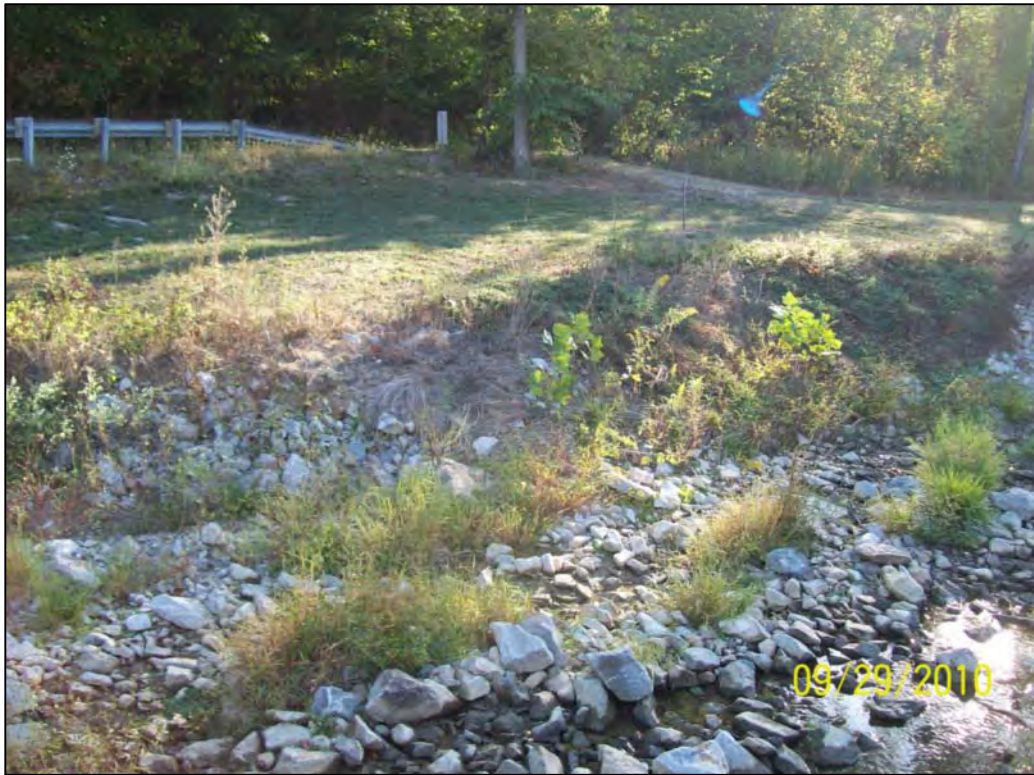
FIGURE 2.2 - PARCEL 22, LOCATION 2, NORTH BANK

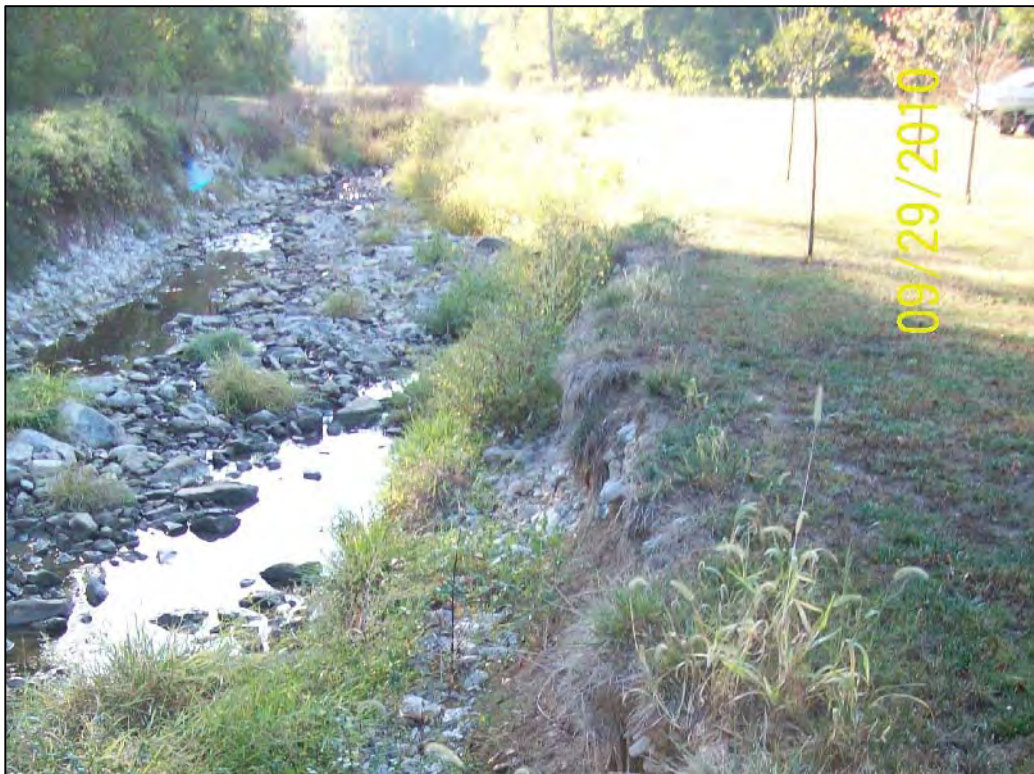
FIGURE 2.3 - PARCEL 22, LOCATION 2, SOUTH BANK

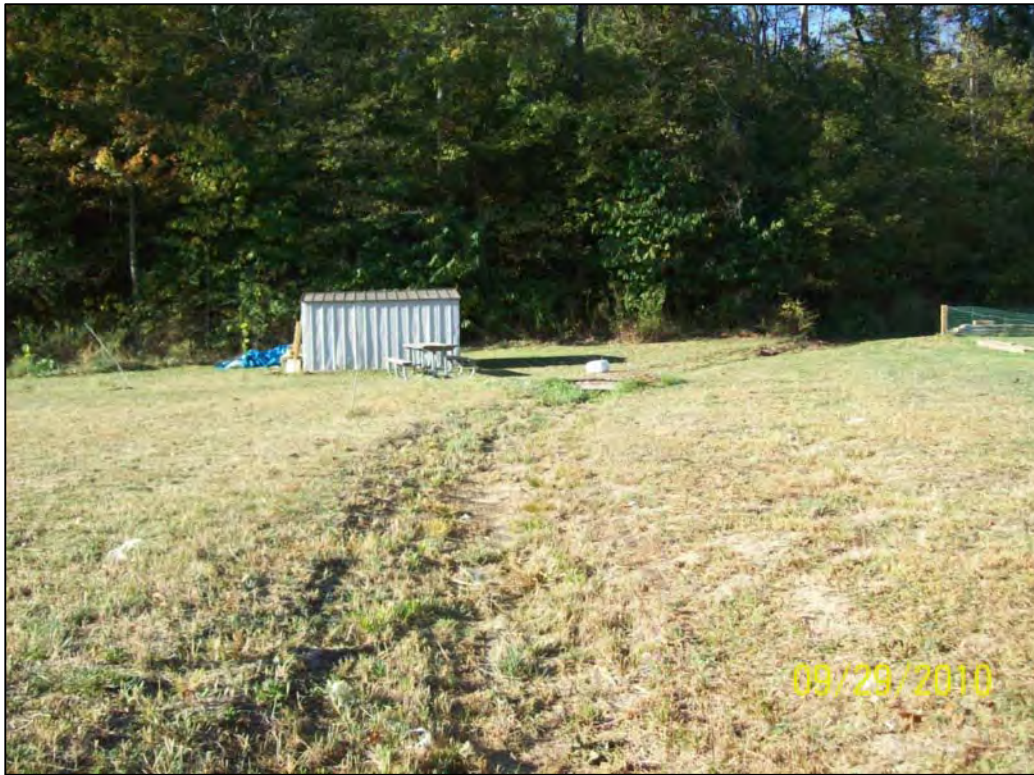
FIGURE 3.0 - PARCEL 22, LOCATION 3, DRAINAGE SWALE - LOOKING SOUTH-WEST (UPSTREAM)

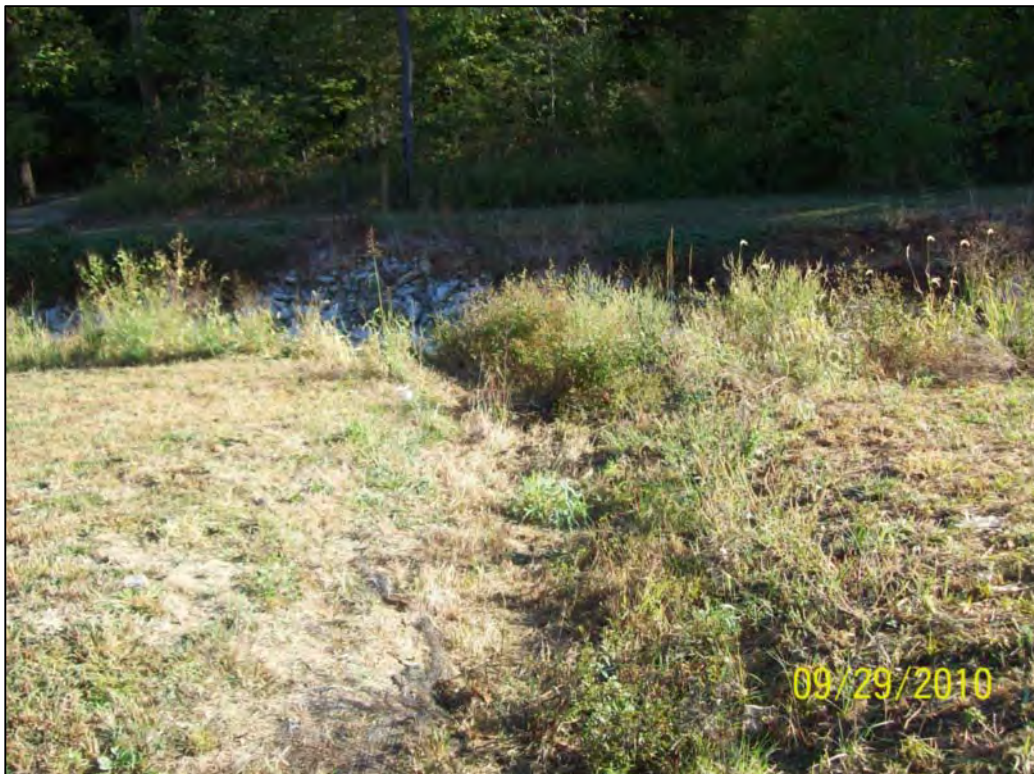
FIGURE 3.1 - PARCEL 22, LOCATION 3, DRAINAGE SWALE, LOOKING NORTH-EAST (DOWNSTREAM)

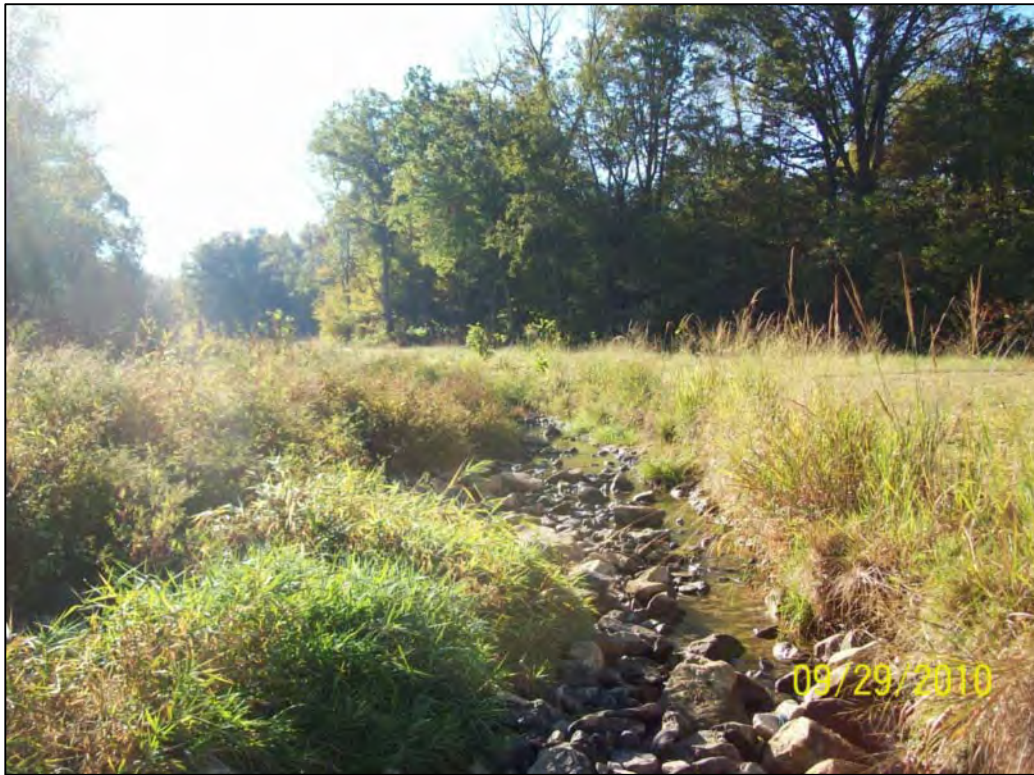
FIGURE 4.0 - PARCEL 22, LOCATION 4, LOOKING UPSTREAM

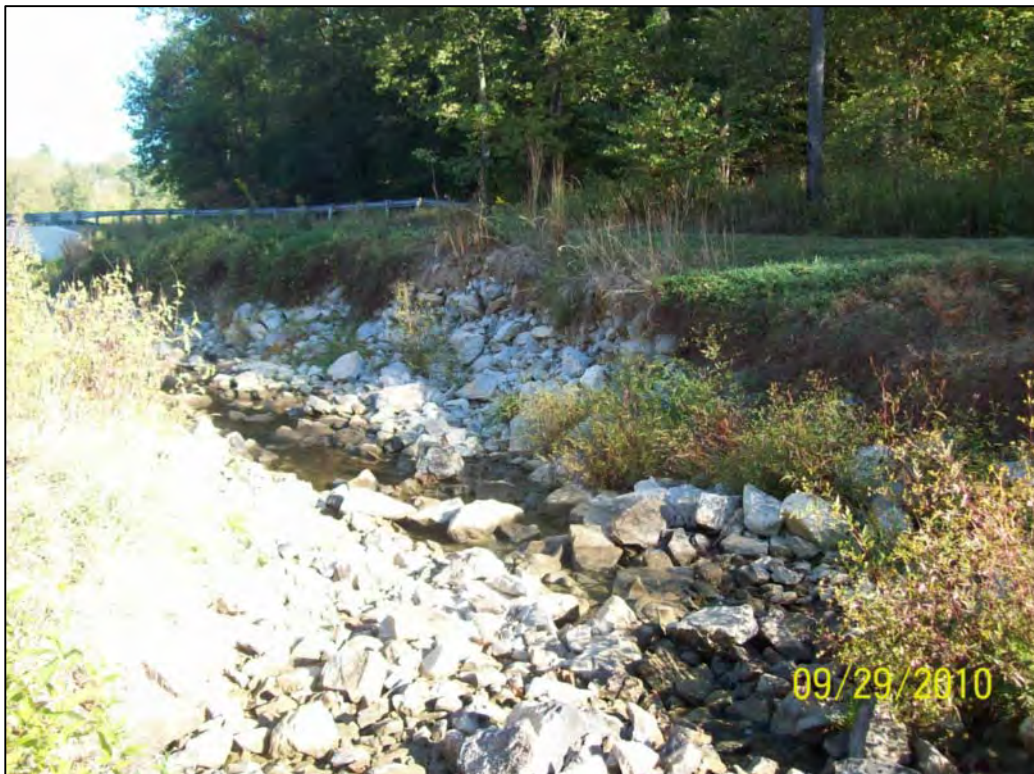
FIGURE 4.1 - PARCEL 22, LOCATION 4, LOOKING DOWNSTREAM

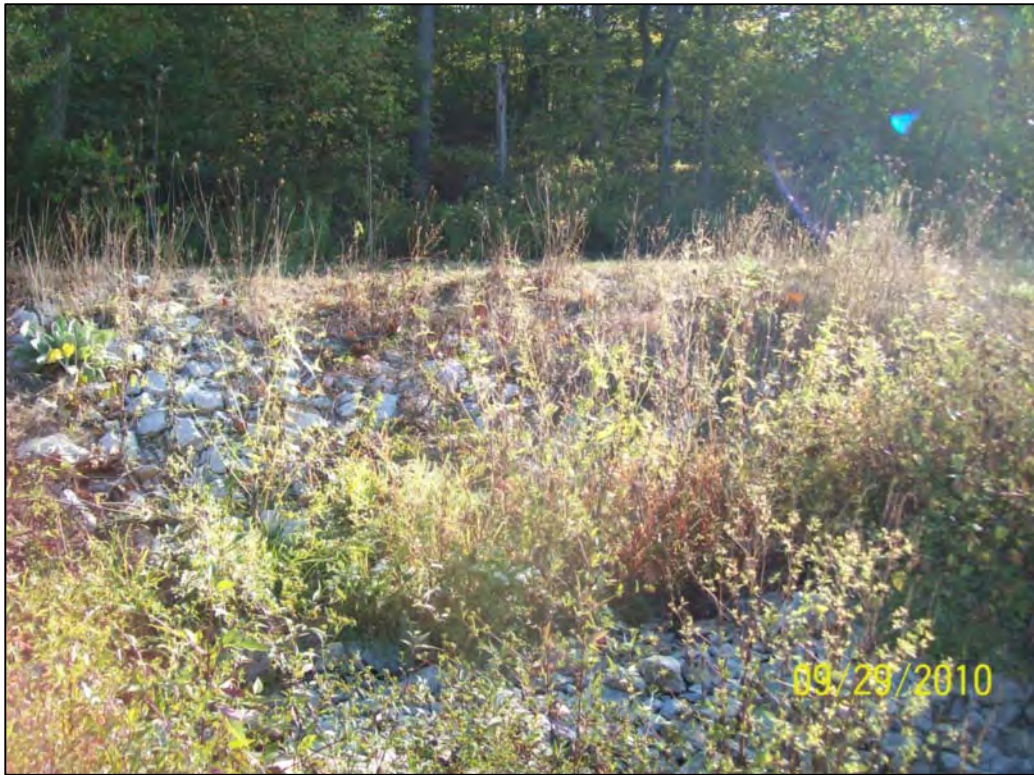
FIGURE 4.2 - PARCEL 22, LOCATION 4, NORTH BANK

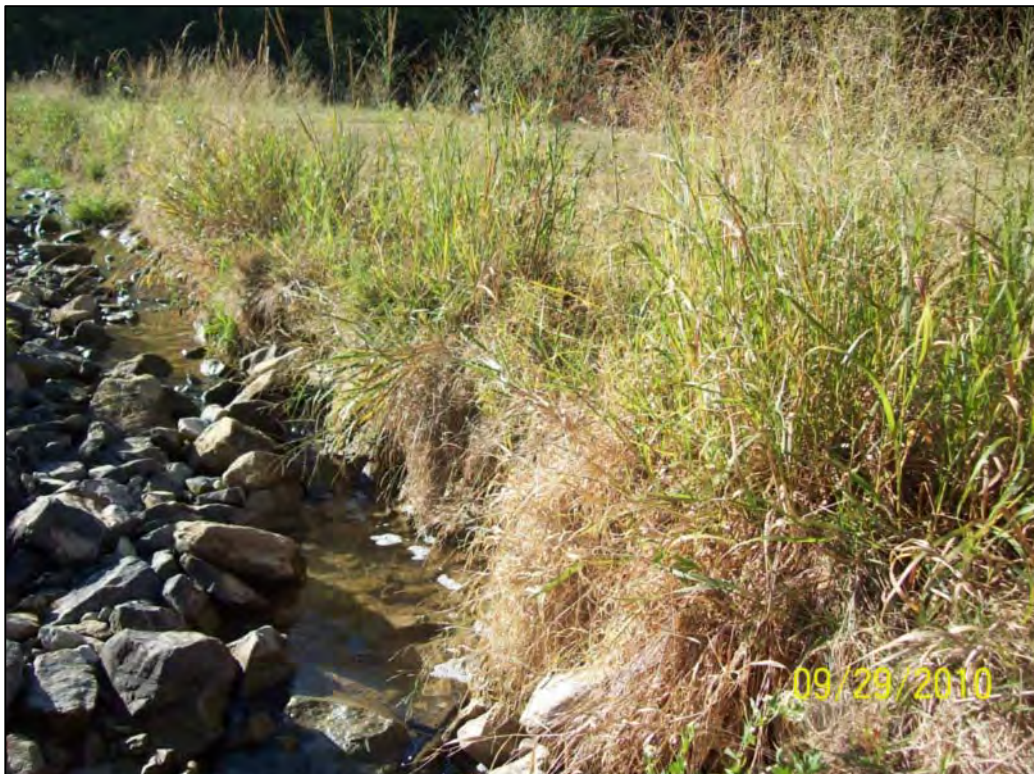
FIGURE 4.3 - PARCEL 22, LOCATION 4, SOUTH BANK

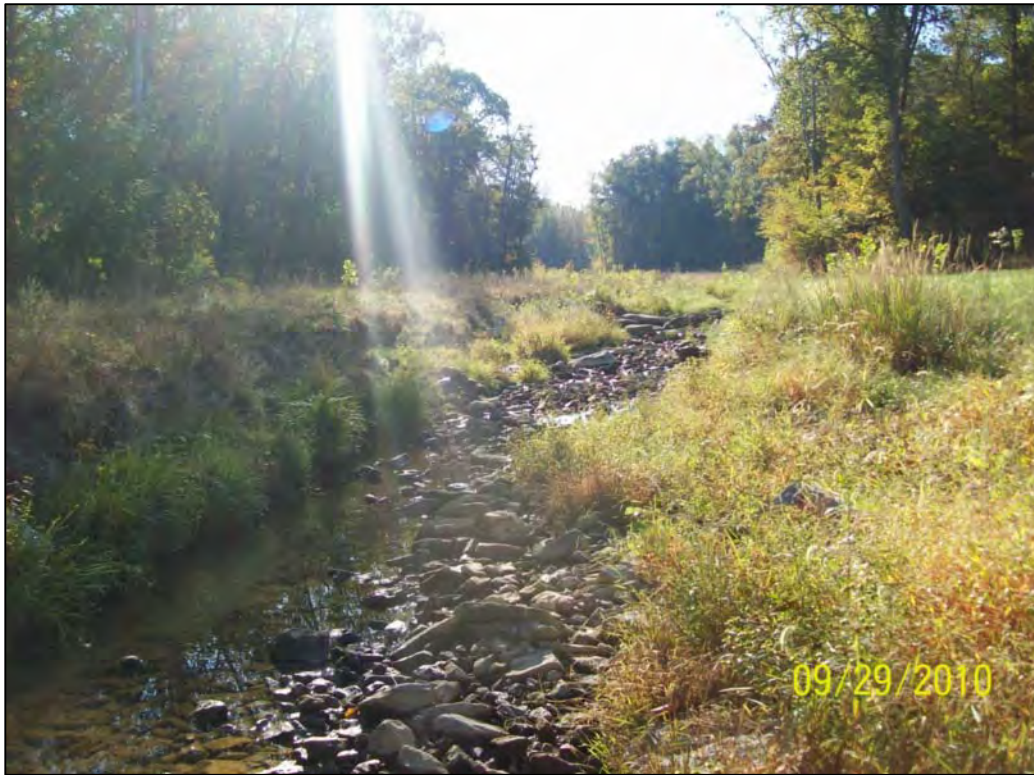
FIGURE 5.0 - PARCEL 22, LOCATION 5, LOOKING UPSTREAM

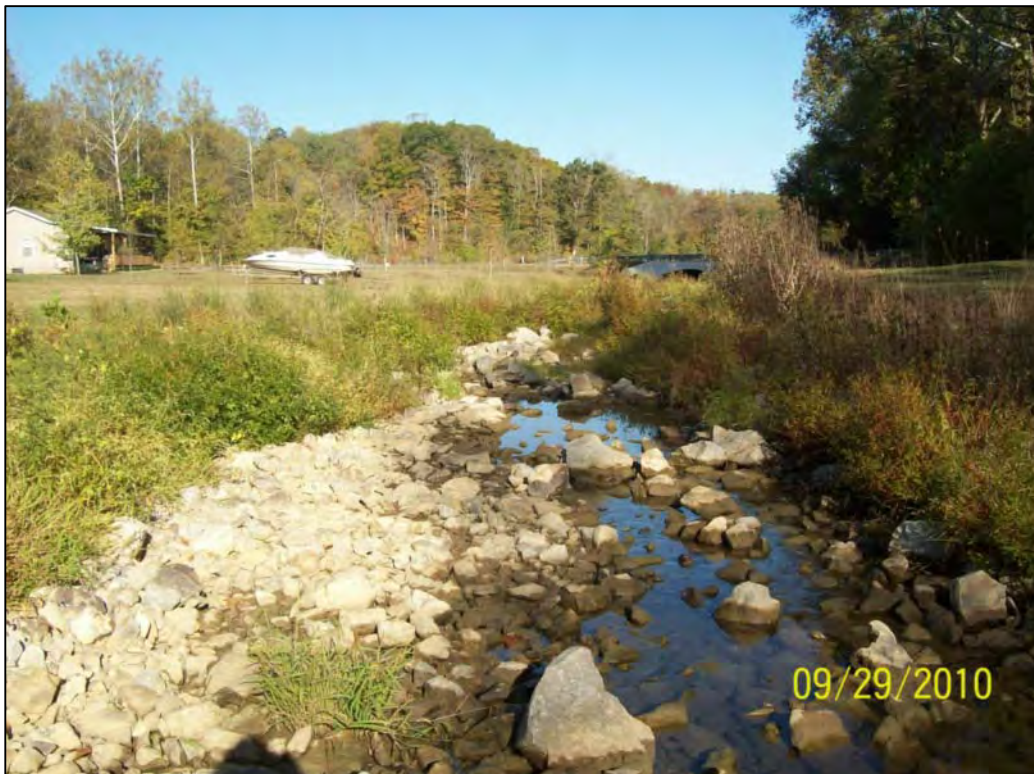
FIGURE 5.1 - PARCEL 22, LOCATION 5, LOOKING DOWNSTREAM

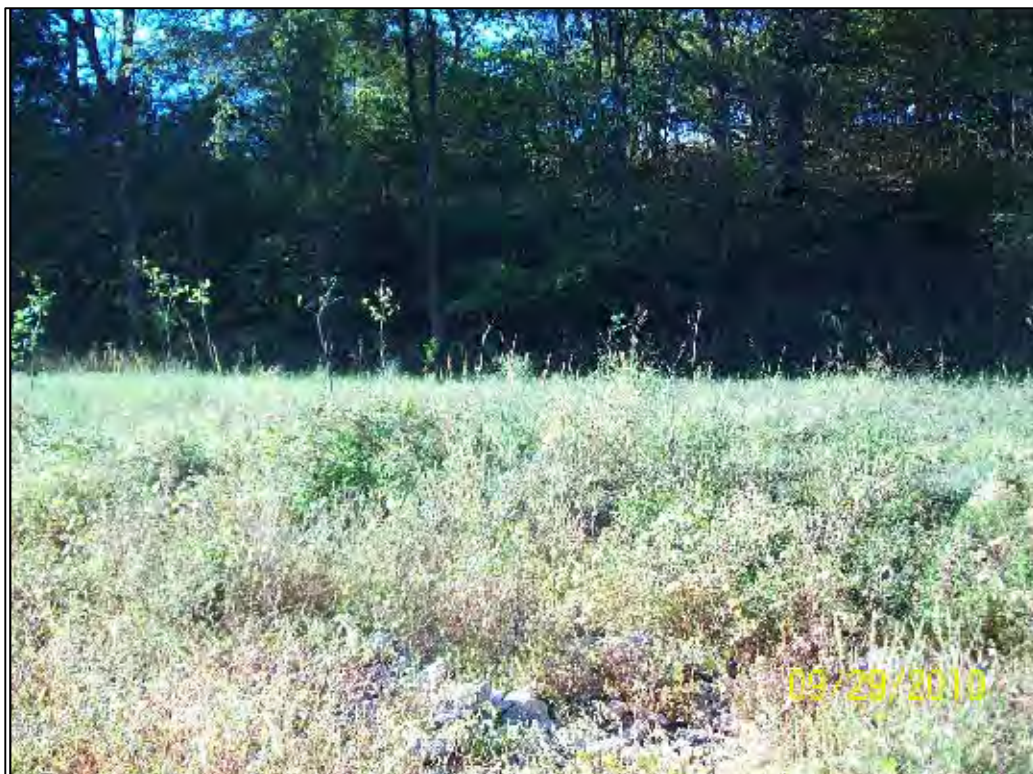
FIGURE 5.2 - PARCEL 22, LOCATION 5, NORTH BANK

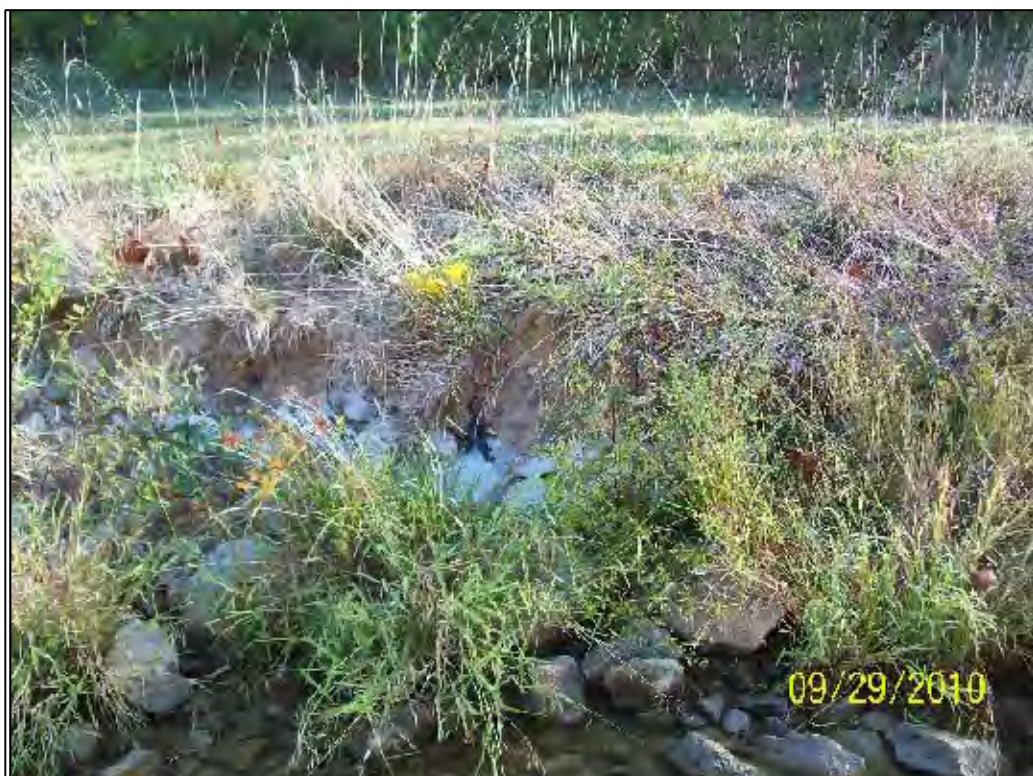
FIGURE 5.3 - PARCEL 22, LOCATION 5, SOUTH BANK

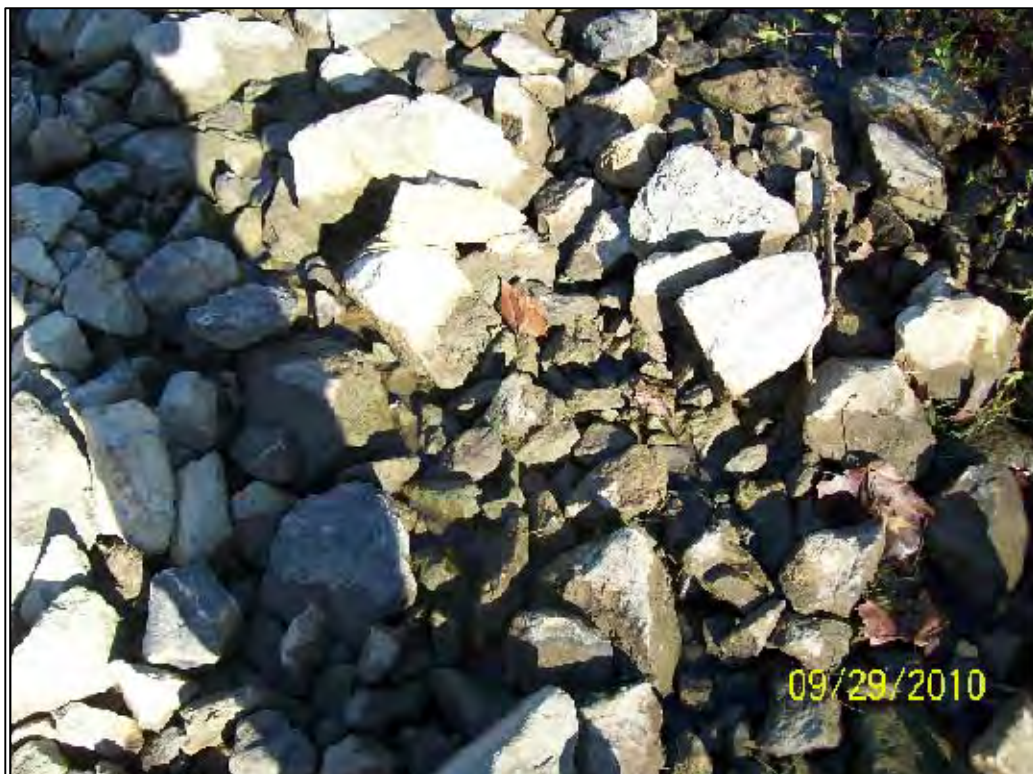
In general, the creek channel has not moved or shifted significantly since the restoration activities were completed. As expected, the creek substrate within the creek channel has been sorted, forming a smaller meandering channel with point bars in the larger overall creek channel. The photographic log, in Appendix A, illustrates the creek substrate at various locations along the creek, consisting of stones of varying sizes.

FIGURE 5.4 - PARCEL 22, LOCATION 5, CREEK SUBSTRATE

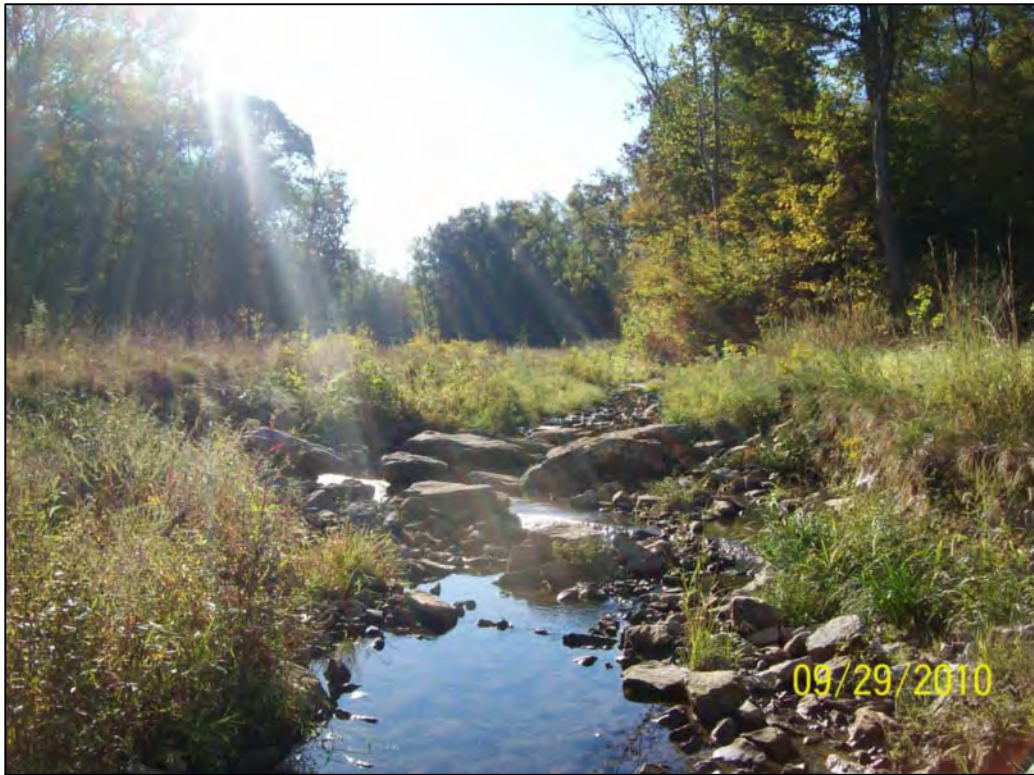
FIGURE 6.0 - PARCEL 22, LOCATION 6, LOOKING UPSTREAM

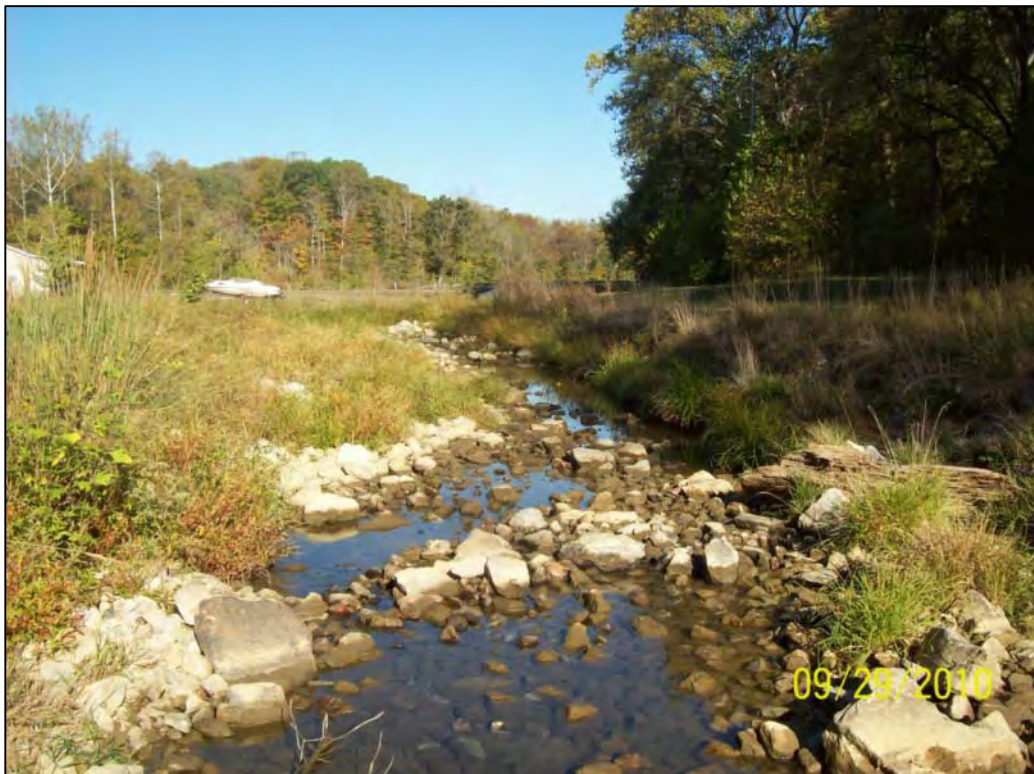
FIGURE 6.1 - PARCEL 22, LOCATION 6, LOOKING DOWNSTREAM

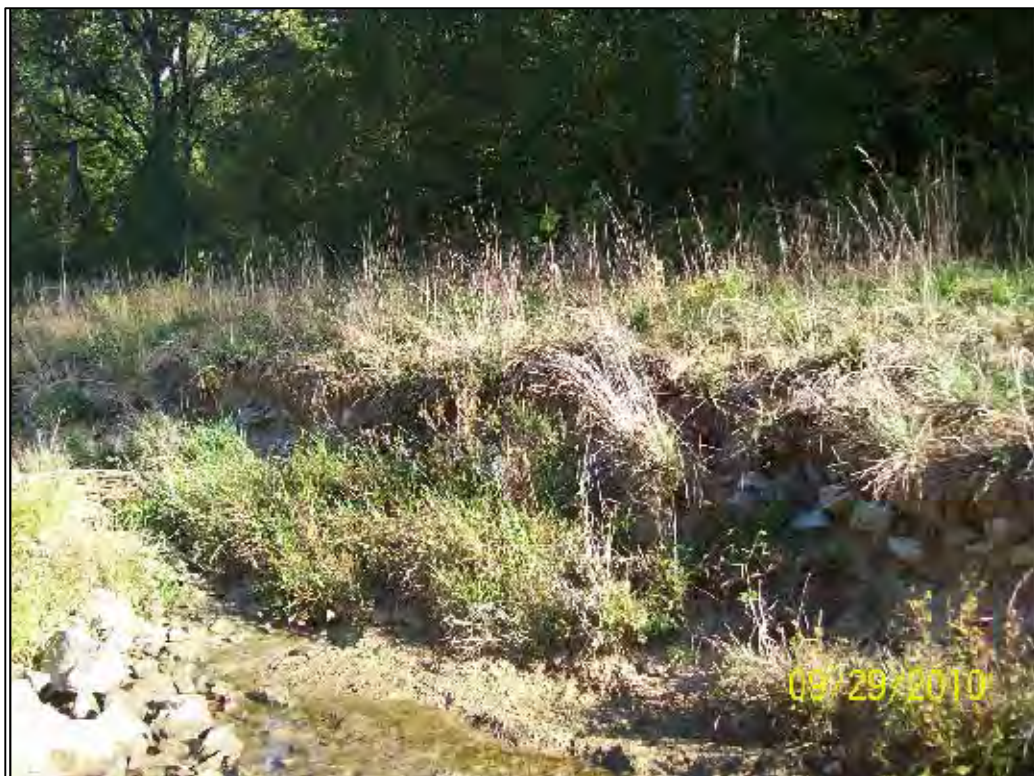
FIGURE 6.2 - PARCEL 22, LOCATION 6, NORTH BANK

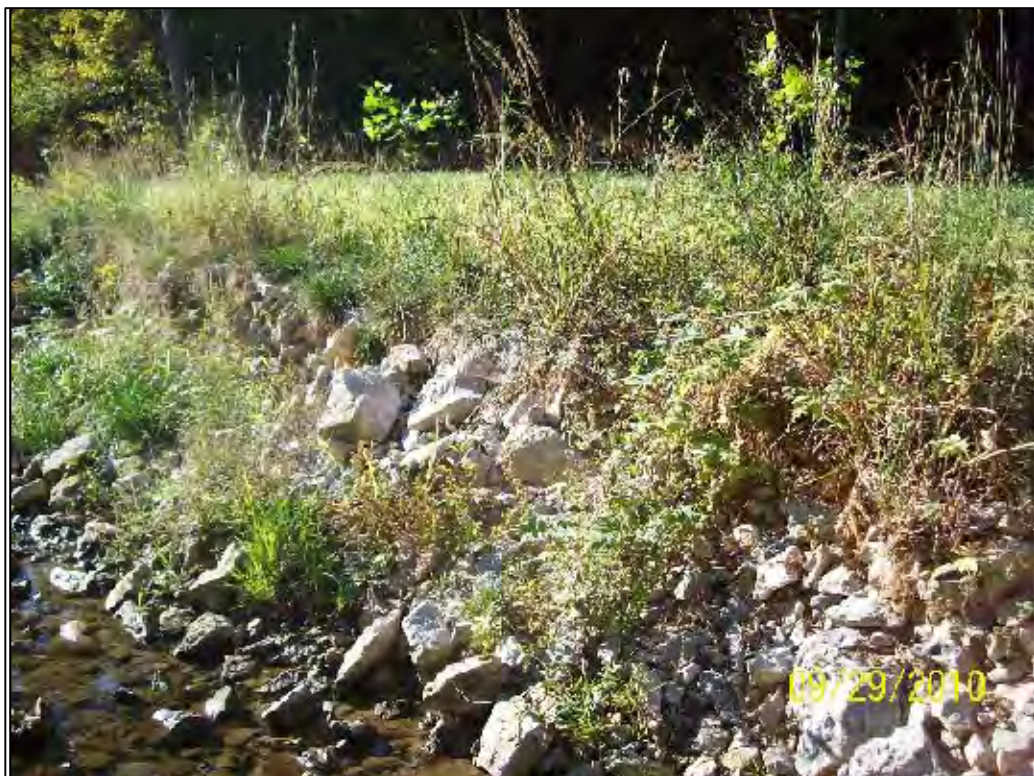
FIGURE 6.3 - PARCEL 22, LOCATION 6, SOUTH BANK

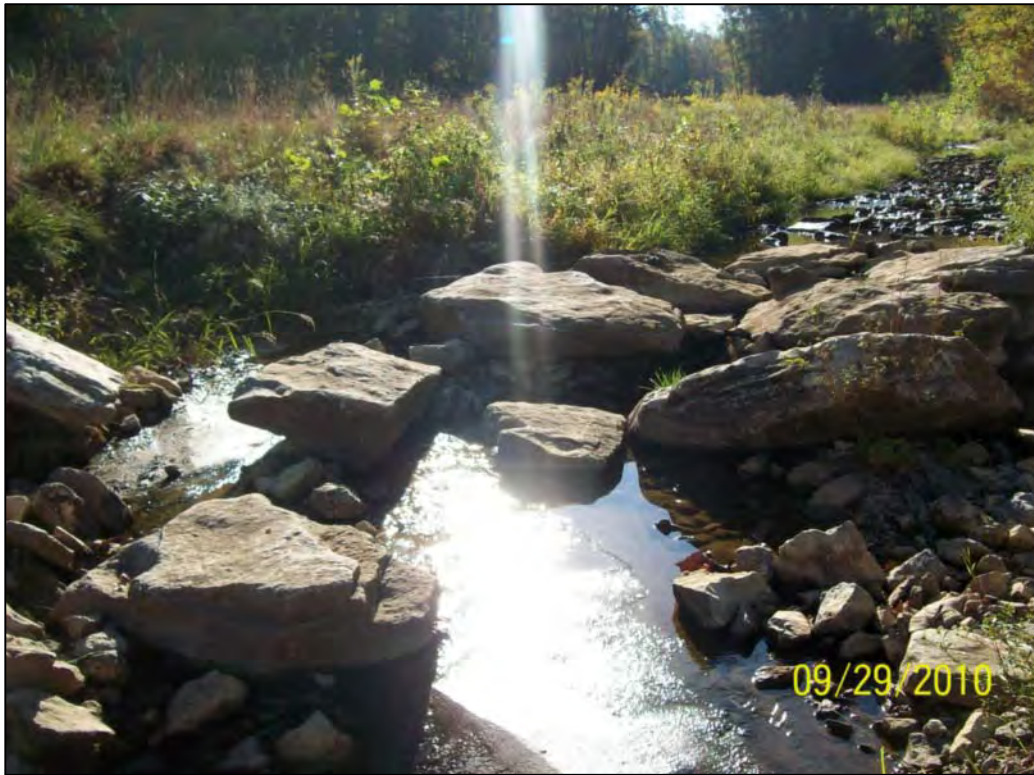
FIGURE 7.0 - PARCEL 22, LOCATION 7, FORCEMAIN CROSSING, LOOKING UPSTREAM

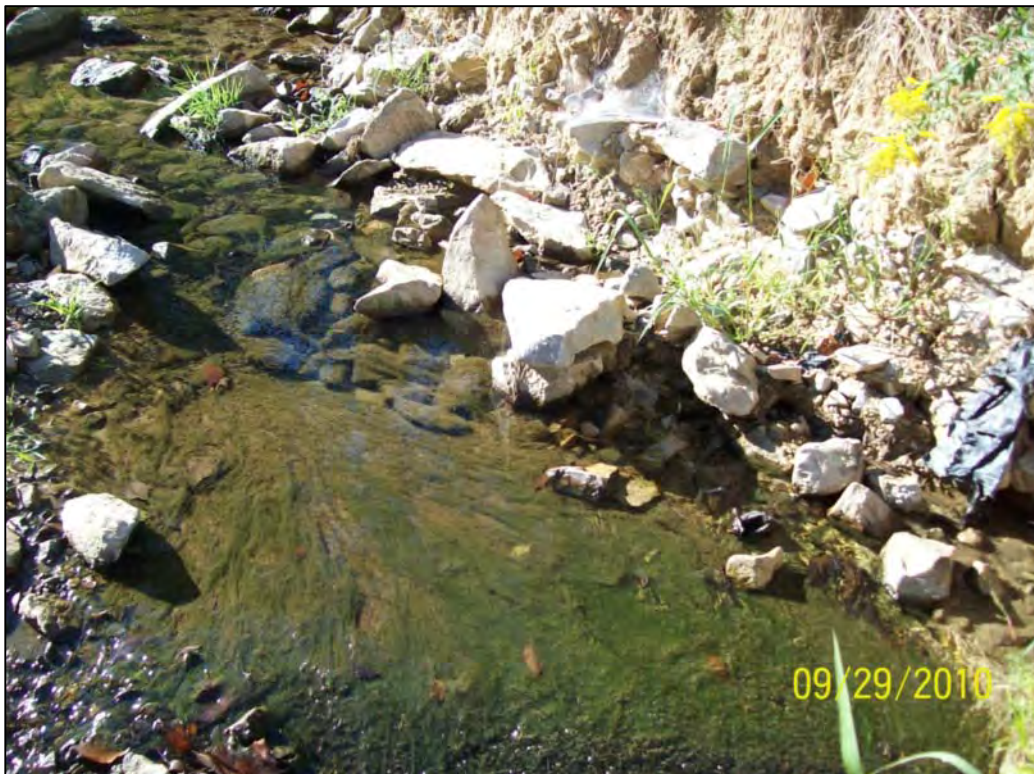
FIGURE 7.1 - PARCEL 22, LOCATION 7, GAS LINE CROSSING

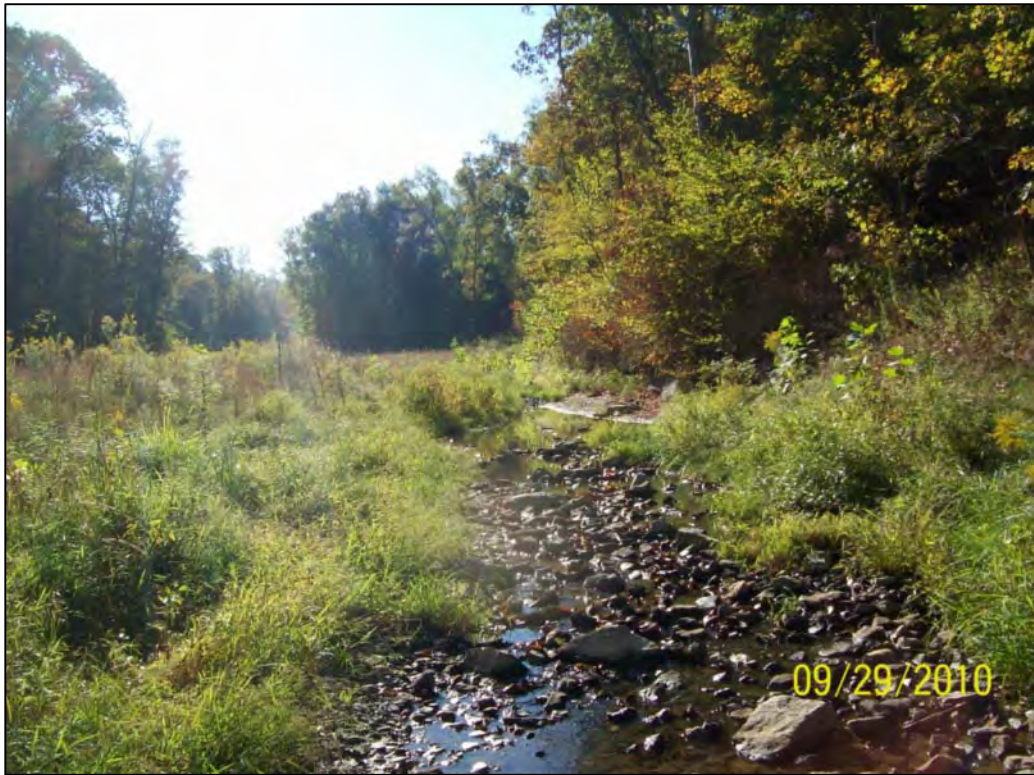
FIGURE 8.0 - PARCEL 22, LOCATION 8, LOOKING UPSTREAM

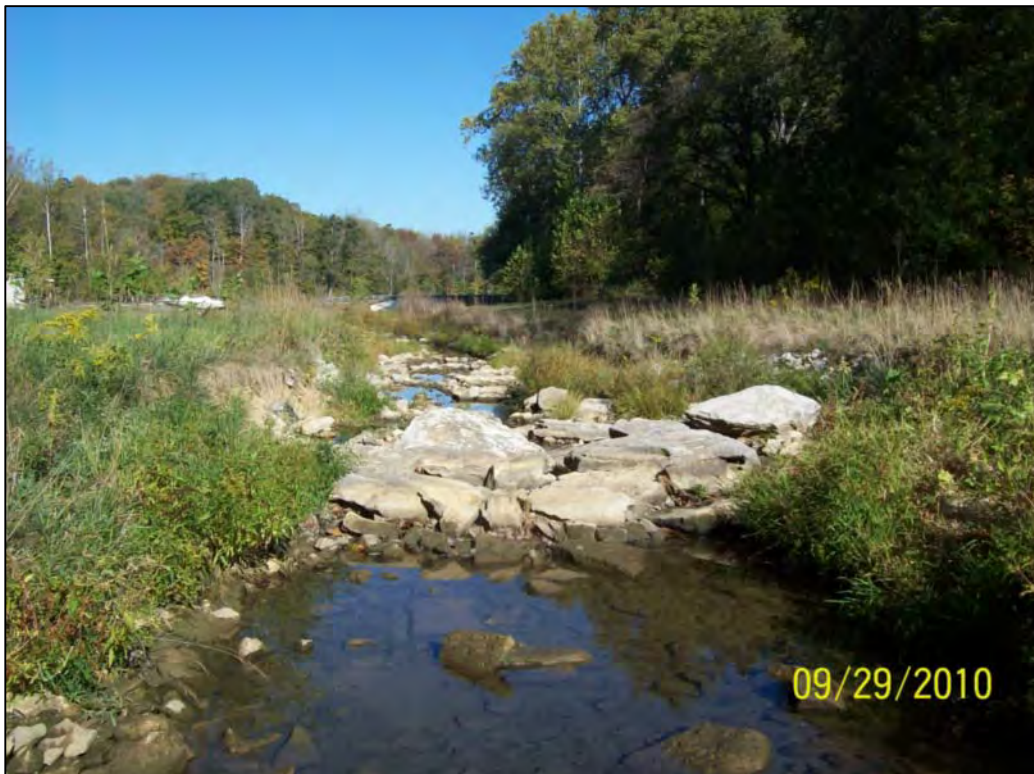
FIGURE 8.1 - PARCEL 22, LOCATION 8, LOOKING DOWNSTREAM

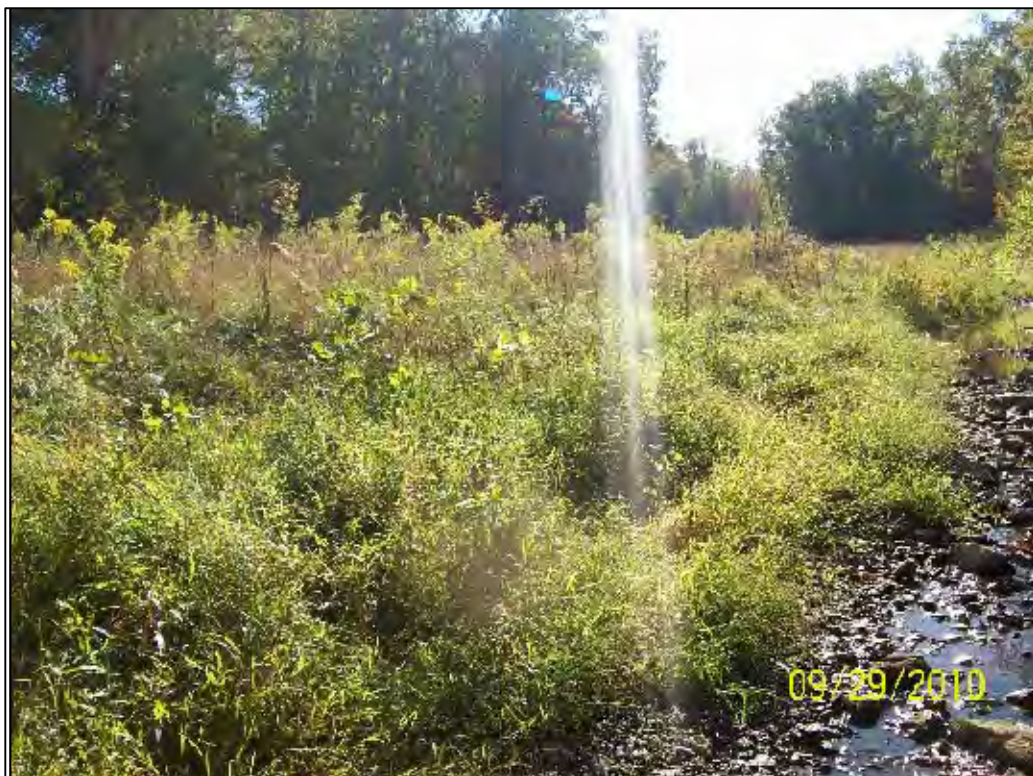
FIGURE 8.2 - PARCEL 22, LOCATION 8, NORTH BANK
