# **2010 PARCEL 22 MONITORING REPORT**

**BAILEY'S BRANCH AND PLEASANT RUN REMOVAL ACTION  
BEDFORD, INDIANA**

**Prepared For:**  
**General Motors LLC**

**FEBRUARY 2011**

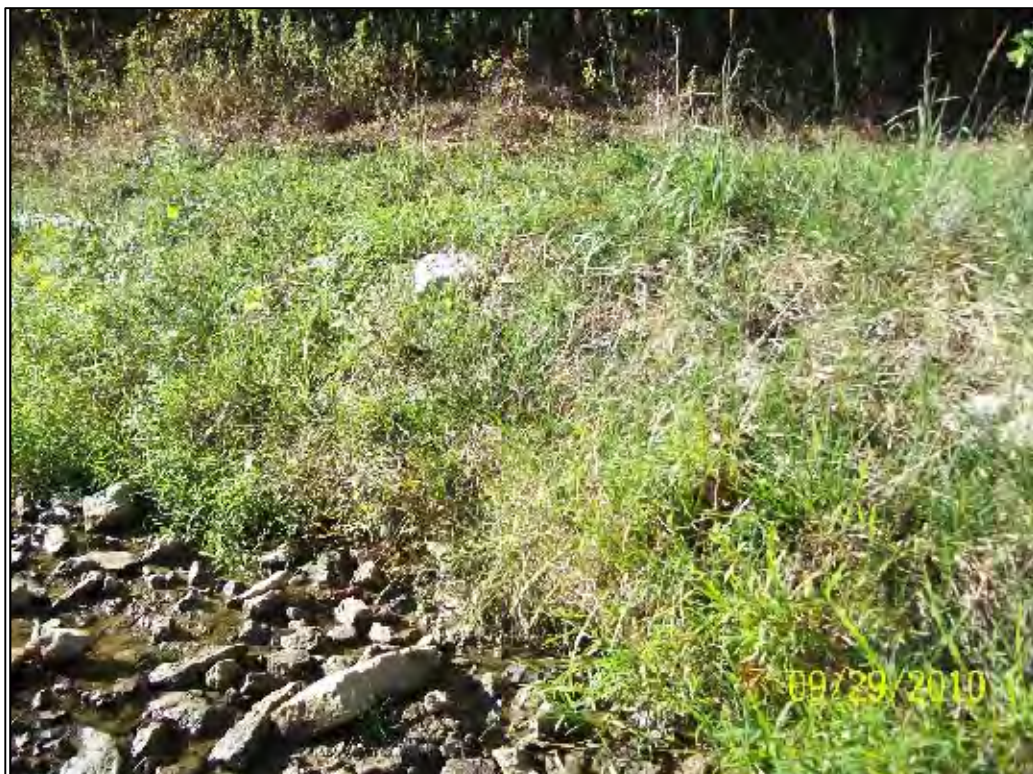
FIGURE 8.3 - PARCEL 22, LOCATION 8, SOUTH BANK

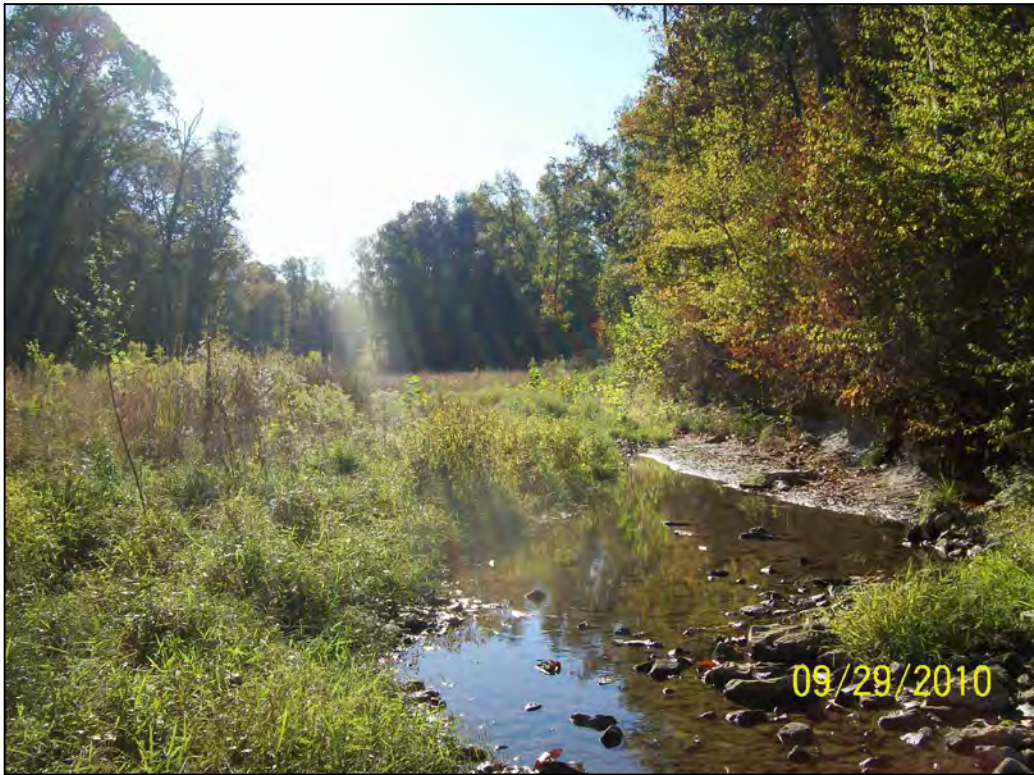
FIGURE 9.0 - PARCEL 22, LOCATION 9, LOOKING UPSTREAM

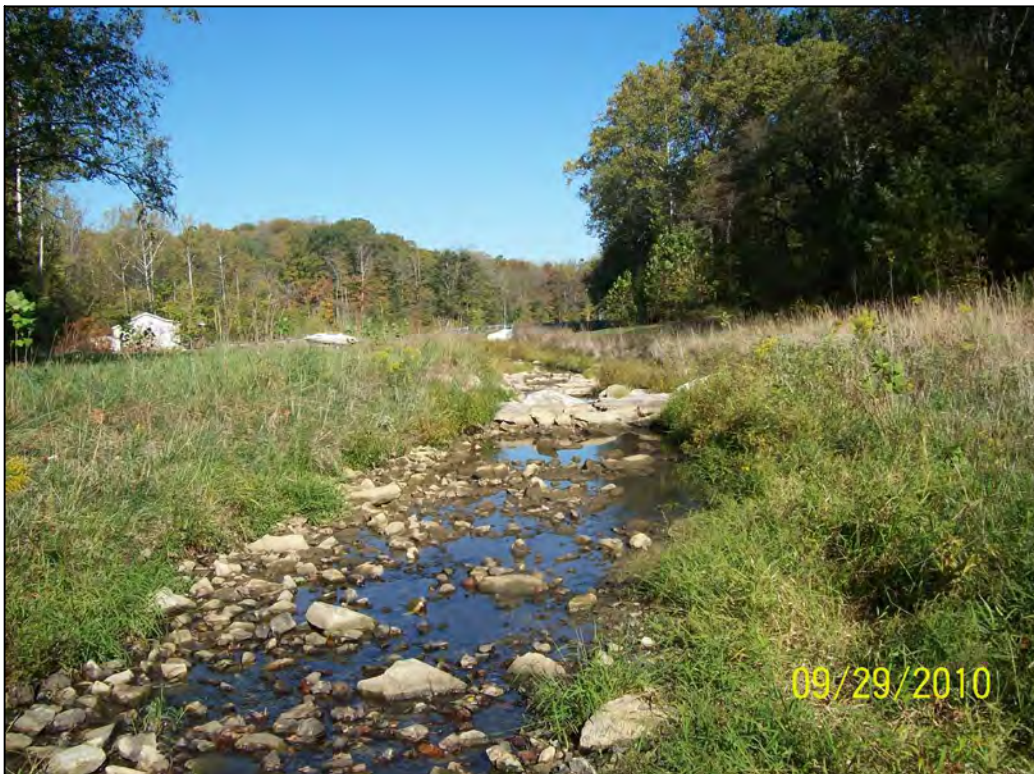
FIGURE 9.1 - PARCEL 22, LOCATION 9, LOOKING DOWNSTREAM

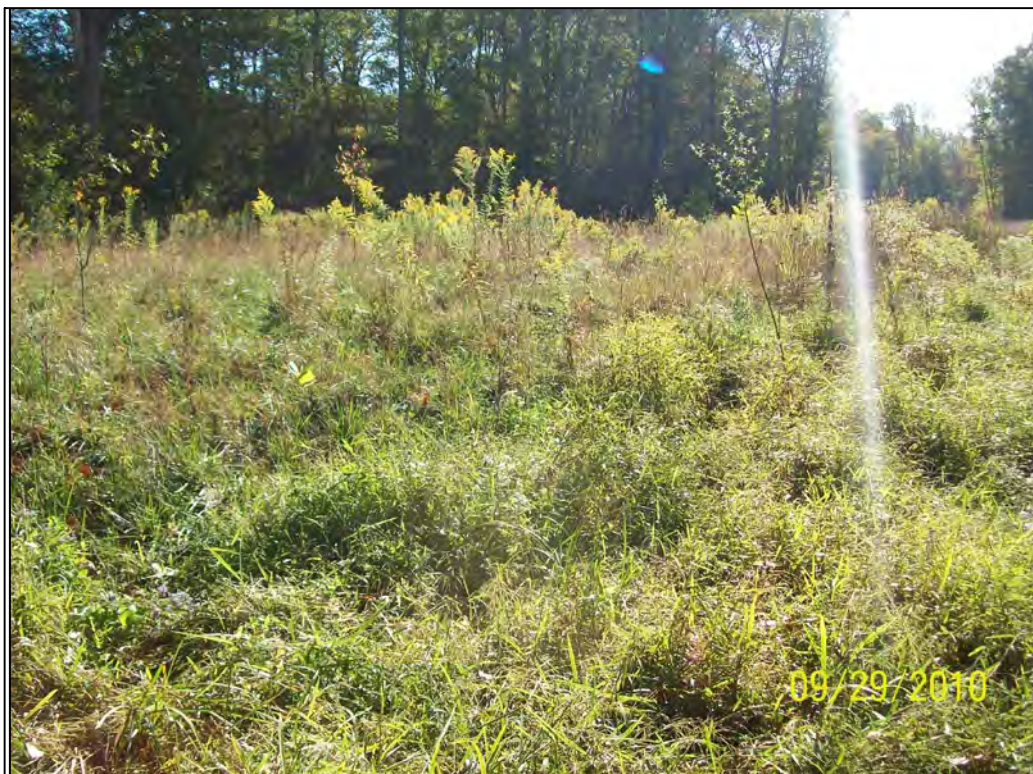
FIGURE 9.2 - PARCEL 22, LOCATION 9, LOOKING NORTH-EAST

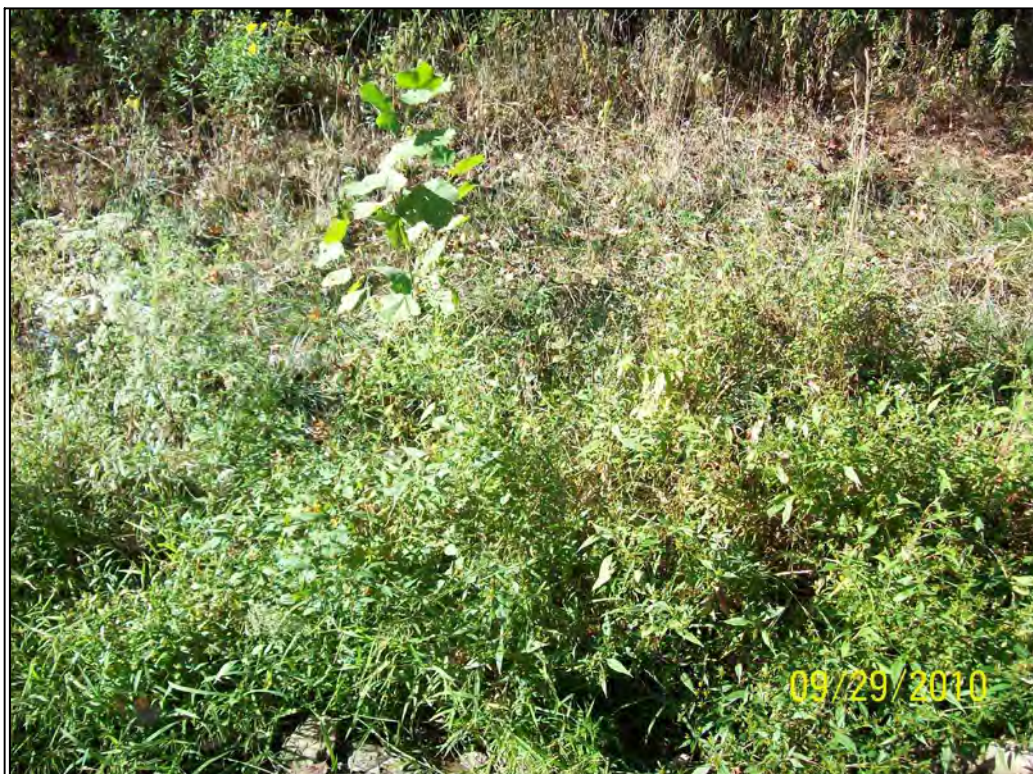
FIGURE 9.3 - PARCEL 22, LOCATION 9, SOUTH BANK

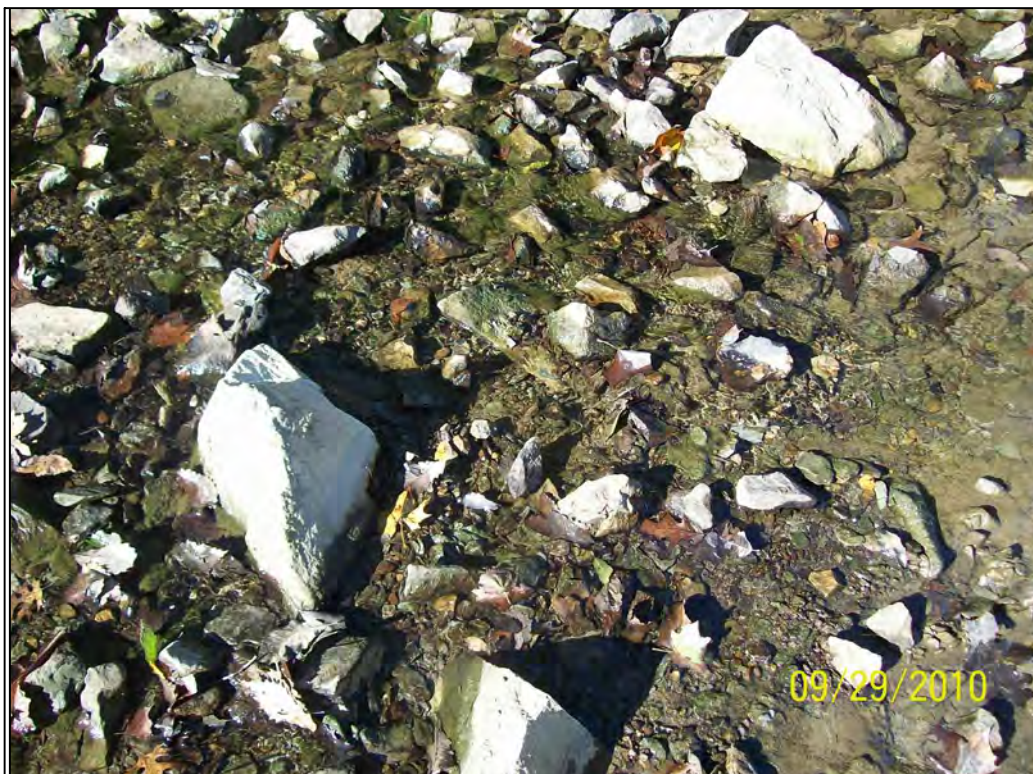
In general, the creek channel has not moved or shifted significantly since the restoration activities were completed. As expected, the creek substrate within the creek channel has been sorted, forming a smaller meandering channel with point bars in the larger overall creek channel. The photographic log, in Appendix A, illustrates the creek substrate at various locations along the creek, consisting of stones of varying sizes.

FIGURE 9.4 - PARCEL 22, LOCATION 9, CREEK SUBSTRATE

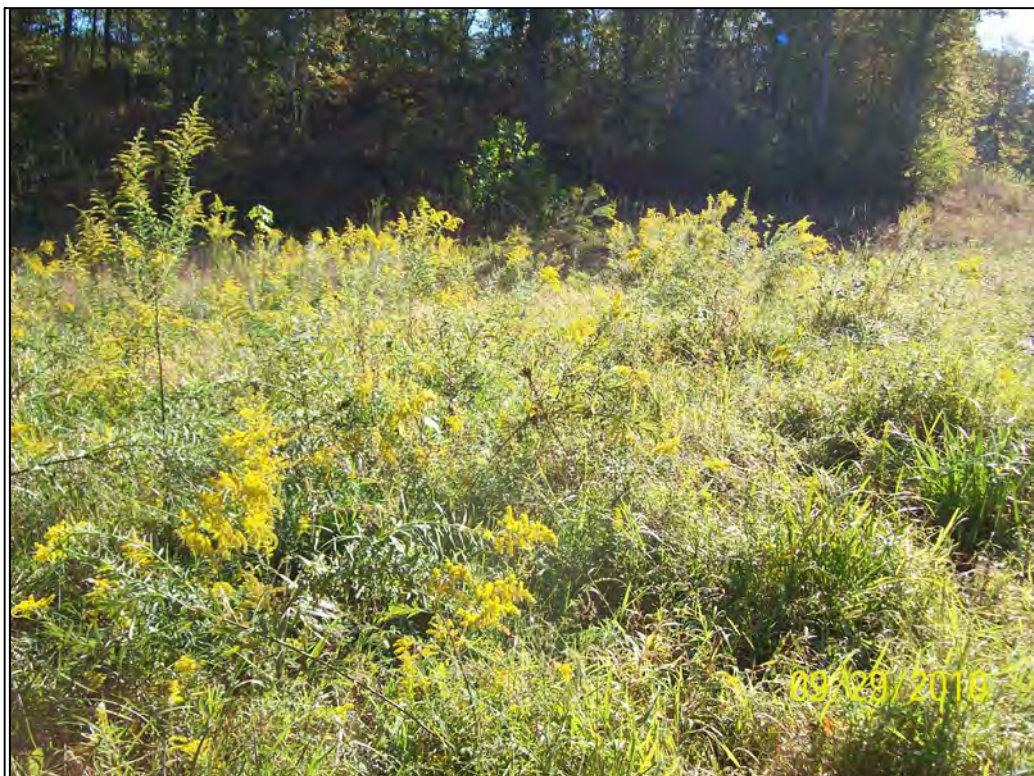
FIGURE 10.2 - PARCEL 22, LOCATION 10, NORTH BANK

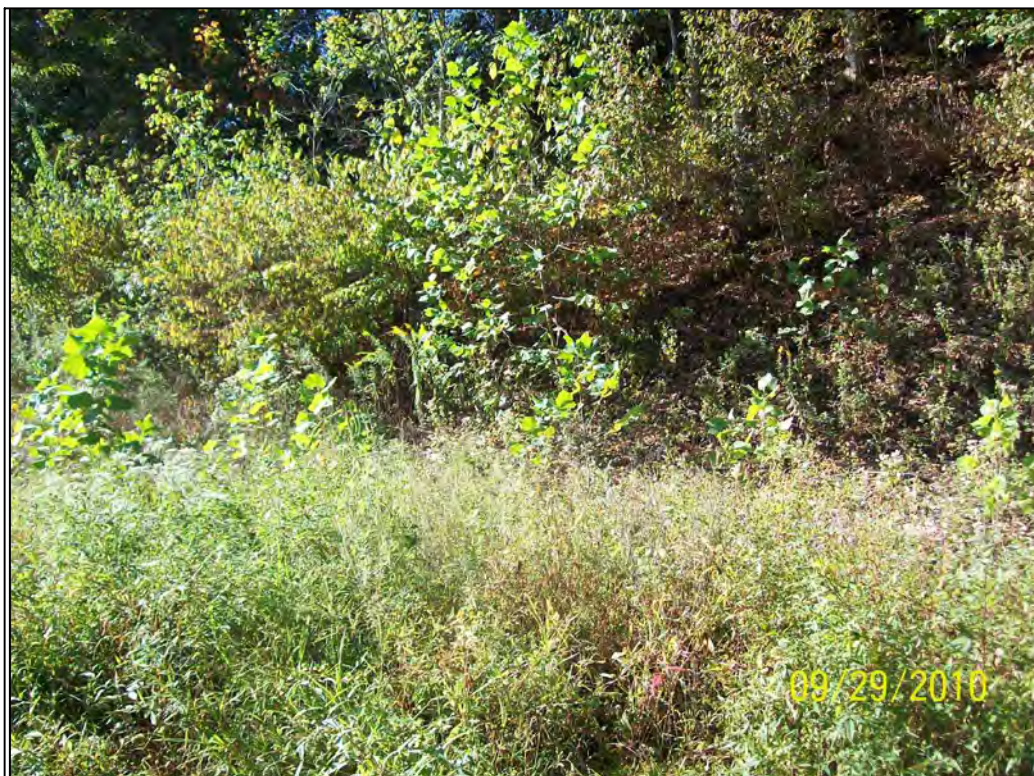
FIGURE 10.3 - PARCEL 22, LOCATION 10, SOUTH BANK

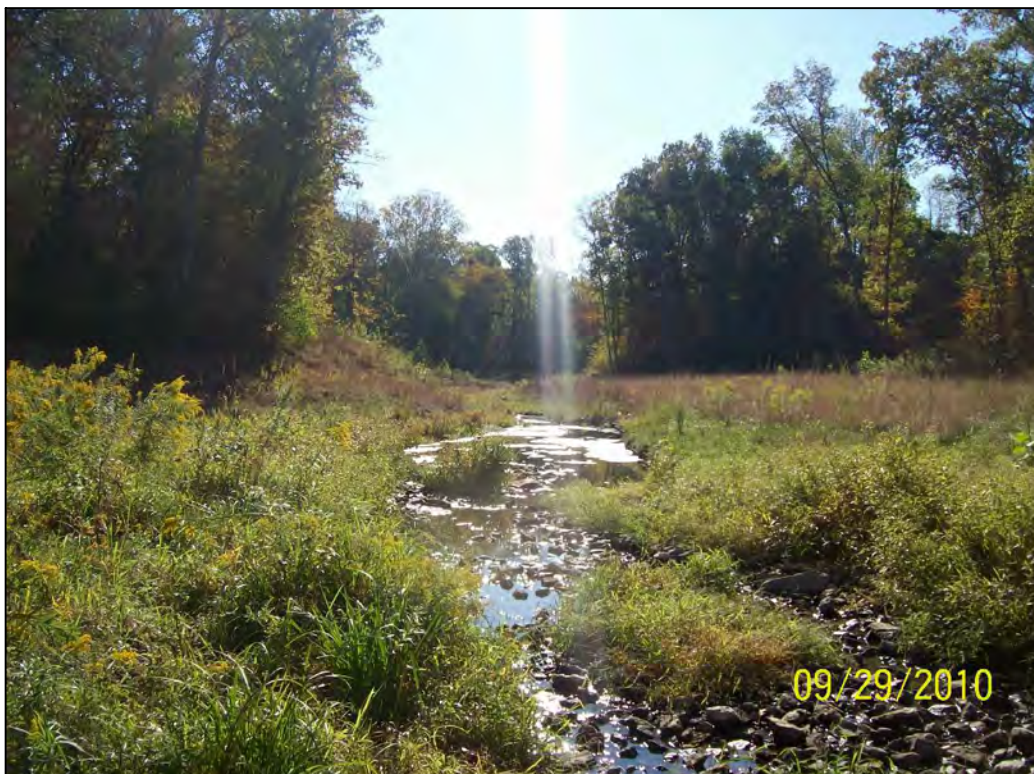
FIGURE 10.0 - PARCEL 22, LOCATION 10, LOOKING UPSTREAM

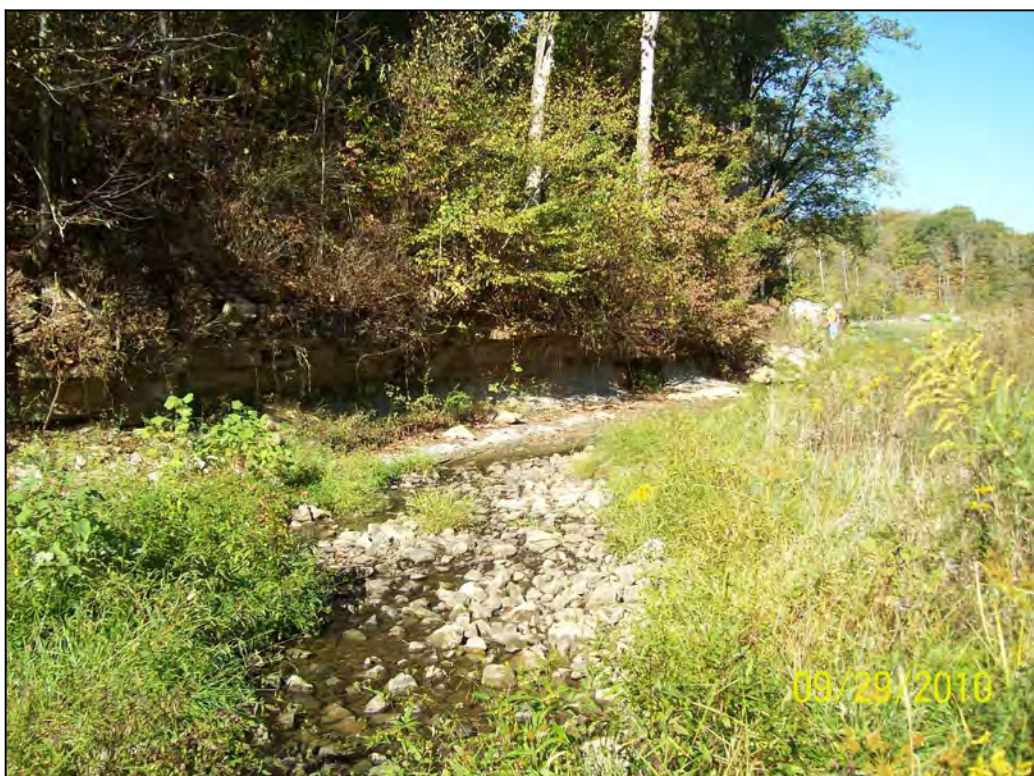
FIGURE 10.1 - PARCEL 22, LOCATION 10, LOOKING DOWNSTREAM
