## Public Information Session December 10, 2014

# REMOVAL ACTION STATUS

G M C E T B E D F O R D F A C I L I T Y , B E D F O R D , I N D I A N A

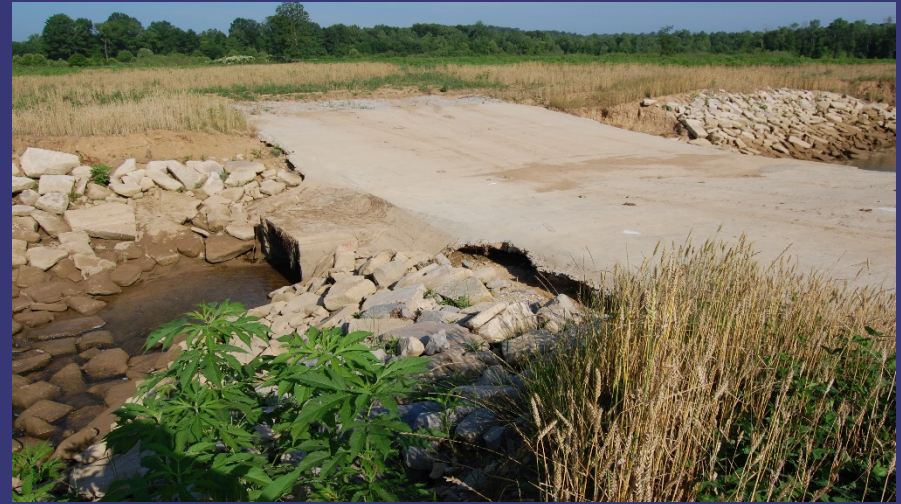
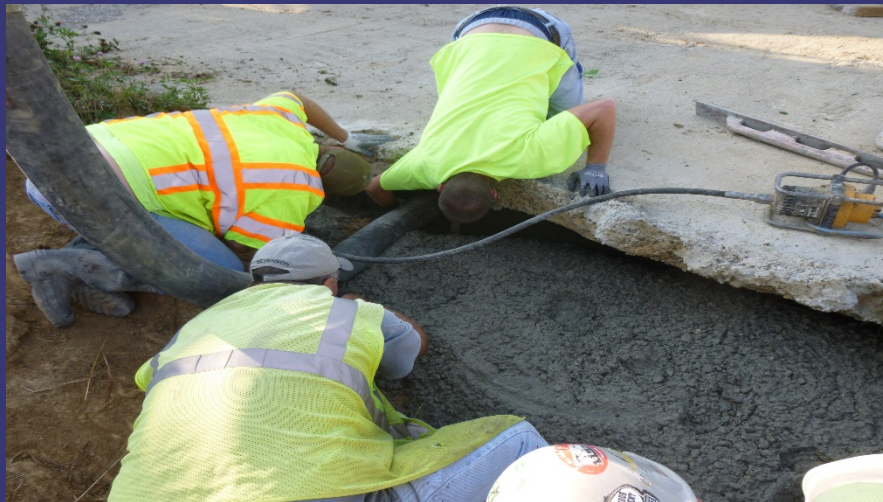
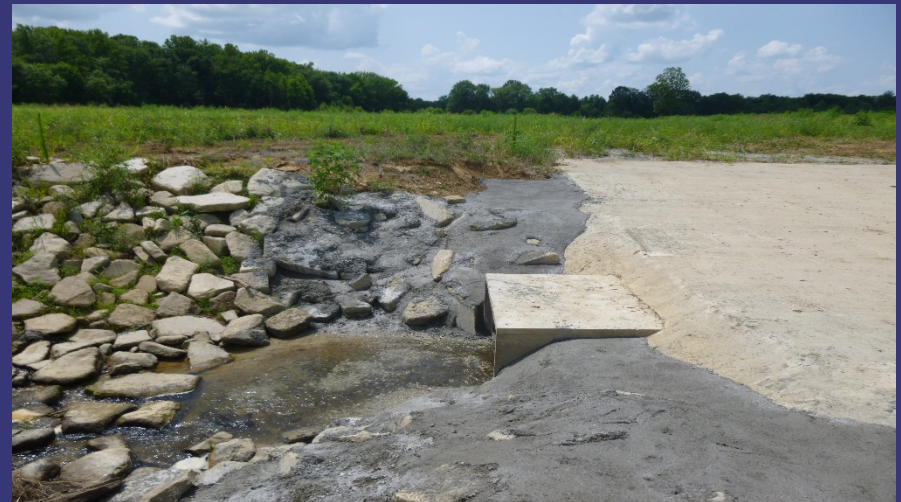
- Spring flooding caused some undercutting of the concrete crossing on Parcel 40
- Reinforced the sidewalls of the crossing with additional concrete

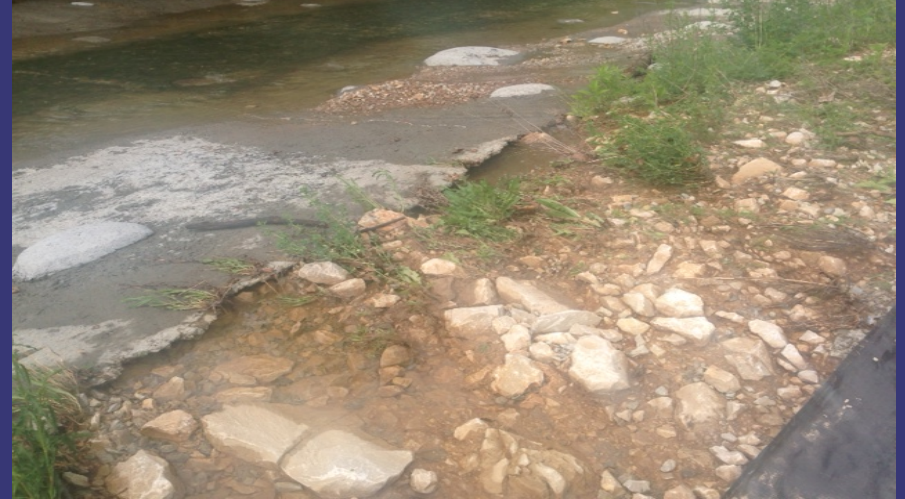
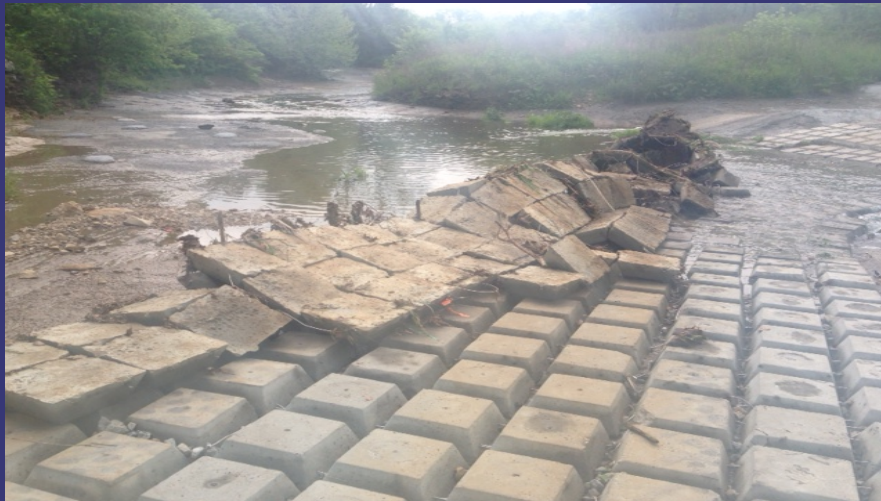
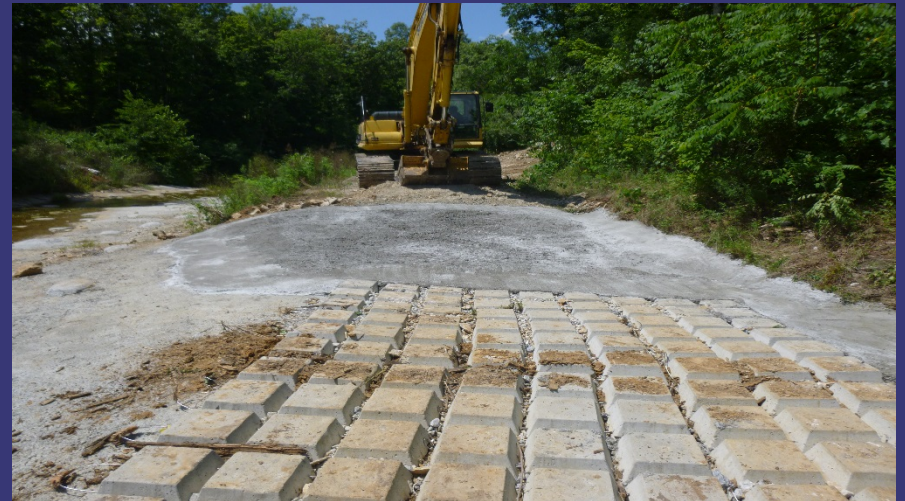
- High stream flow caused some undercutting of the concrete channel
- Also caused concrete cable mat to flip
- Placed additional concrete to reinforce the crossing

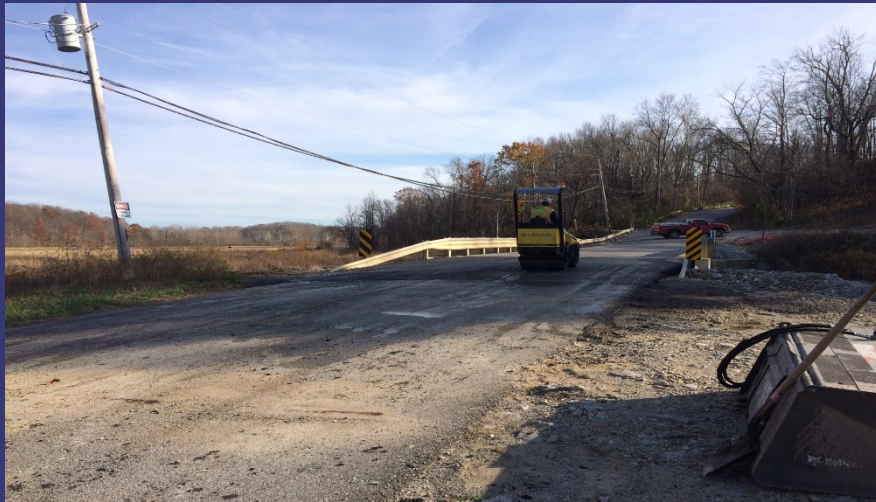
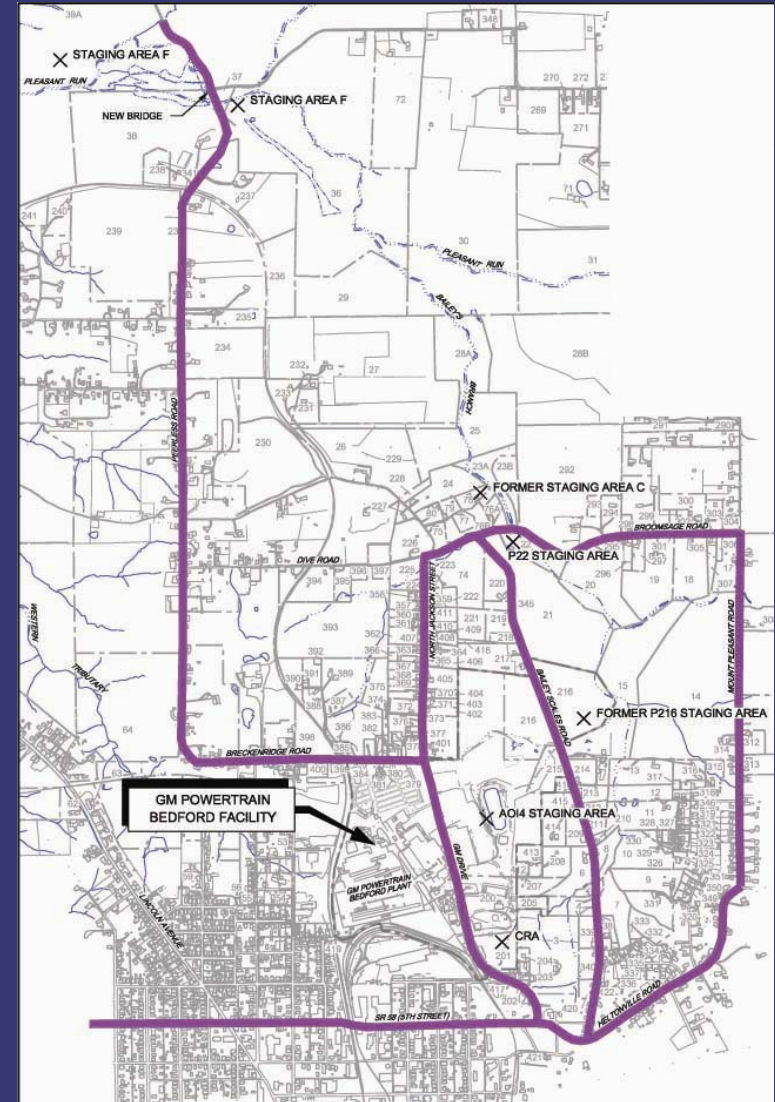
- Inspected the former traffic route with County Highway Superintendent
- One issue was identified on the north side of the Peerless Road bridge where it joins the road surface
- Repair has been completed

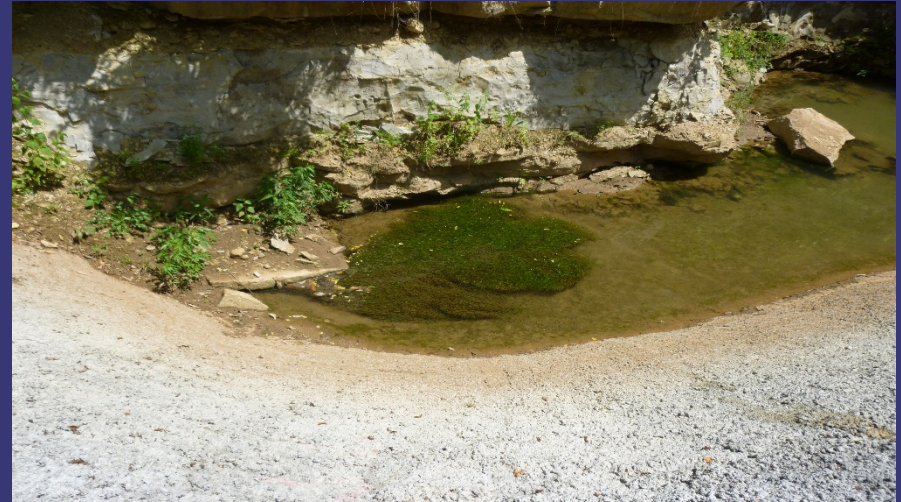
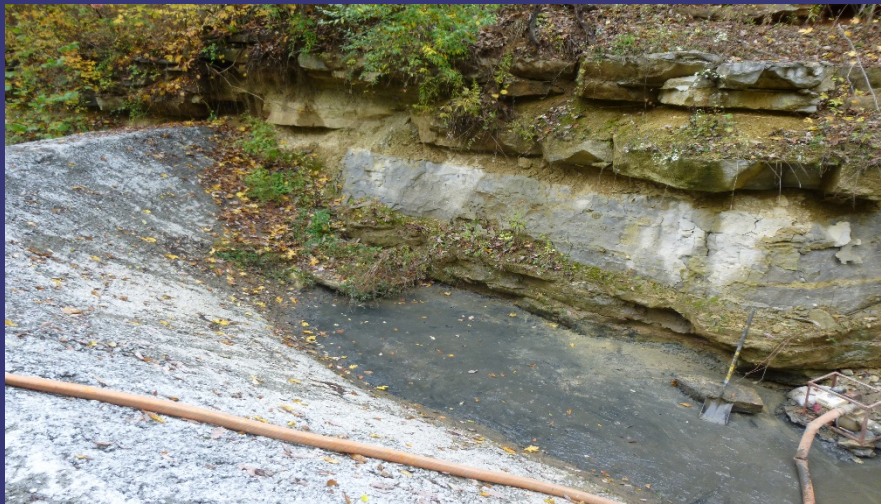
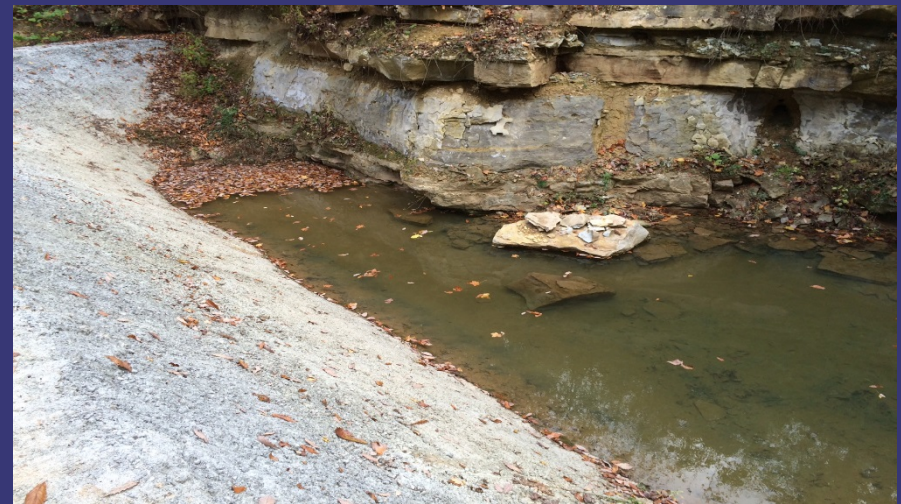
- Removed sediment accumulation (a result of rain washing over upland soils)
- Improved drainage for Spring 18
