# East Plant Area TSCA Vault Annual Report Calendar Year 2015

GM CET Bedford Facility  
105 GM Drive  
Bedford, Indiana  
EPA ID# IND006036099

General Motors LLC

GHD | 651 Colby Drive Waterloo Ontario N2V 1C2  
031968 | Report No 391 Revision 1 | July 10 2017

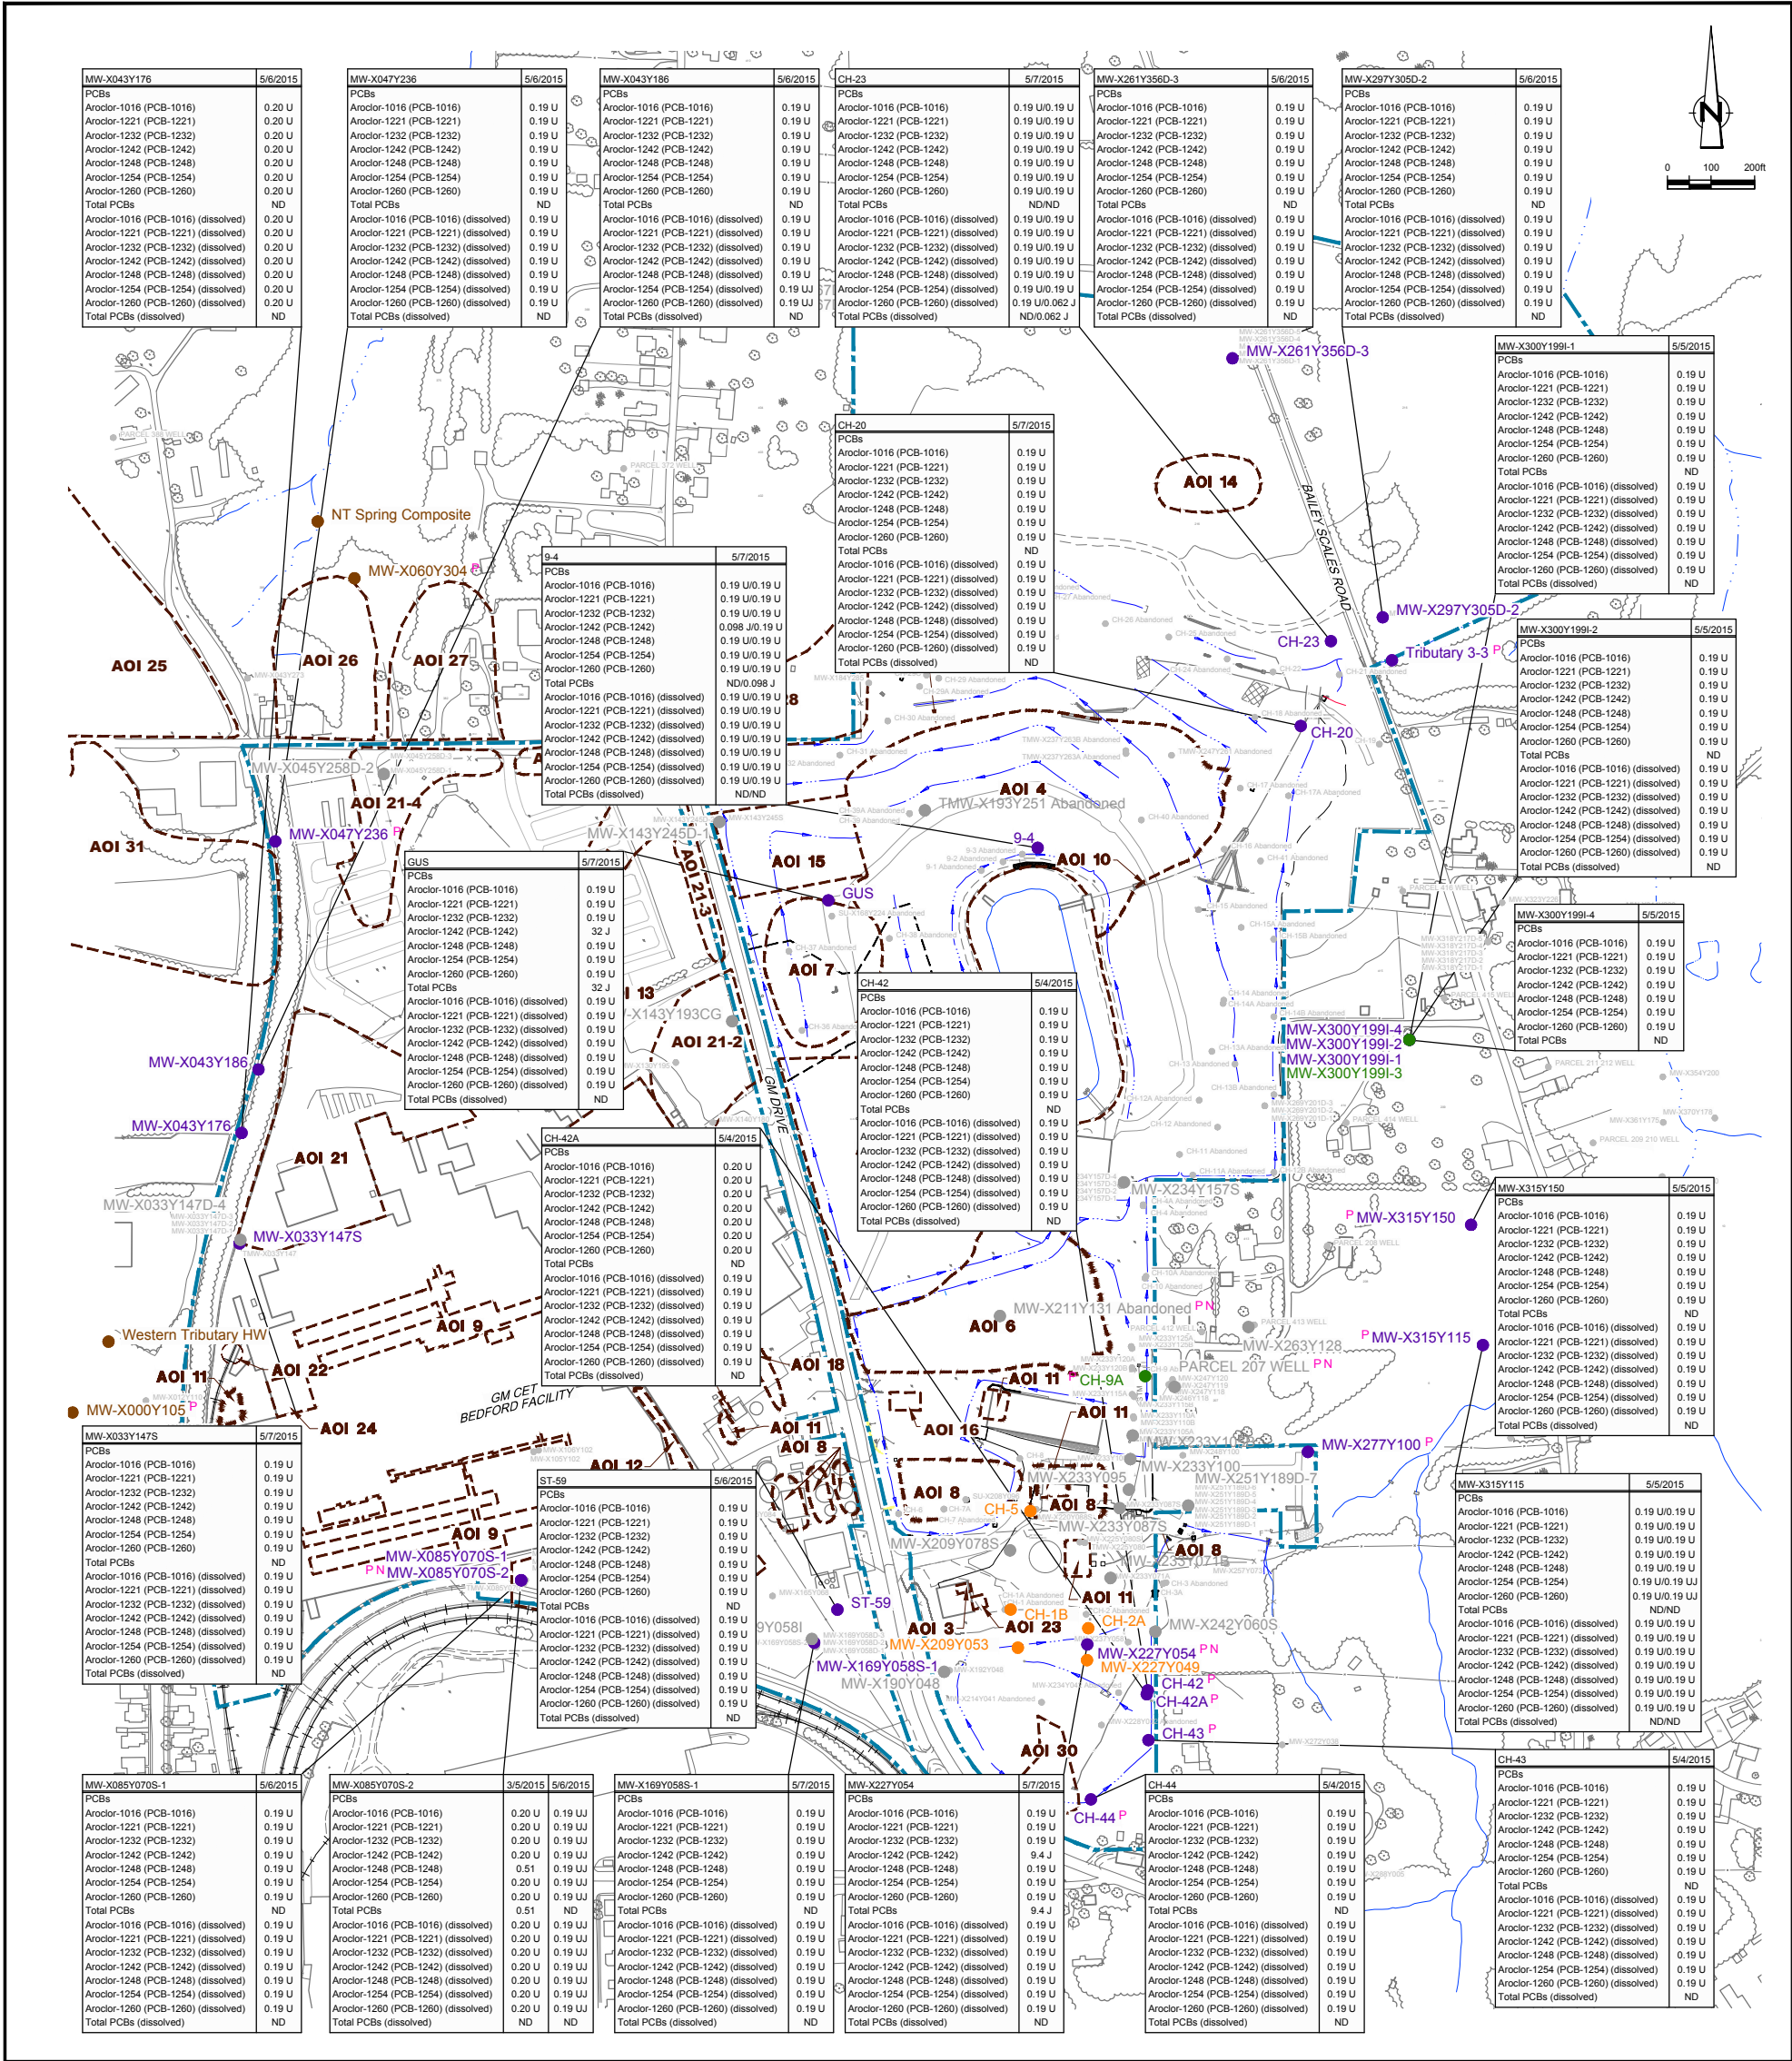
| | | Drawing No:<br>figure 3.1 |

PCBs were detected at the following sampling locations: the GUS sump (32 J µg/L), corehole 9-4 (non-detect in parent sample, 0.098 J µg/L in duplicate sample), CH-23 (0.062 J µg/L for the parent sample and non-detect for the duplicate sample), and MW-X227Y054 (9.4 J µg/L). MW-X227Y054 had previous detections in May and November 2014, June and October 2013, and July 2012. Detections at other wells with previous recent detections (CH-42, CH-44, MW-X085Y070S-2, MW-X047Y236, MW-X060Y304, MW-X277Y100, MW-X315Y150, Tributary 3-3) were not observed during this event. The concentration of PCBs during this sampling event at corehole 9-4 and CH-23 were below the Maximum Contaminant Level (MCL) of 0.5 µg/L, while MW-X227Y054 and the GUS sump had concentrations above 0.5 µg/L.

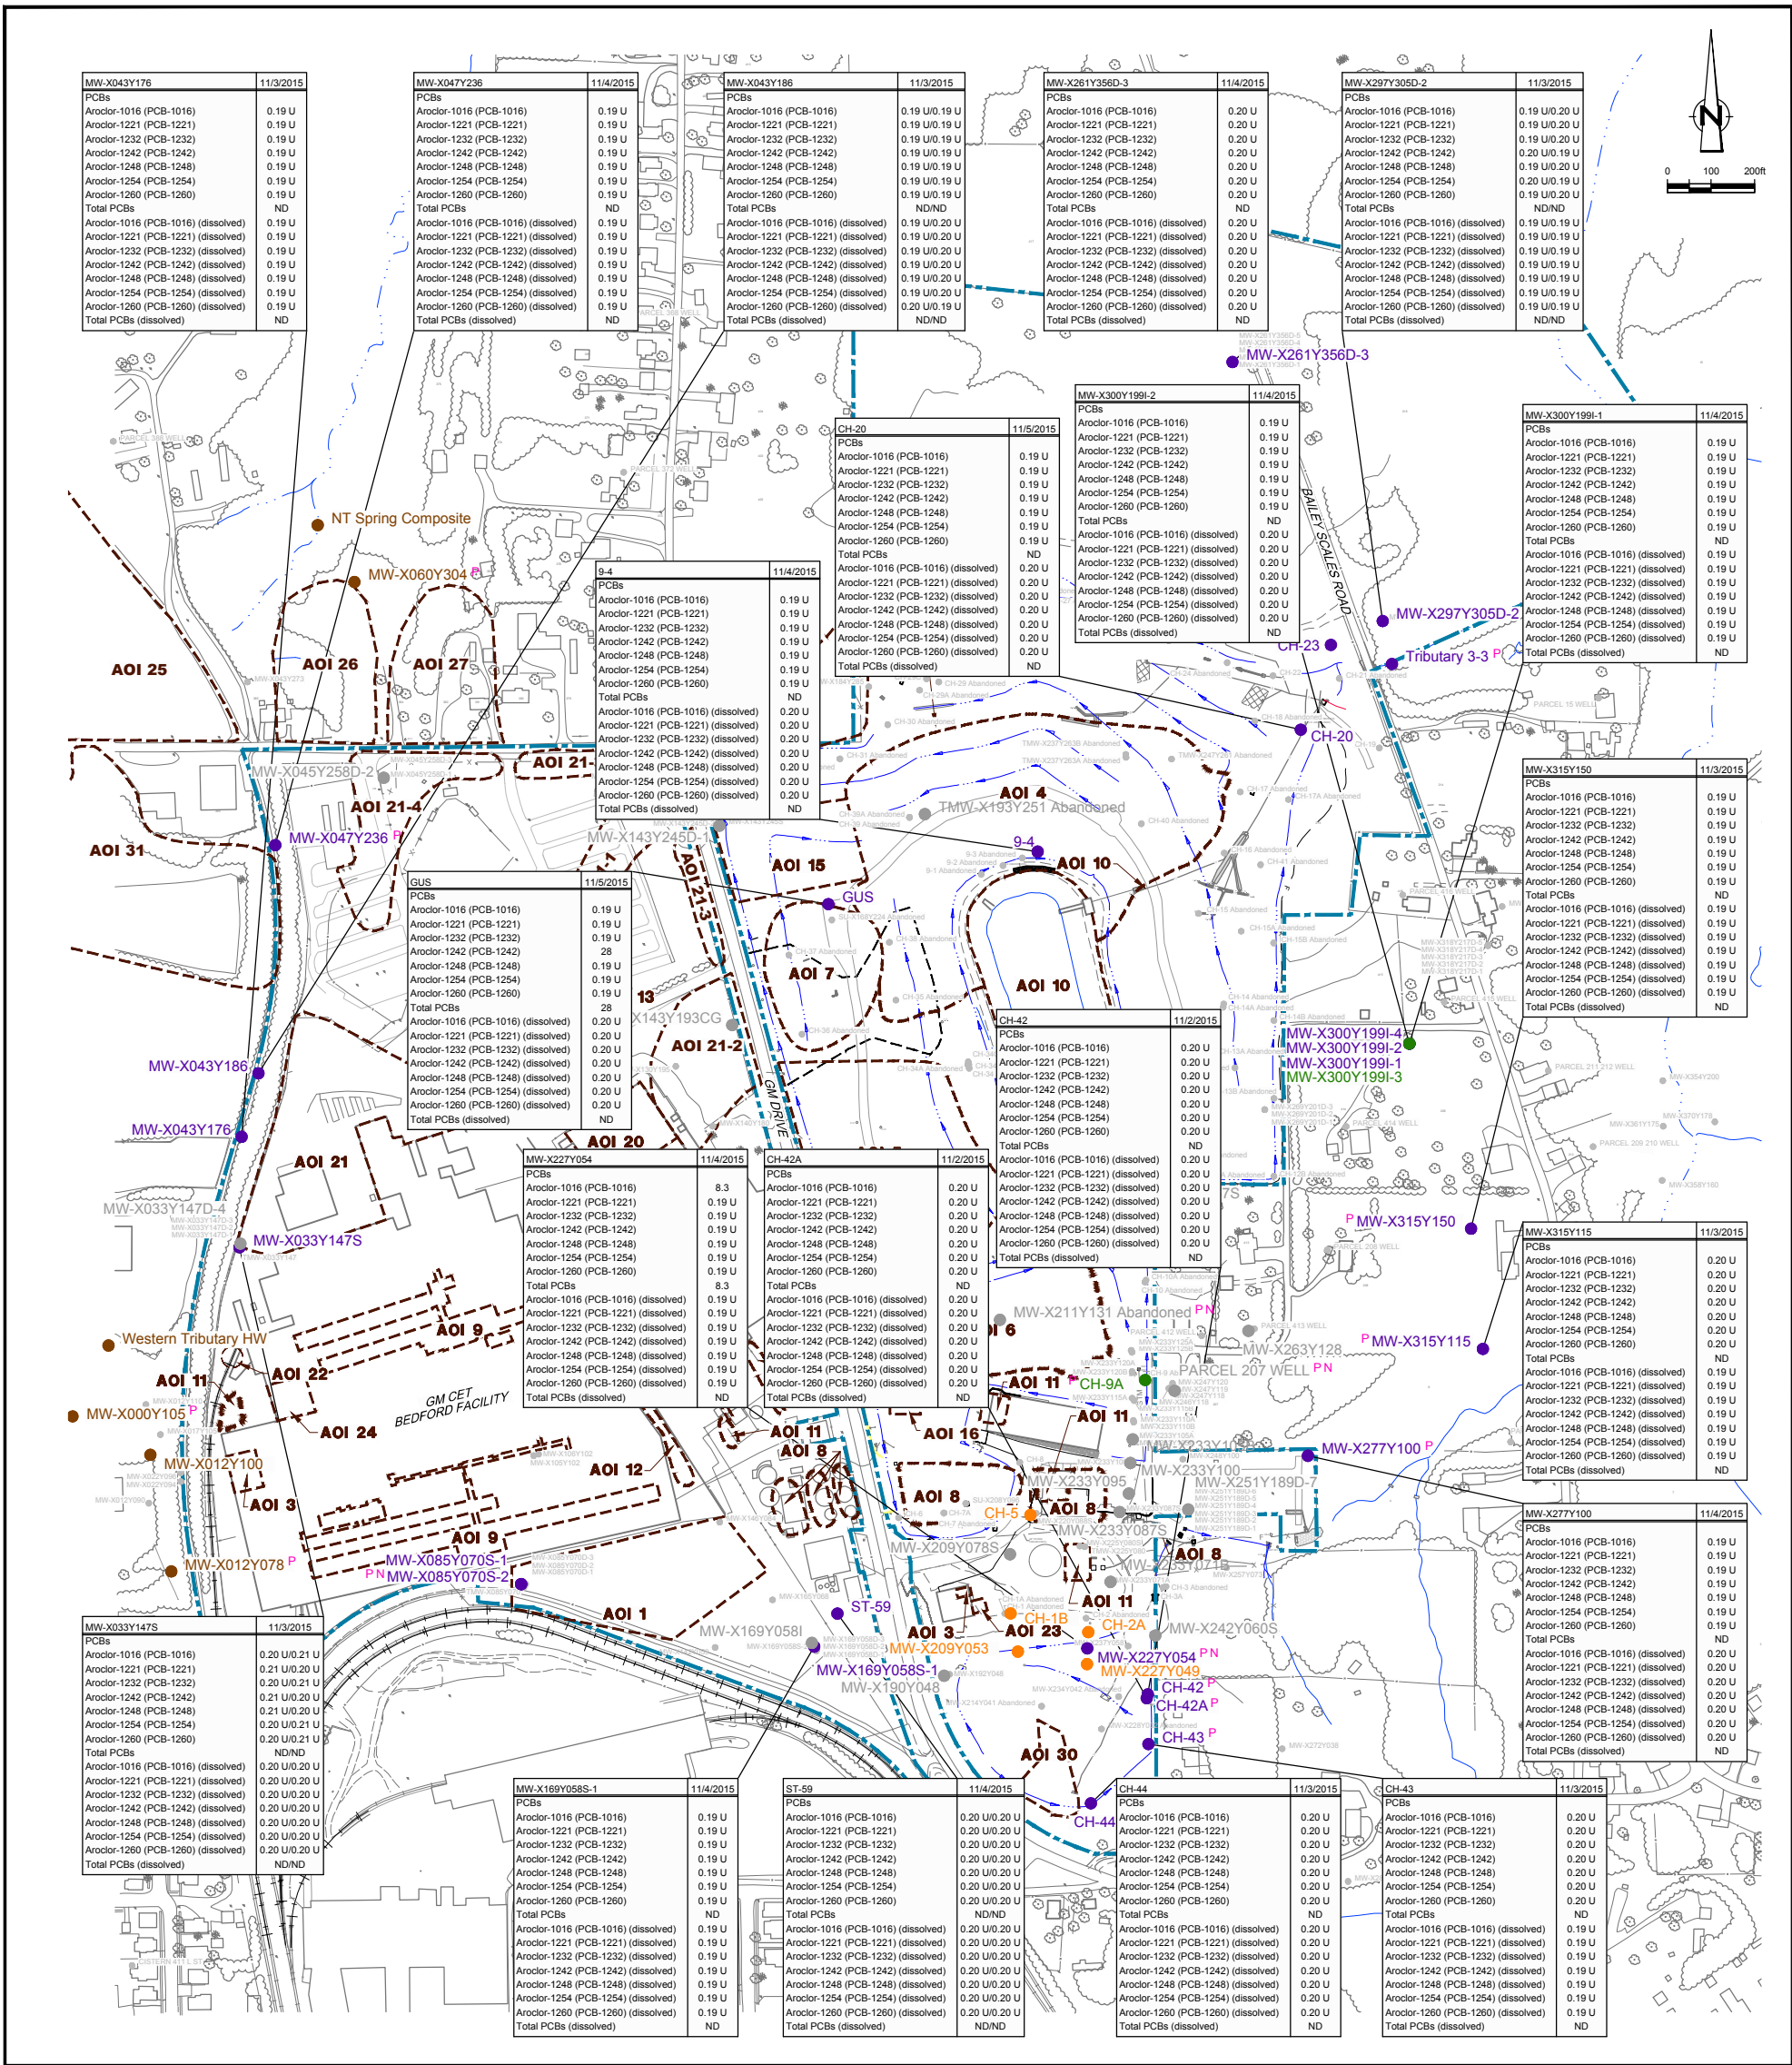
| | | Drawing No:<br>figure 3.2 |

PCBs were detected at the following sampling locations: the GUS sump and MW-X227Y054. The detection was 28 µg/L PCBs for the GUS sump. MW-X227Y054 had a detection of 8.3 µg/L for PCBs, consistent with previous detections in May 2015, May and November 2014, July 2012, June and October 2013, and May 2015. Detections at other wells with previous recent detections (corehole 9-4, CH-23, CH-42, CH-44, MW-X085Y070S-2, MW-X047Y236, MW-X060Y304, MW-X277Y100, MW-X315Y150, Tributary 3-3) were not observed during this event. The concentration of PCBs during this sampling event at MW-X227Y054 and the GUS sump (8.3 µg/L and 28 µg/L, respectively) were above the MCL of 0.5 µg/L.

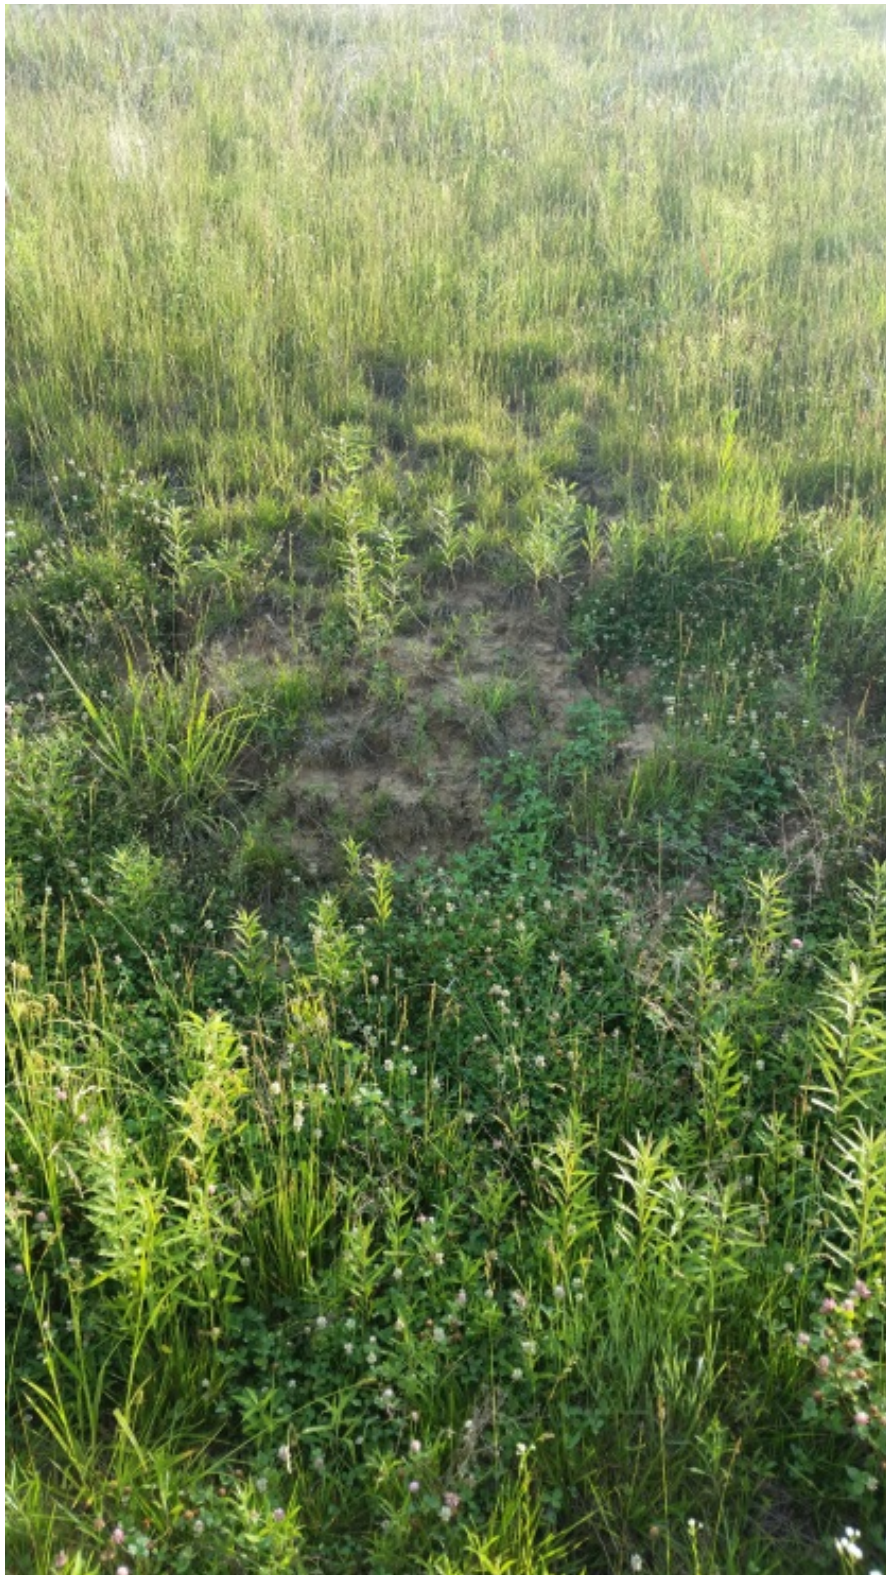
Photo 16: EV9 patchy vegetation

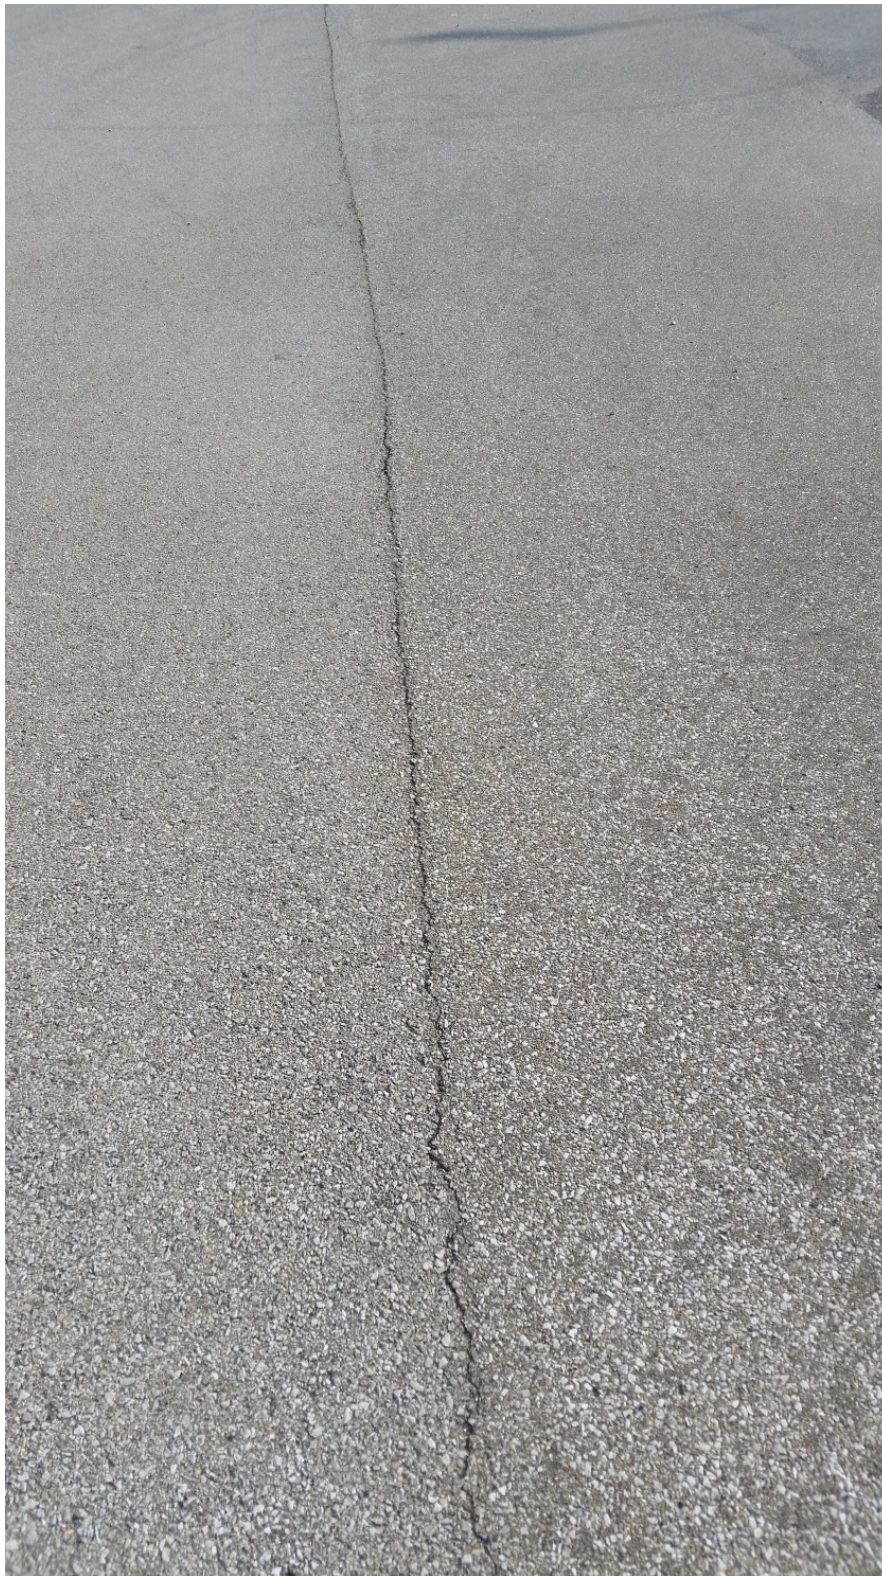
Photo 24: EA2 crack near WWTP aeration basin facing north

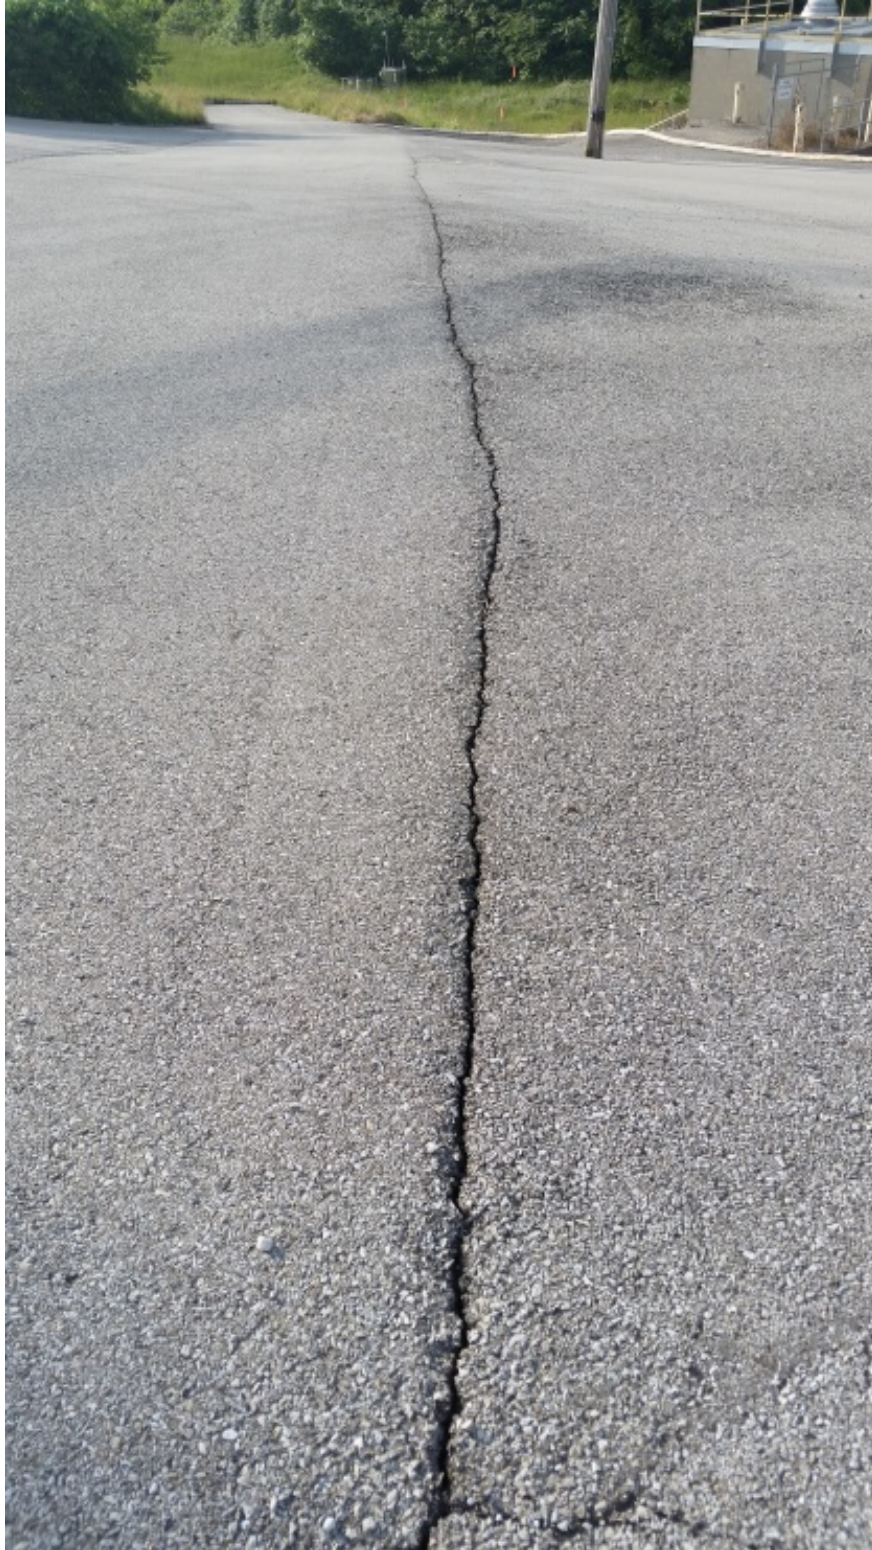
Photo 25: EA2 facing east, cracks in asphalt west of Parcel 205

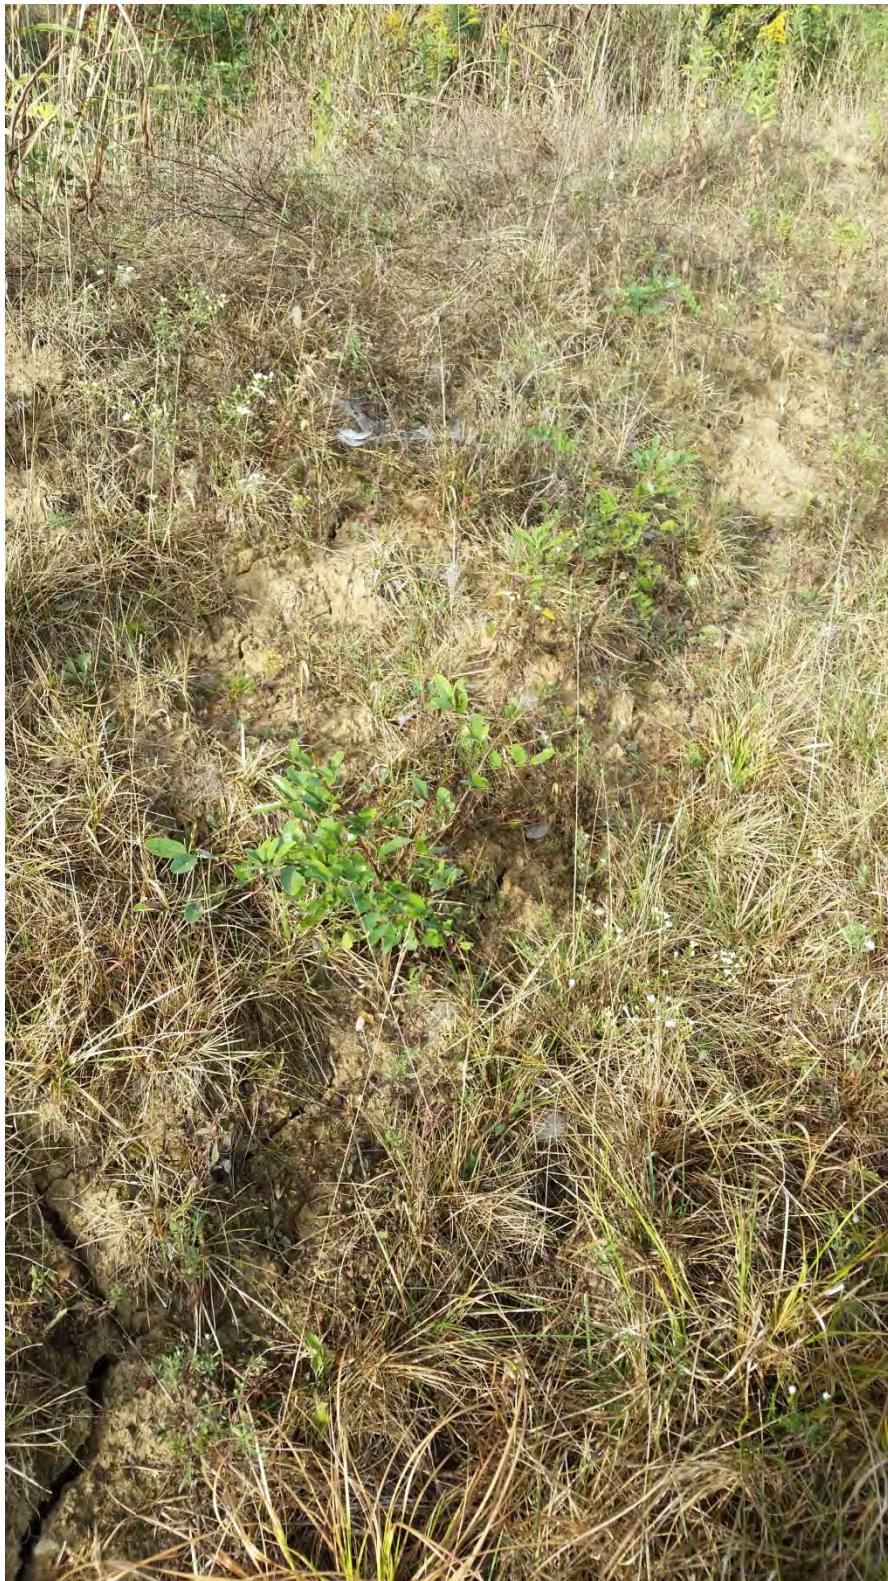
Photo 18: EV9 patchy vegetation

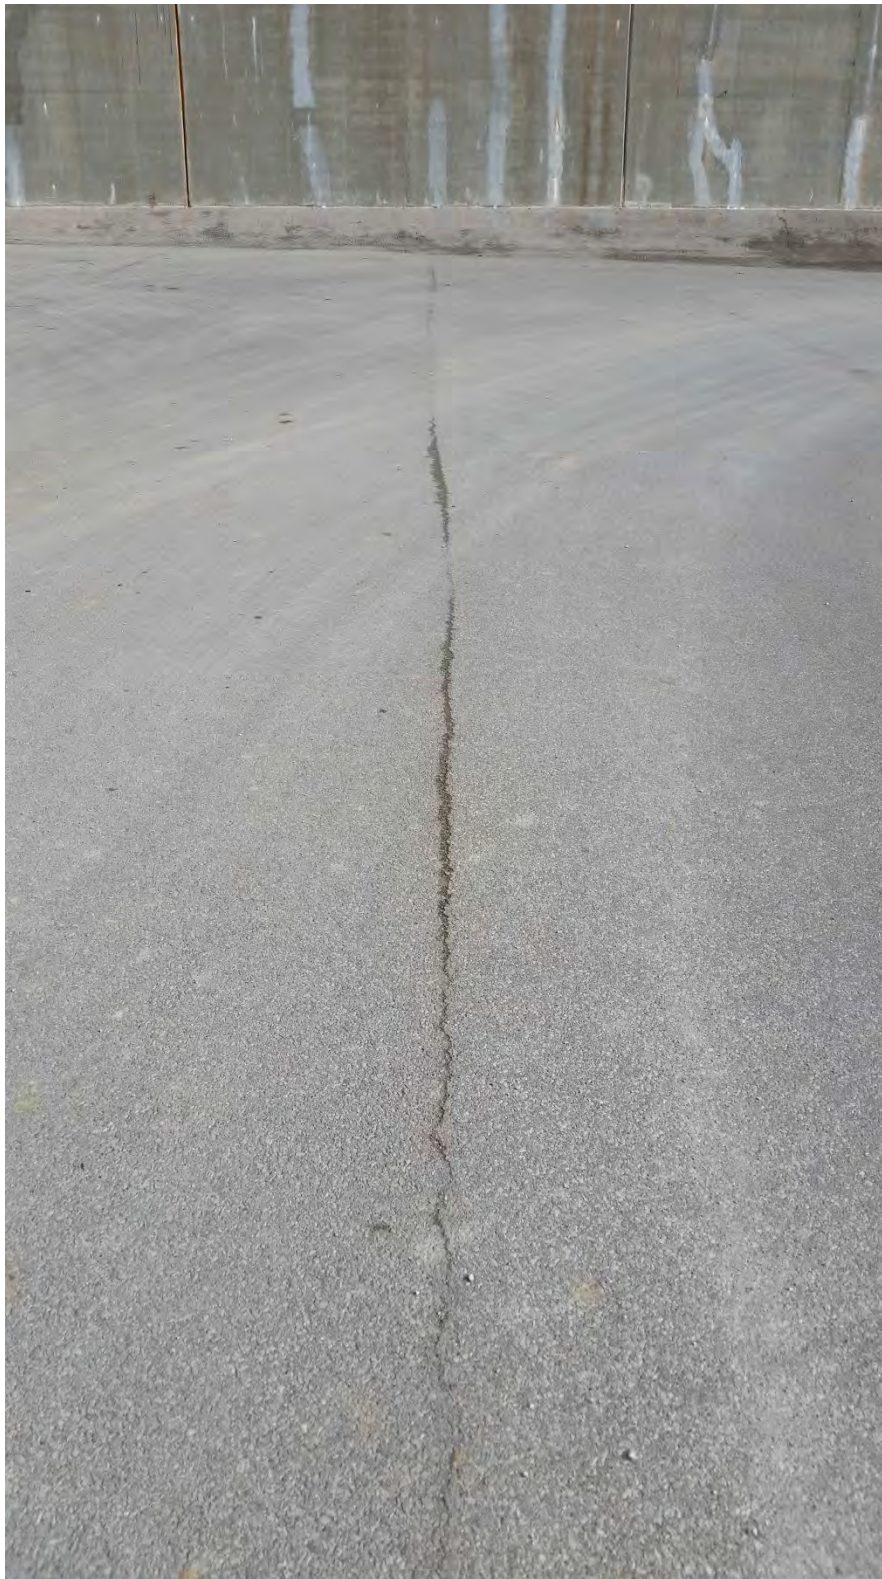
Photo 30: EA2 crack near WWTP aeration basin facing north

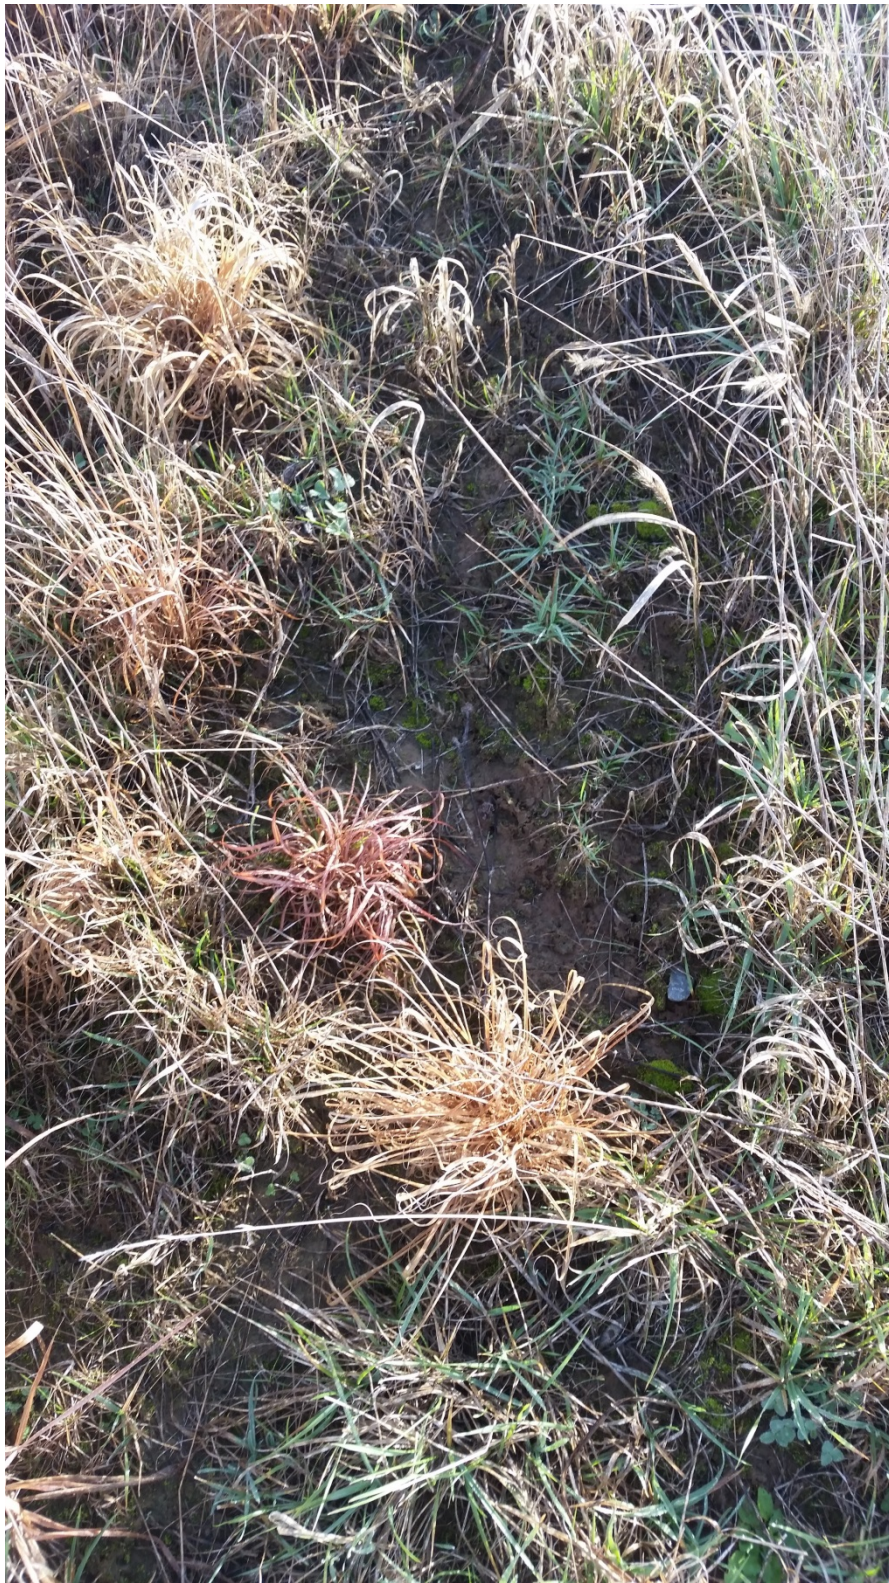
Photo 19: EV9 patchy vegetation.

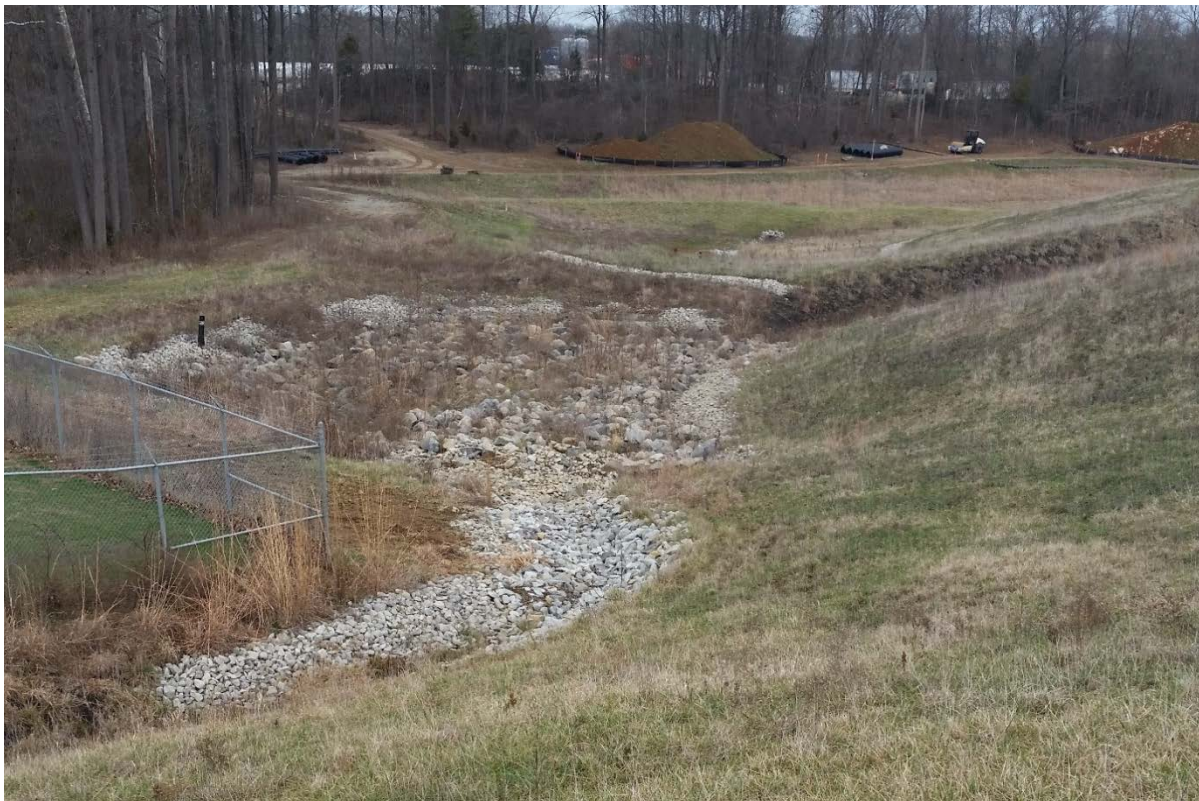
Photo 27: ES6 drainage swale facing east, repaired channel erosion.

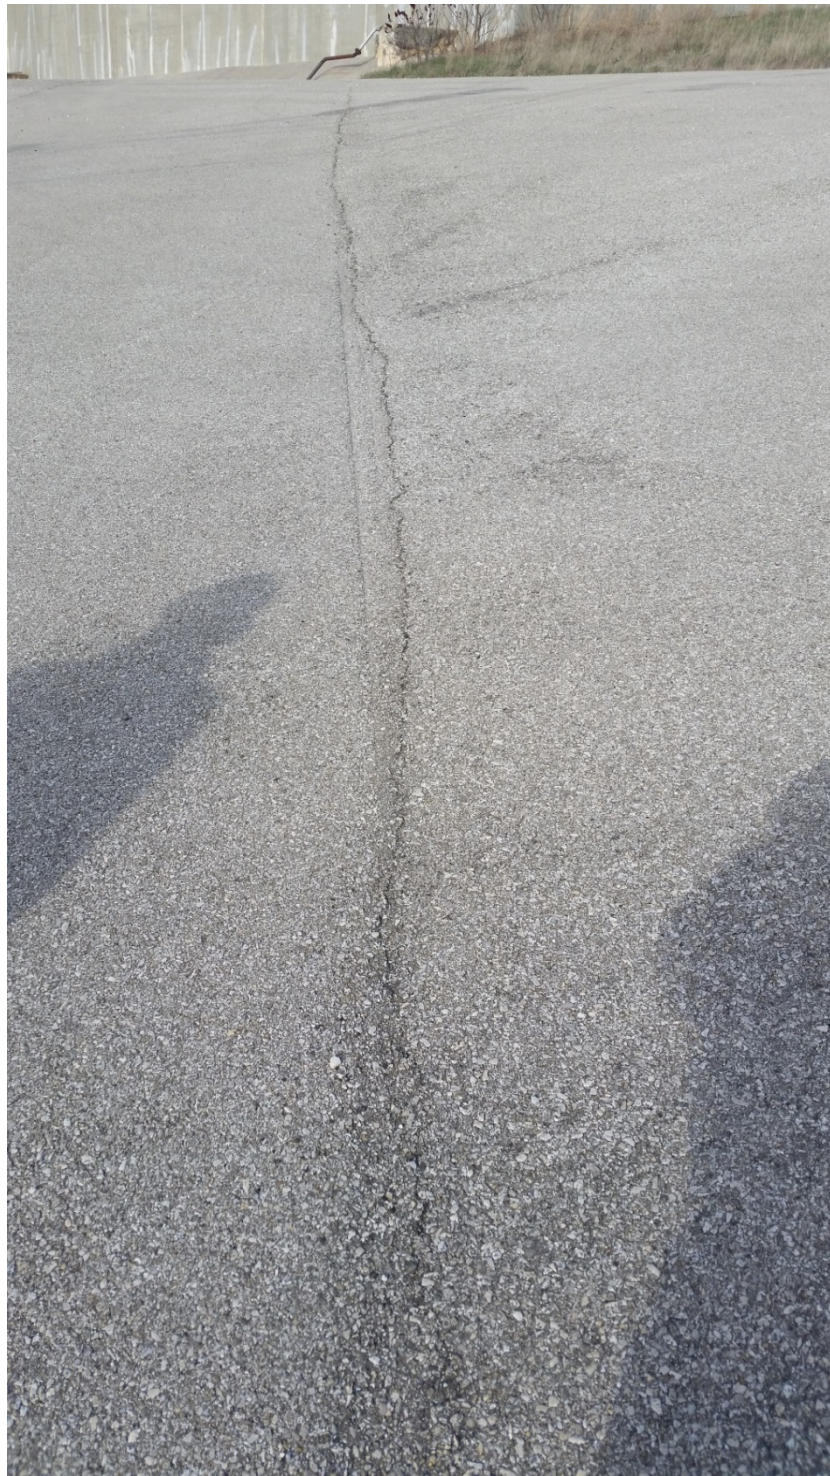
Photo 34: EA2 facing north, cracks in asphalt west of Parcel 205.
