Re: RCRA Corrective Action Administrative Order on Consent (AOC)  
Progress Report 69, Second Quarter 2018  
GM GPS – Bedford Facility, IND 006036099, Docket No. RCRA 05 2014 0011  
Bedford, Indiana

## **Second Quarter 2018 Progress Report 69**

GM GPS – Bedford Facility  
105 GM Drive  
Bedford, Indiana  
EPA ID# IND006036099  
AOC Docket No. RCRA 05 2014 0011

## **Second Quarter 2018 Cover System Inspection: Photograph Log, Transect Figures, and Field Log**

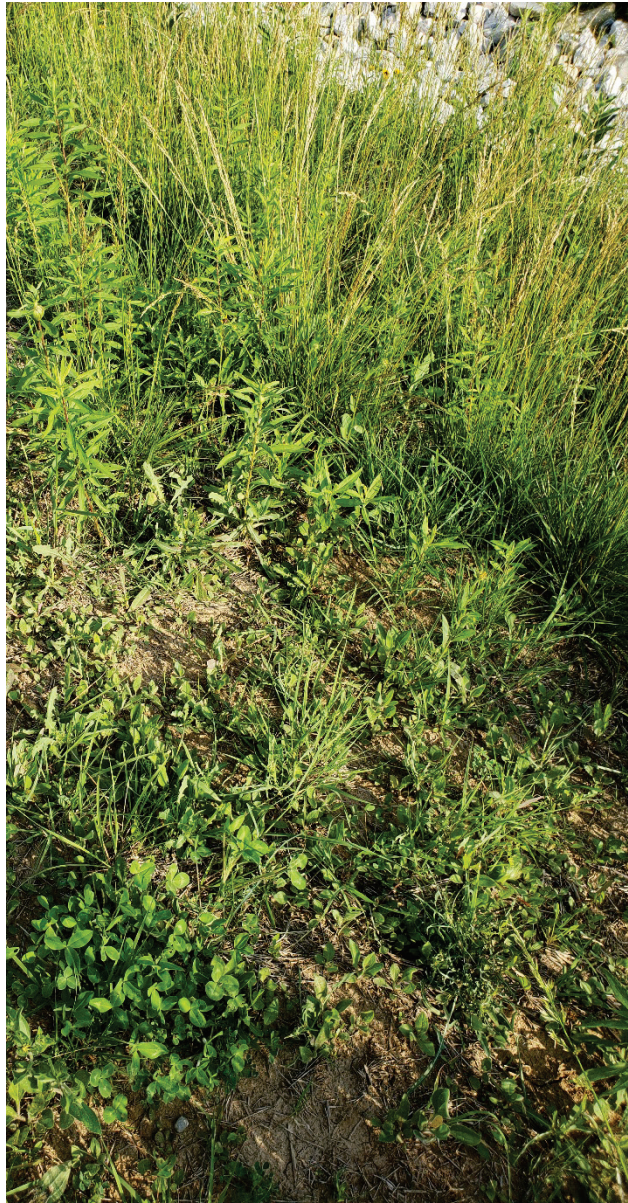
Photo 1: Vegetation along EV2 facing west

| ITEM | TYPES OF PROBLEMS | CHECKED | | DETAILED ACTIONS REQUIRED | DATE AND NATURE OF ACTIONS COMPLETED |
|---|---|---|---|---|---|
| <u>Transect EV2</u> | - QUALITY OF VEGETATIVE COVER<br>- LENGTH OF GRASS<br>- DEAD/DYING GRASS<br>- GRASS COVERAGE<br>- NOXIOUS WEEDS | X | | heavy weed growth and<br>some bare spots | |

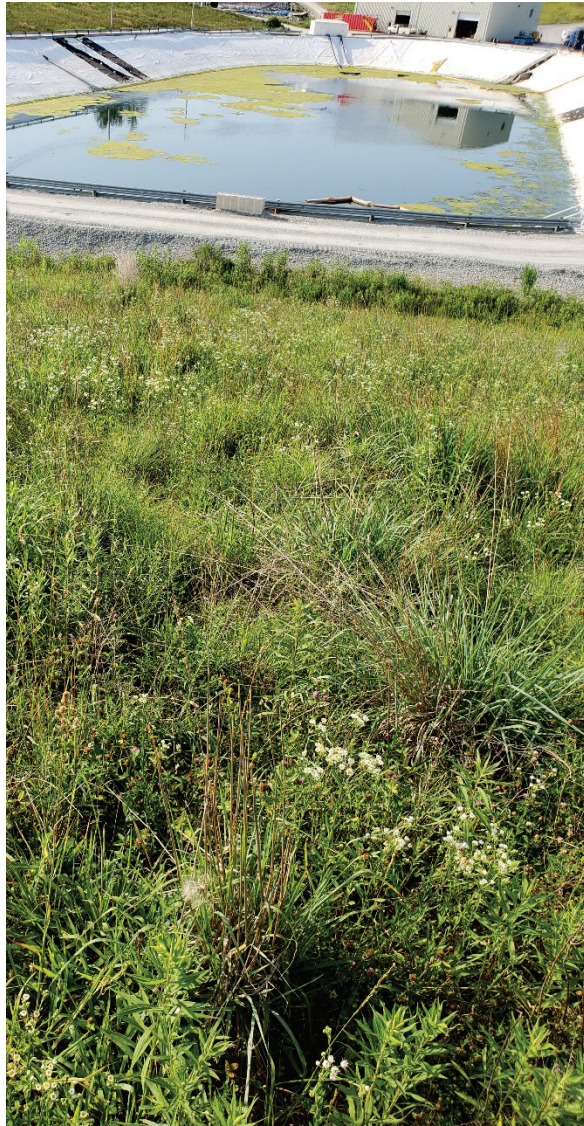
Photo 2: EV3 East Plant Cover facing south toward pond

| ITEM | TYPES OF PROBLEMS | CHECKED | | DETAILED ACTIONS REQUIRED | DATE AND NATURE OF ACTIONS COMPLETED | |
|---|---|---|---|---|---|--|
| | Transect EV3 | - QUALITY OF VEGETATIVE COVER<br>- LENGTH OF GRASS<br>- DEAD/DYING GRASS<br>- GRASS COVERAGE<br>- NOXIOUS WEEDS | X | | heavy weed growth and<br>some bare spots | |

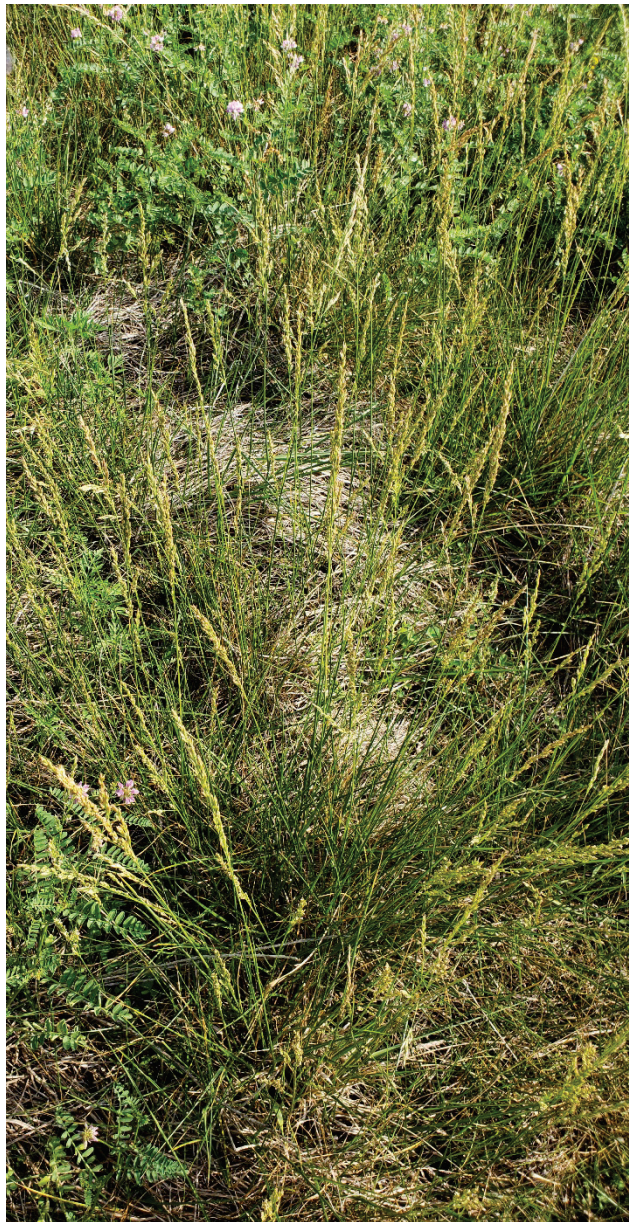
Photo 3: Vegetation at ES1 facing northwest

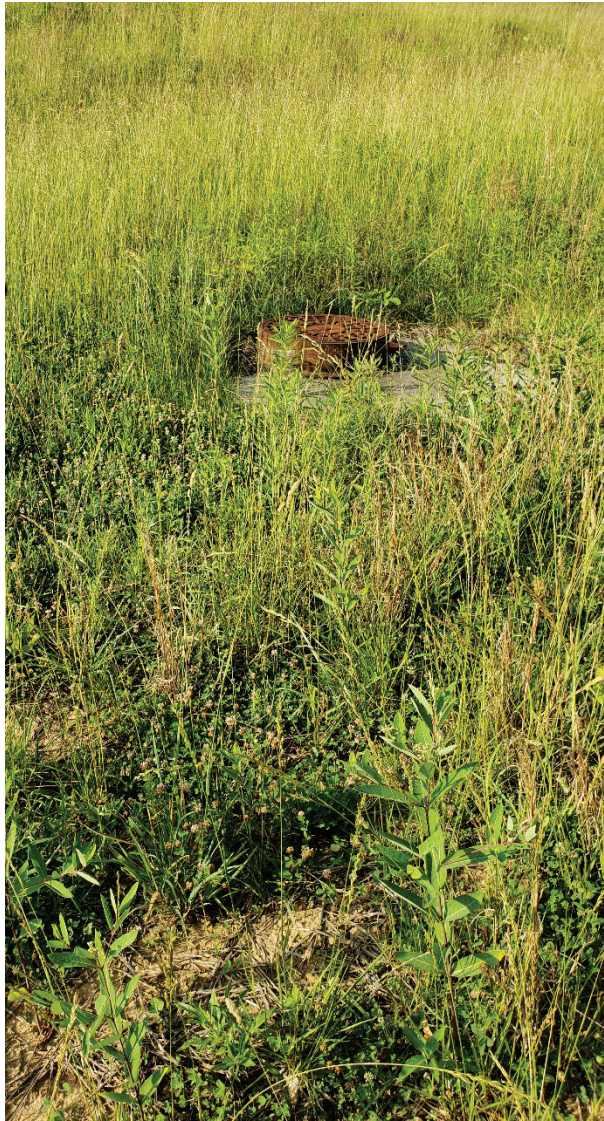
Photo 4: EV3 at ES9 East Plant Cover area facing west

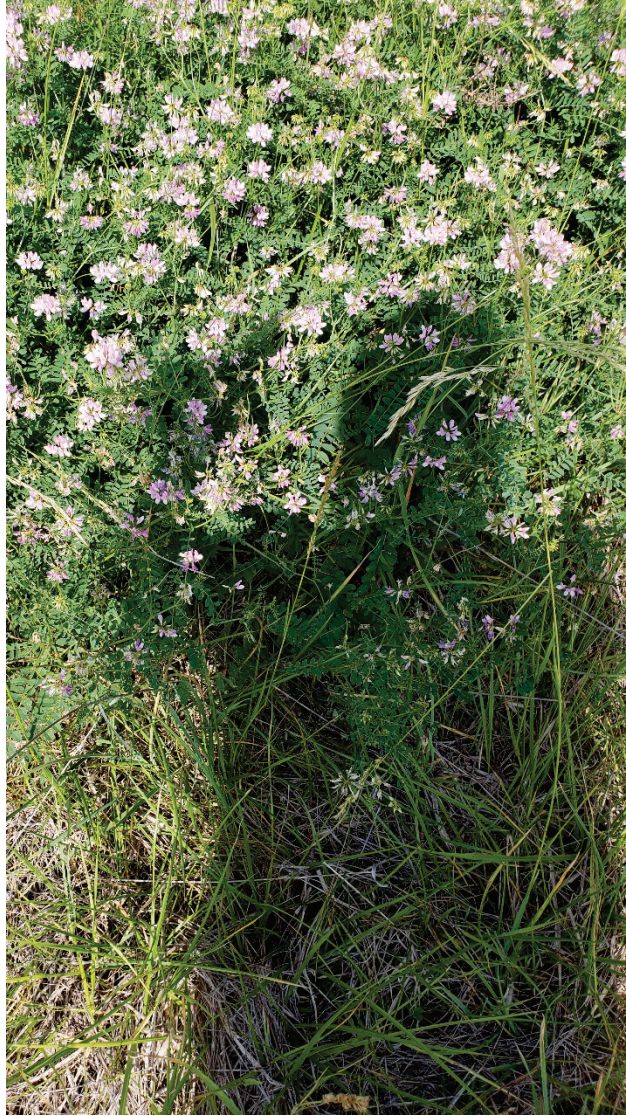
Photo 5: ES2 East Plant Area Cover facing southwest

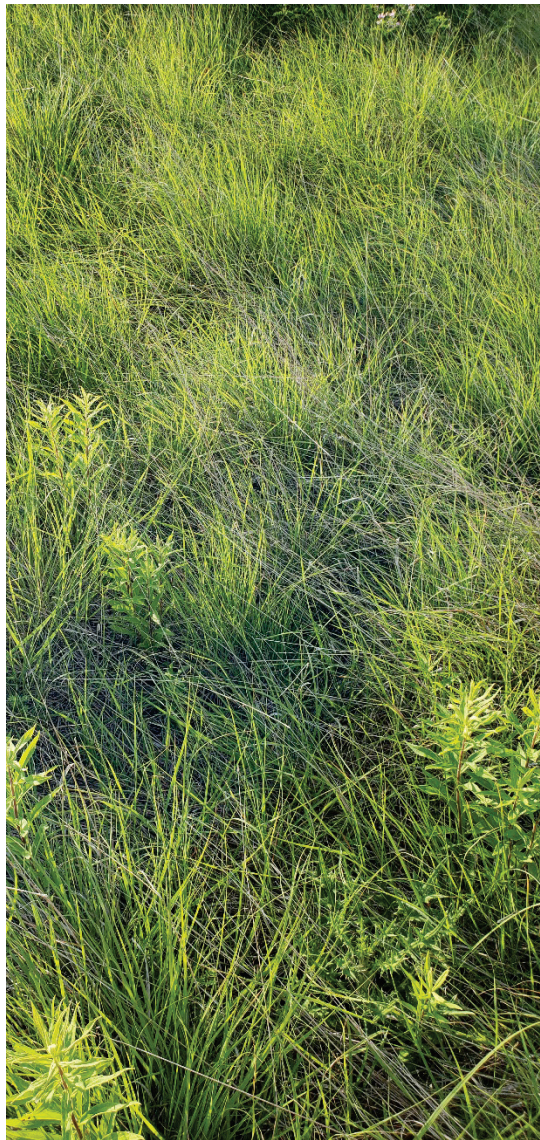
Photo 6: EV2 East Plant Cover area facing south

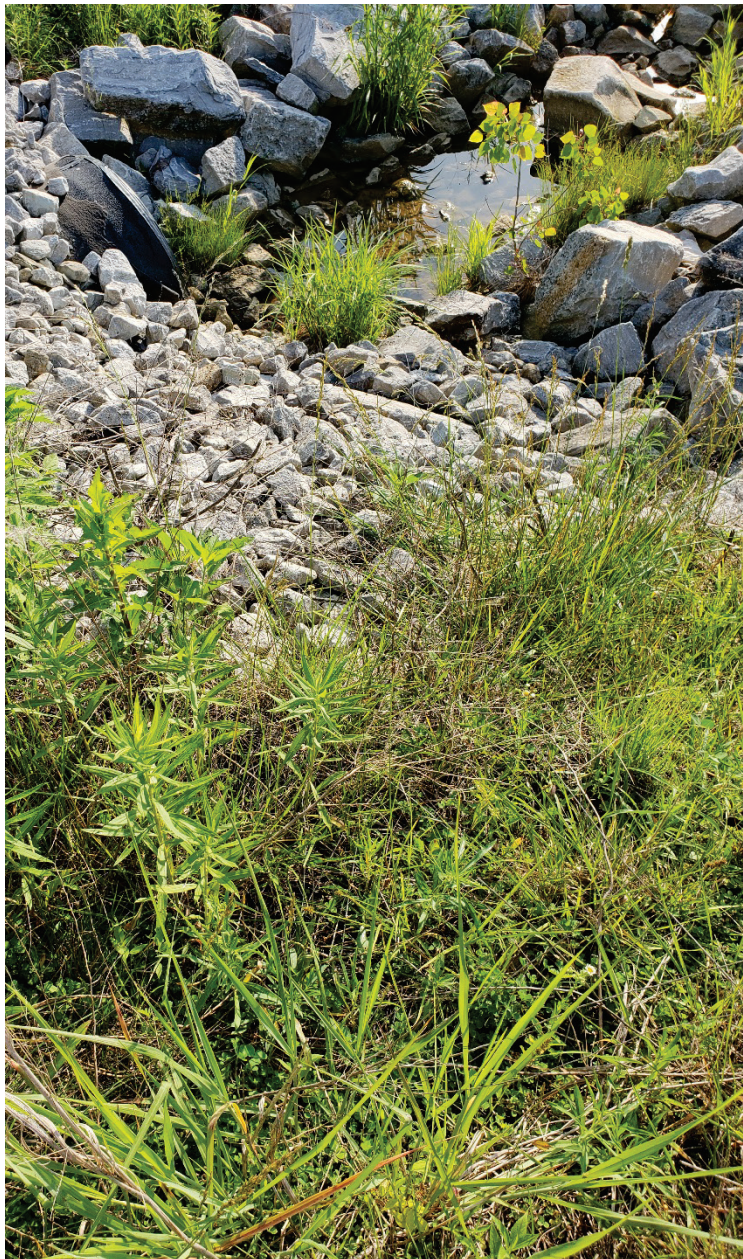
Photo 7:            Drainage at ES6 facing east at EV5

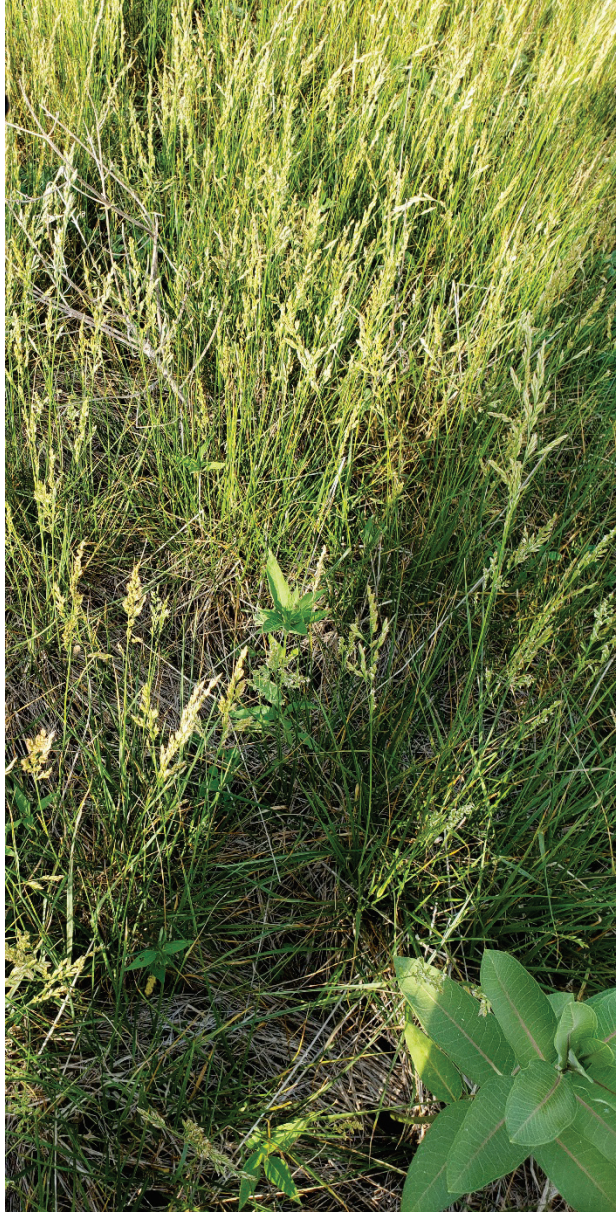
Photo 8: Vegetation along EV5 East Plant Area Cover facing southwest

| ITEM | TYPES OF PROBLEMS | CHECKED | | DETAILED ACTIONS REQUIRED | DATE AND NATURE OF ACTIONS COMPLETED | |
|---|---|---|---|---|---|--|
| | Transect EV5 | - QUALITY OF VEGETATIVE COVER<br>- LENGTH OF GRASS<br>- DEAD/DYING GRASS<br>- GRASS COVERAGE<br>- NOXIOUS WEEDS | X | | heavy weed growth and<br>some bare spots | |
| | | - EROSION | X | | slight erosion | |

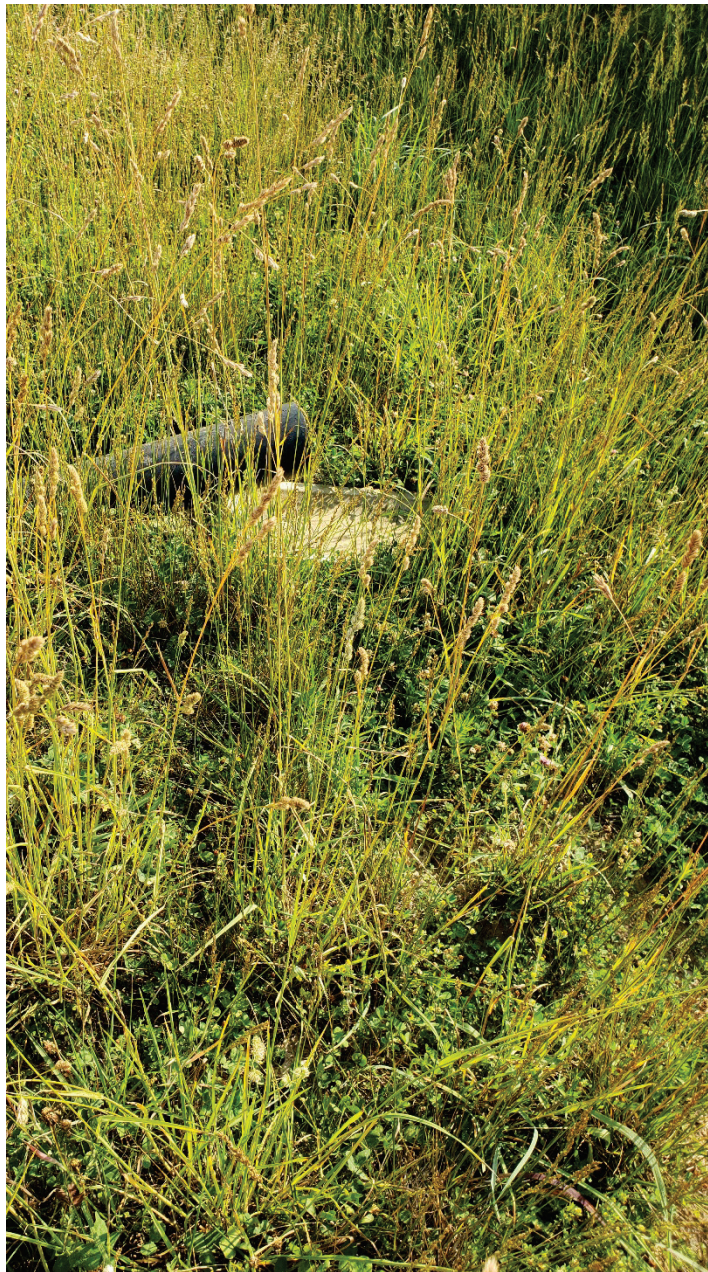
Photo 9:           Vegetation south of ES6 East Plant Area Cover facing east

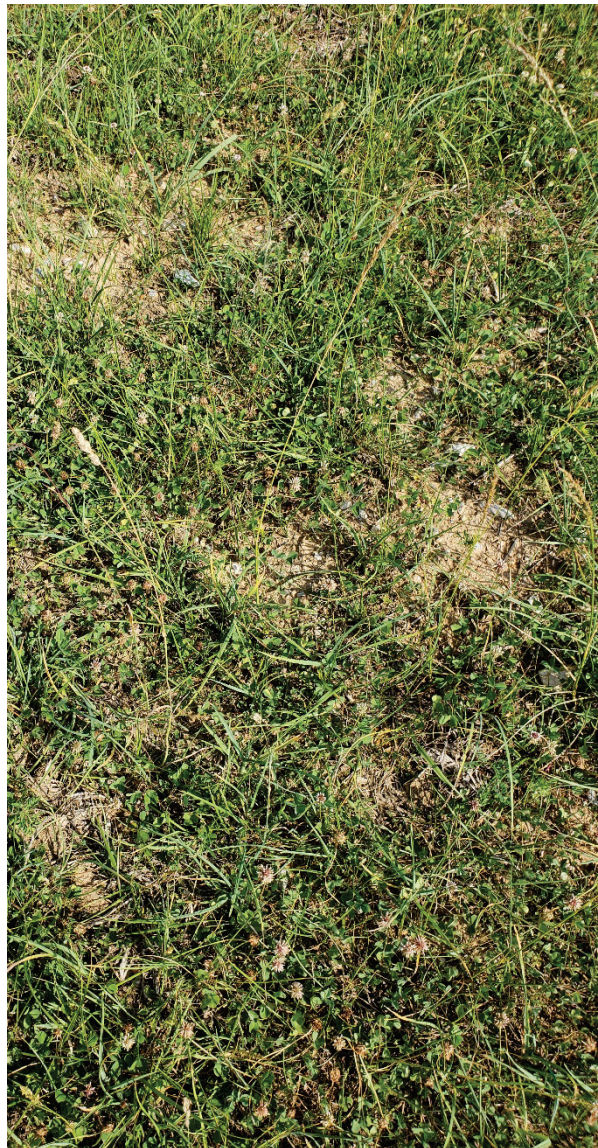
Photo 10: EV6 near EA1 East Plant Area Cover facing northwest

| ITEM | TYPES OF PROBLEMS | CHECKED | | DETAILED ACTIONS REQUIRED | DATE AND NATURE OF ACTIONS COMPLETED | |
|---|---|---|---|---|---|--|
| | <u>Transect EV6</u> | - QUALITY OF VEGETATIVE COVER<br>- LENGTH OF GRASS<br>- DEAD/DYING GRASS<br>- GRASS COVERAGE<br>- NOXIOUS WEEDS | X | | heavy weed growth and<br>some bare spots | |

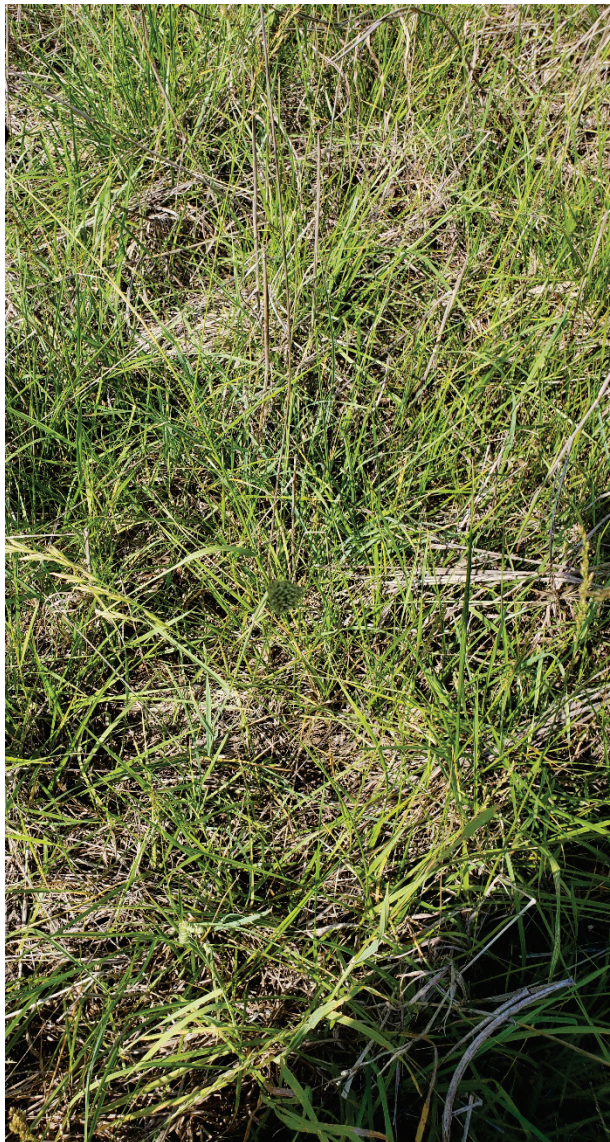
Photo 11:           Vegetation at EV8 East Plant Cover area facing southwest

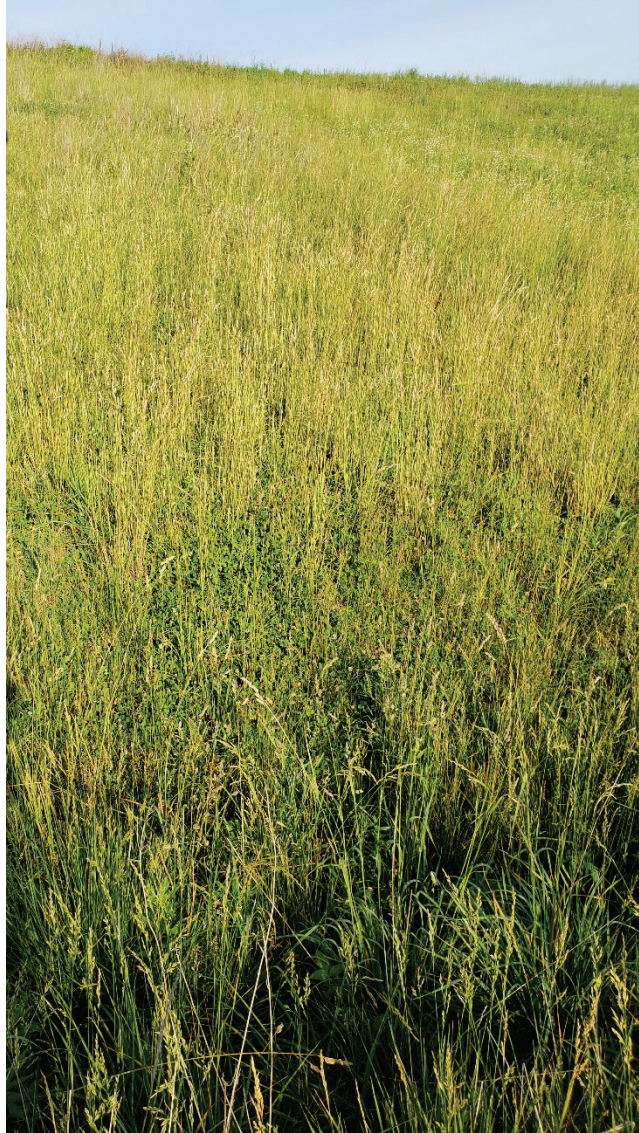
Photo 12: Vegetative growth along EV5 East Plant Area facing southwest

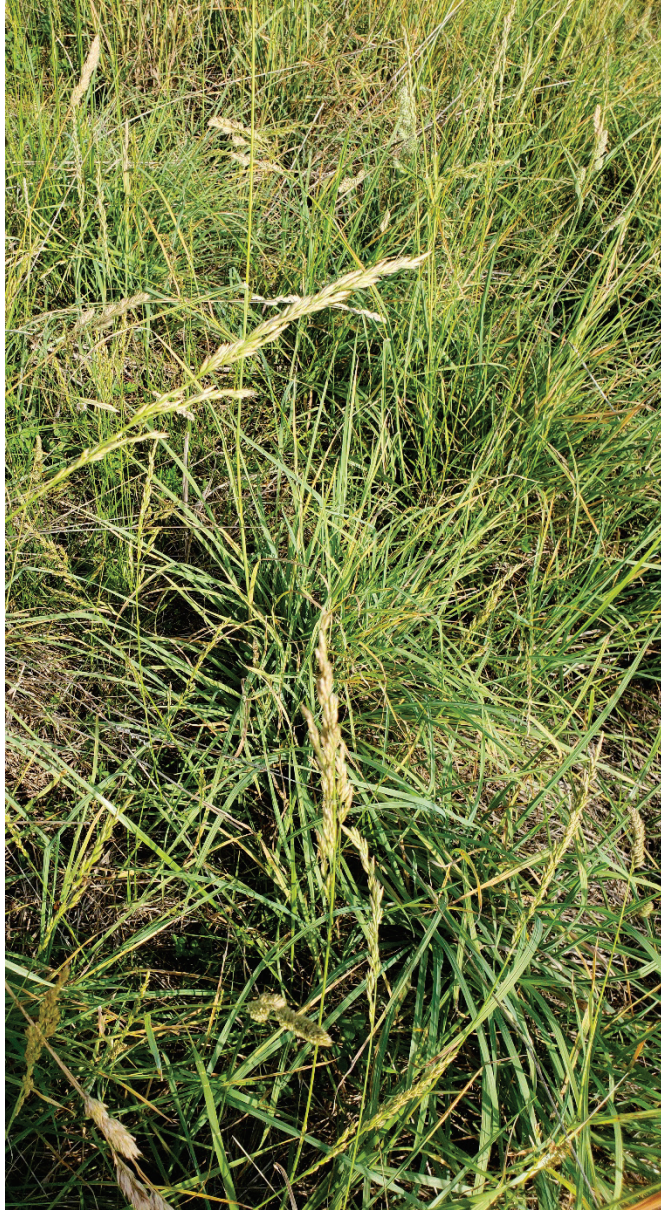
Photo 13: Vegetation growth at ES12 East Plant Area Cover facing west

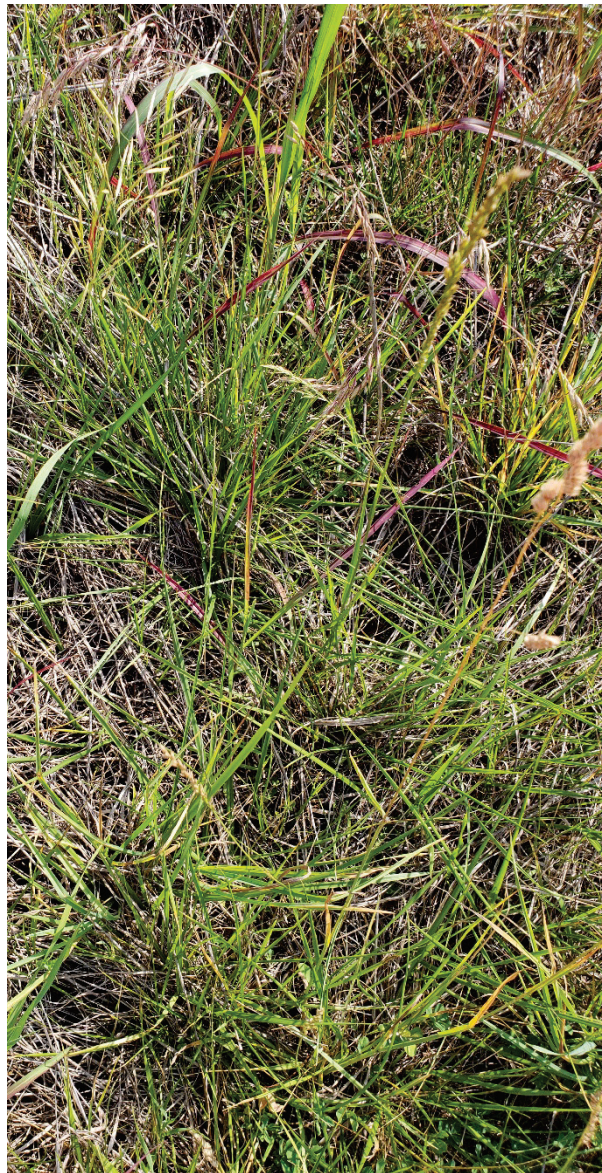
Photo 14: EV7 East Plant Cover facing northeast

| ITEM | TYPES OF PROBLEMS | CHECKED | | DETAILED ACTIONS REQUIRED | DATE AND NATURE OF ACTIONS COMPLETED | |
|---|---|---|---|---|---|--|
| | <u>Transect EV7</u> | - QUALITY OF VEGETATIVE COVER<br>- LENGTH OF GRASS<br>- DEAD/DYING GRASS<br>- GRASS COVERAGE<br>- NOXIOUS WEEDS | X | | heavy weed growth and<br>some bare spots | |

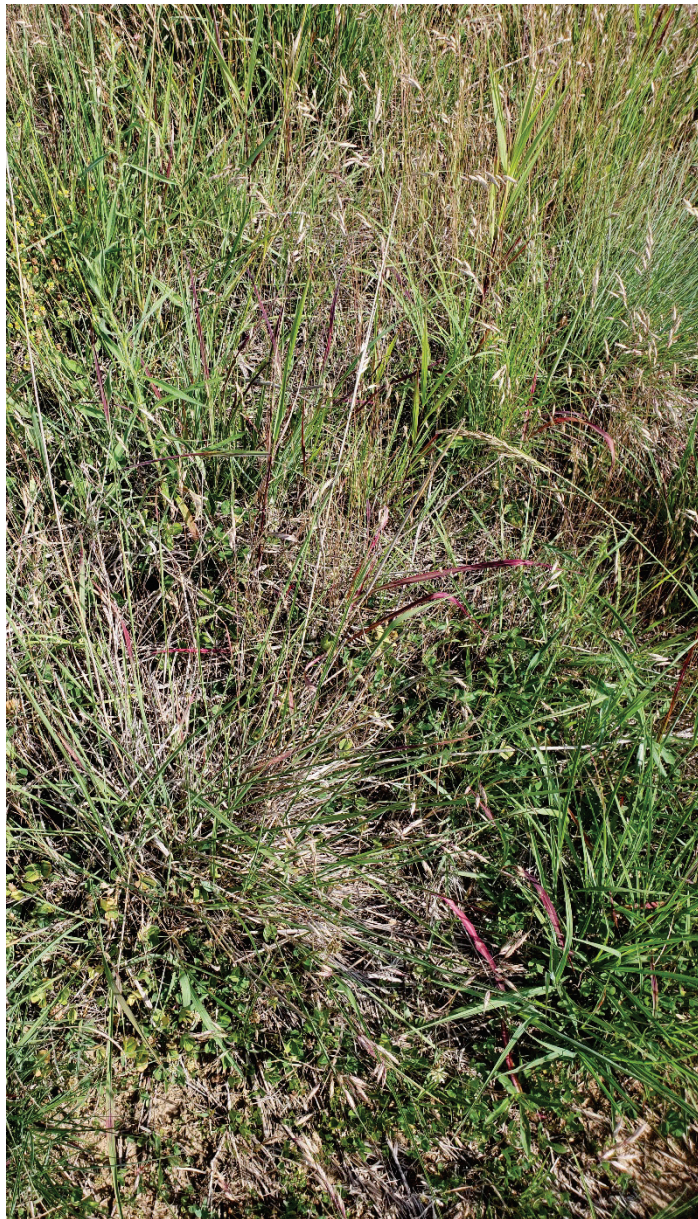
Photo 15: EV6 East Plant Area Cover area facing northwest

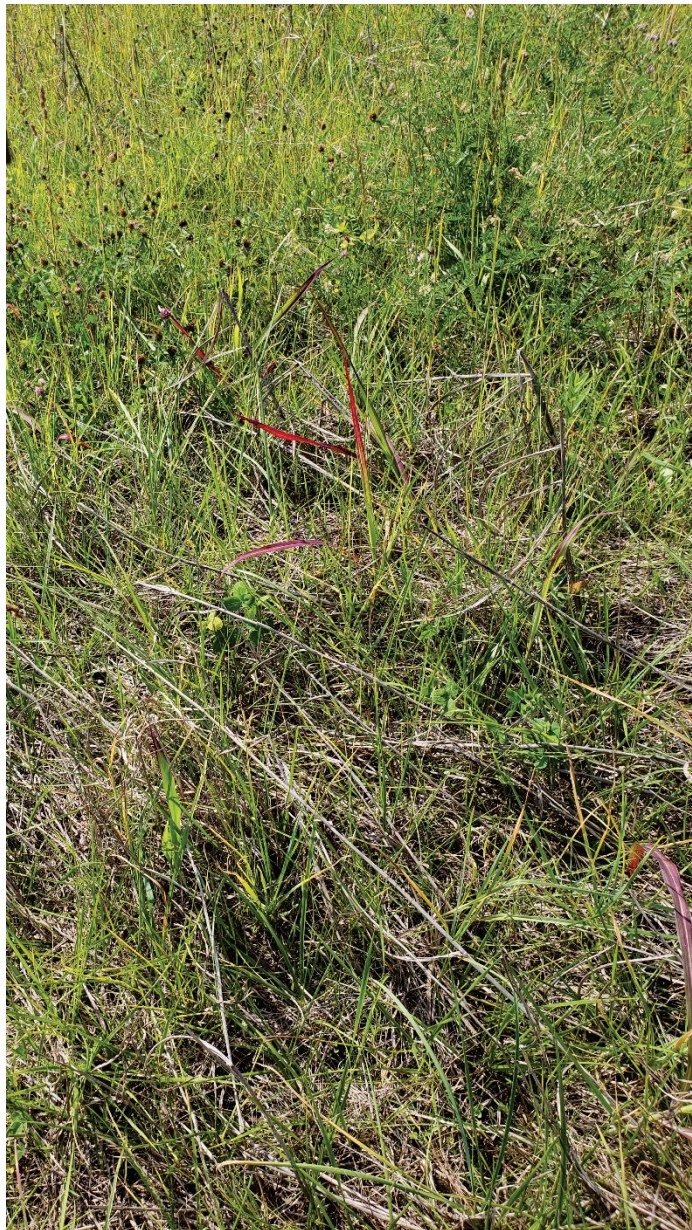
Photo 16: ES12 East Plant Area Cover facing southeast

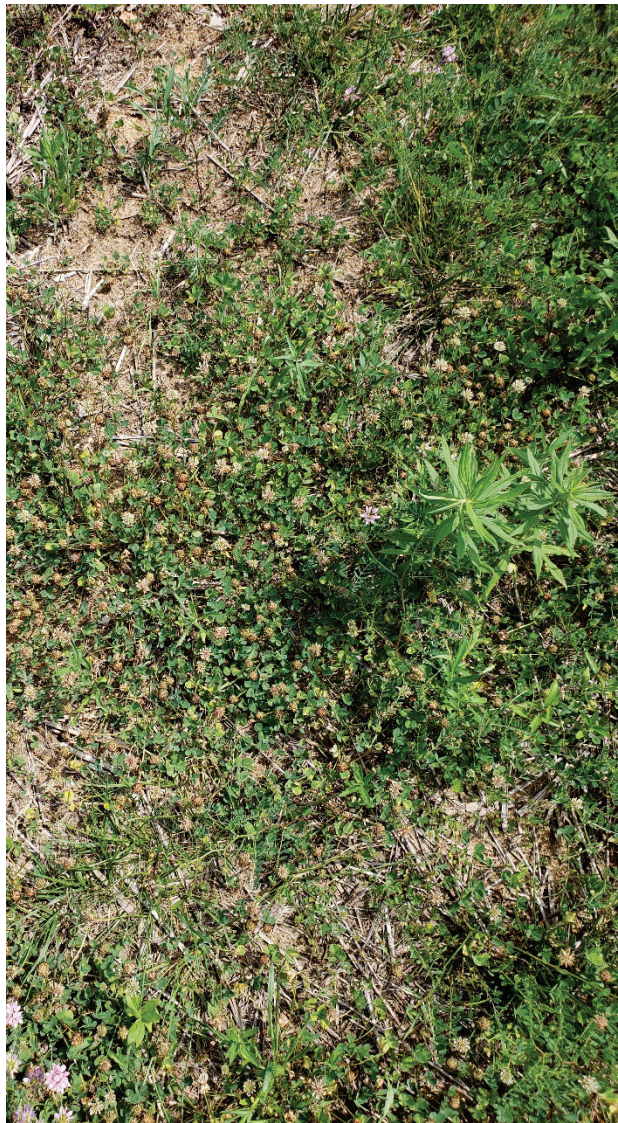
Photo 17: EV9 East Plant Area Cover facing northeast

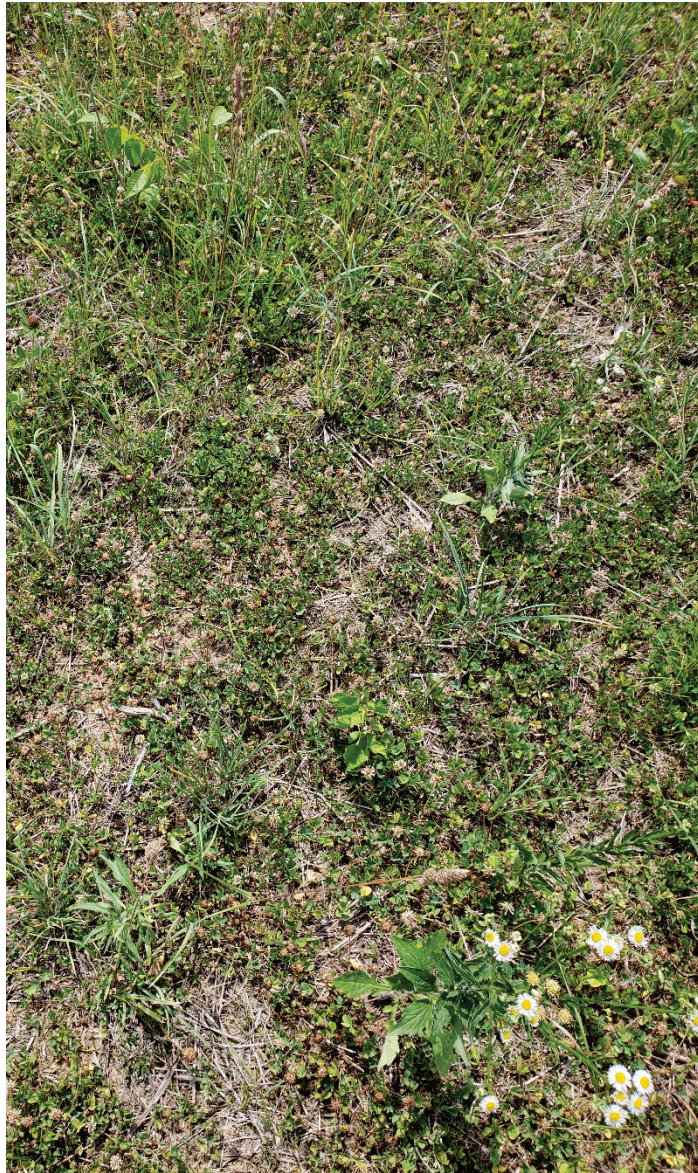
Photo 18: ES14 East Plant Area Cover facing south
