# 2012 PARCEL 22 MONITORING REPORT

BAILEY'S BRANCH AND PLEASANT RUN  
REMOVAL ACTION  
BEDFORD, INDIANA

Prepared for: General Motors LLC

October 2013 • #017368

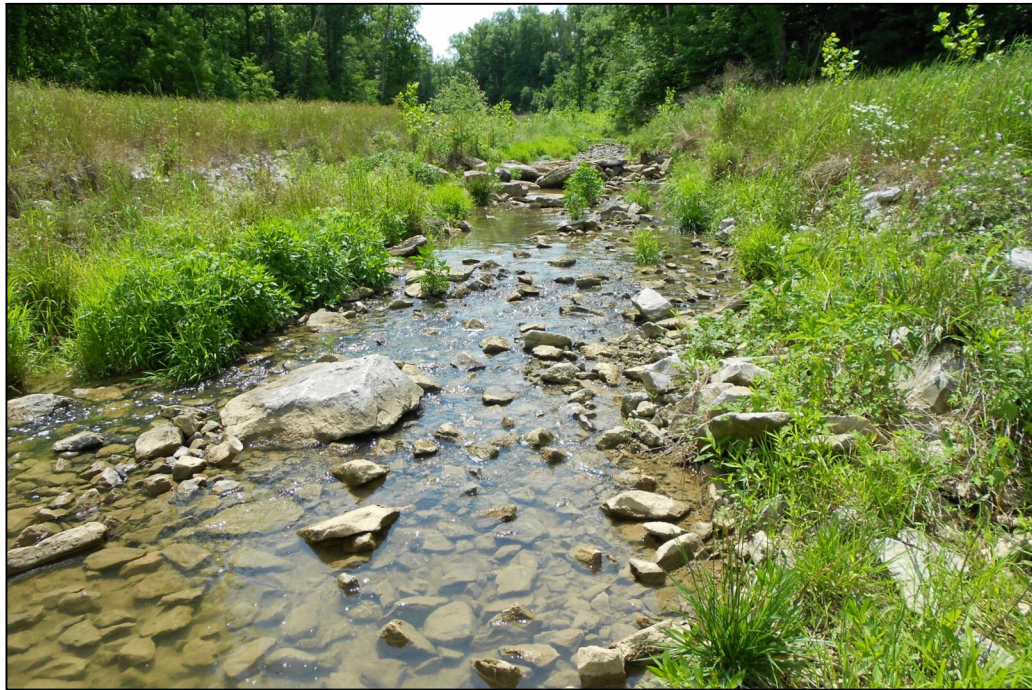
PHOTO 1: LOCATION 1 - LOOKING SOUTHEAST (UPSTREAM)

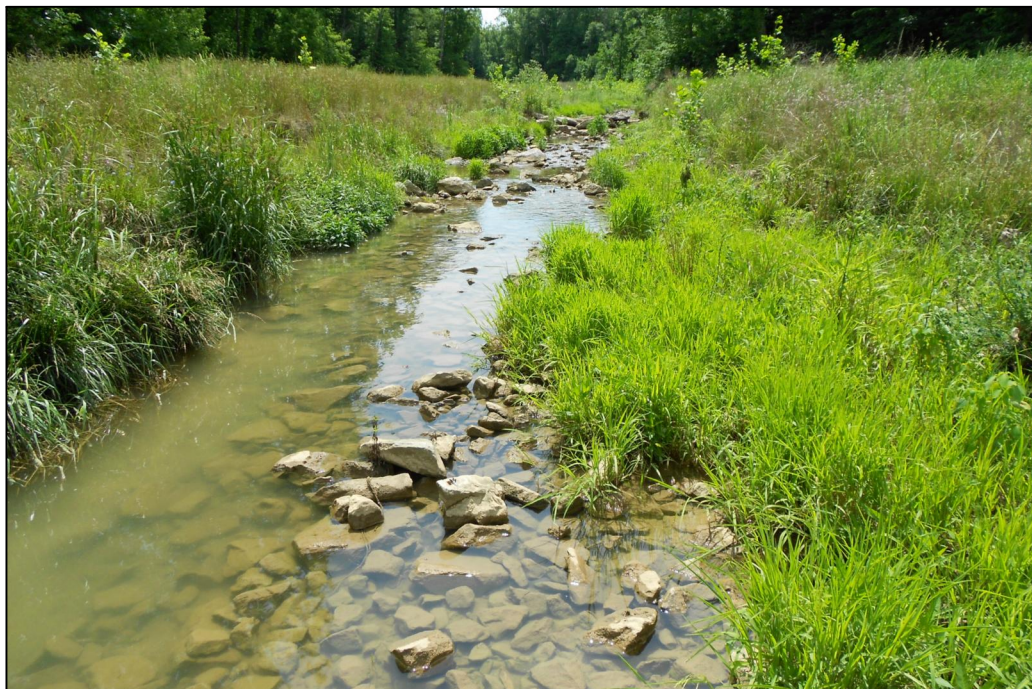
PHOTO 2: LOCATION 2 - LOOKING SOUTHEAST (UPSTREAM)

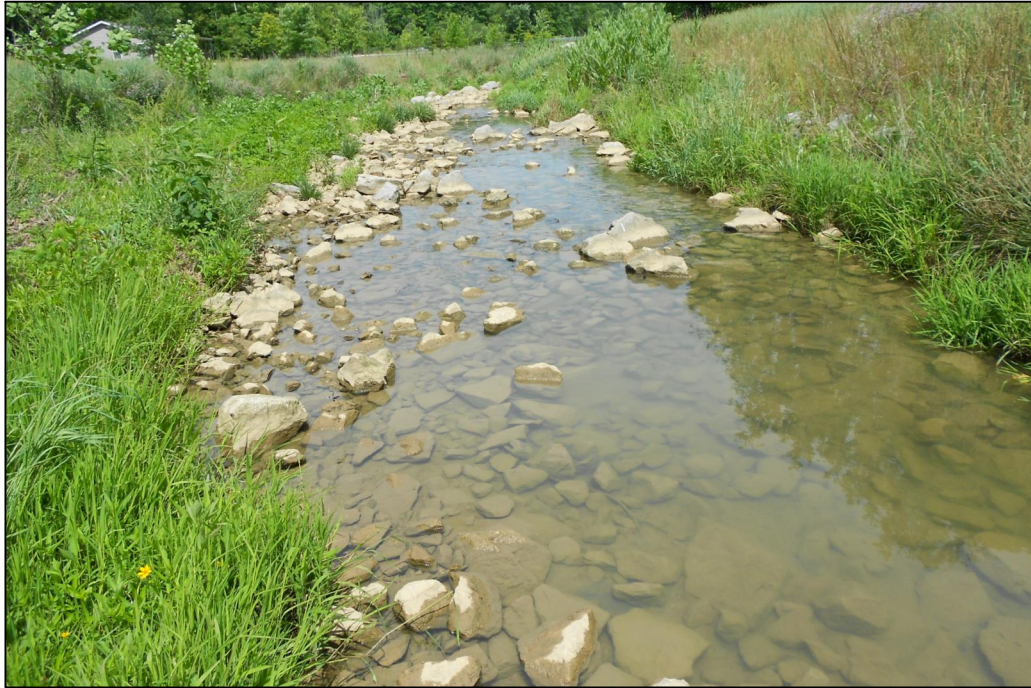
PHOTO 3: LOCATION 2 - LOOKING NORTHWEST (DOWNSTREAM)

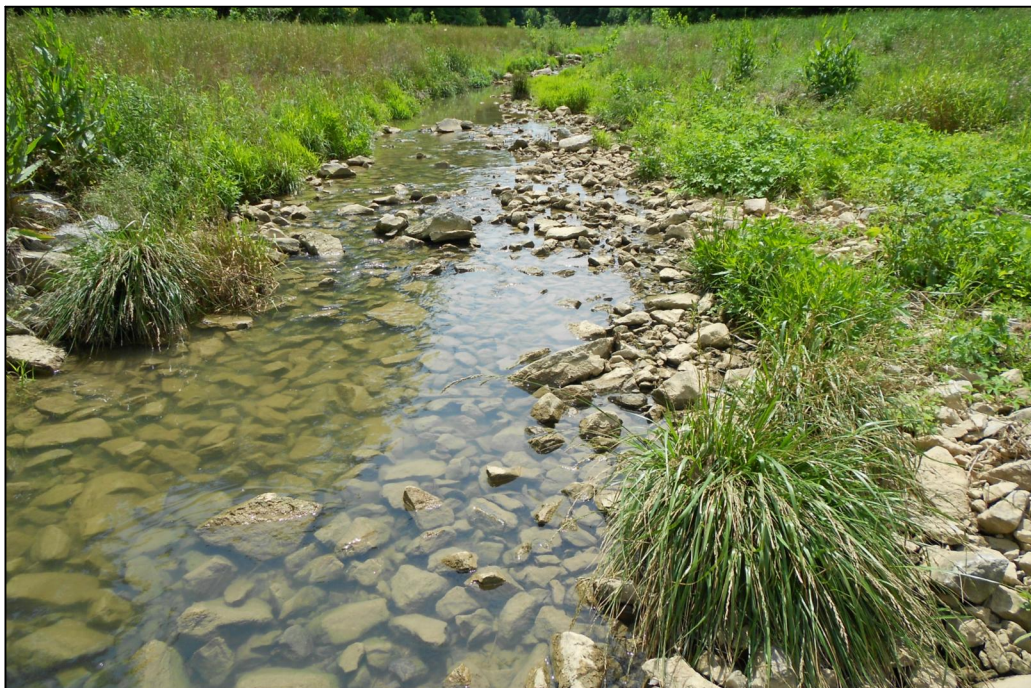
PHOTO 4: LOCATION 3 - LOOKING SOUTHEAST (UPSTREAM)

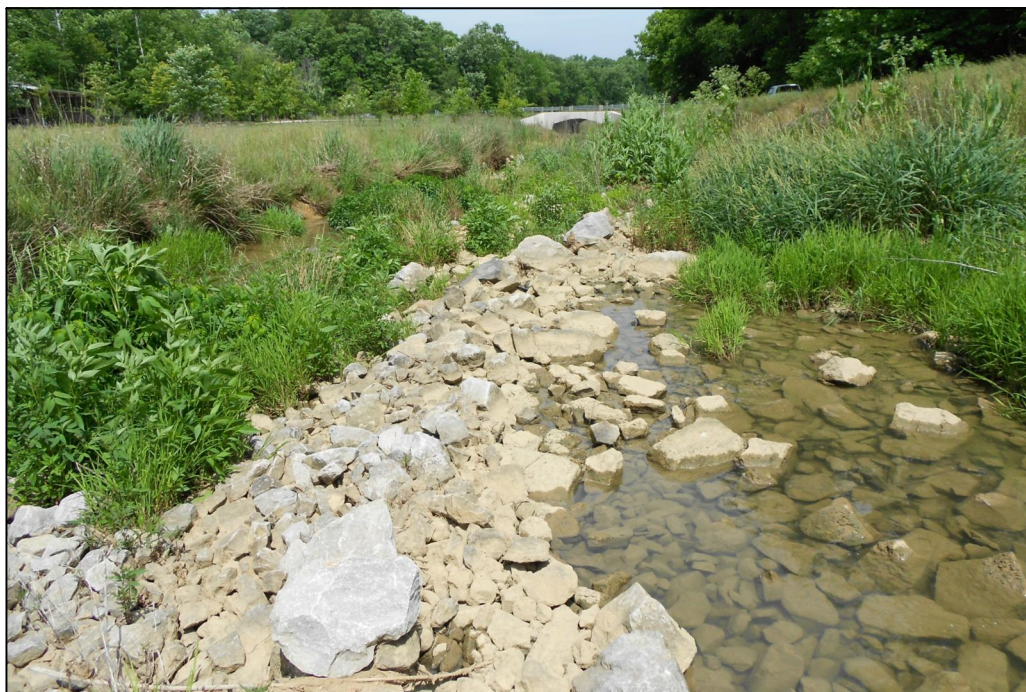
PHOTO 5: LOCATION 3 - LOOKING NORTHWEST (DOWNSTREAM)

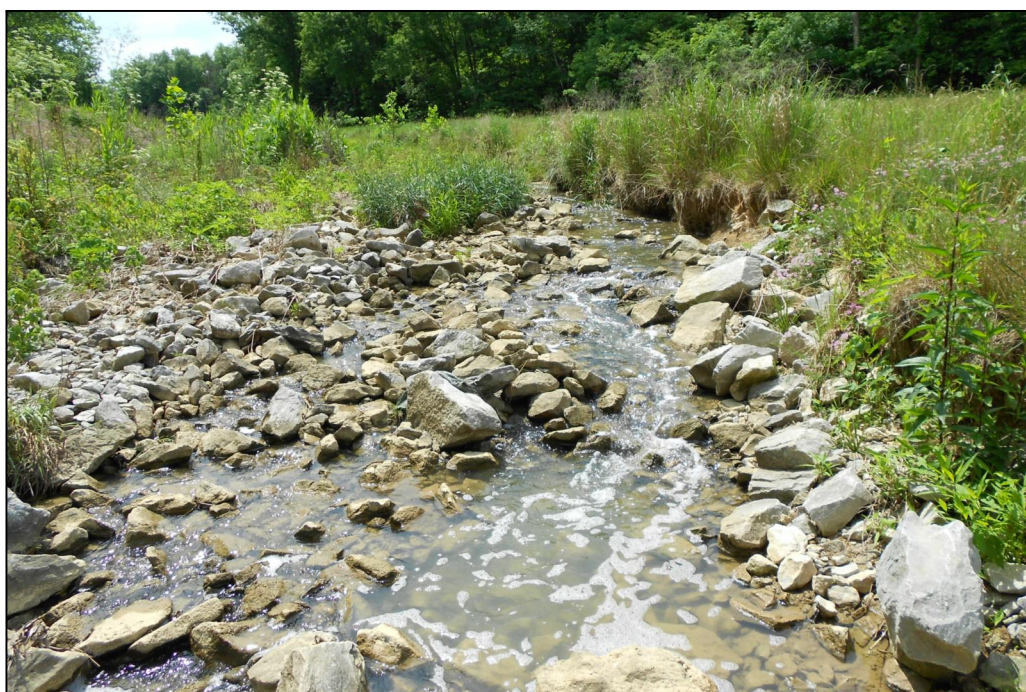
PHOTO 6: LOCATION 4 - LOOKING SOUTHEAST (UPSTREAM).

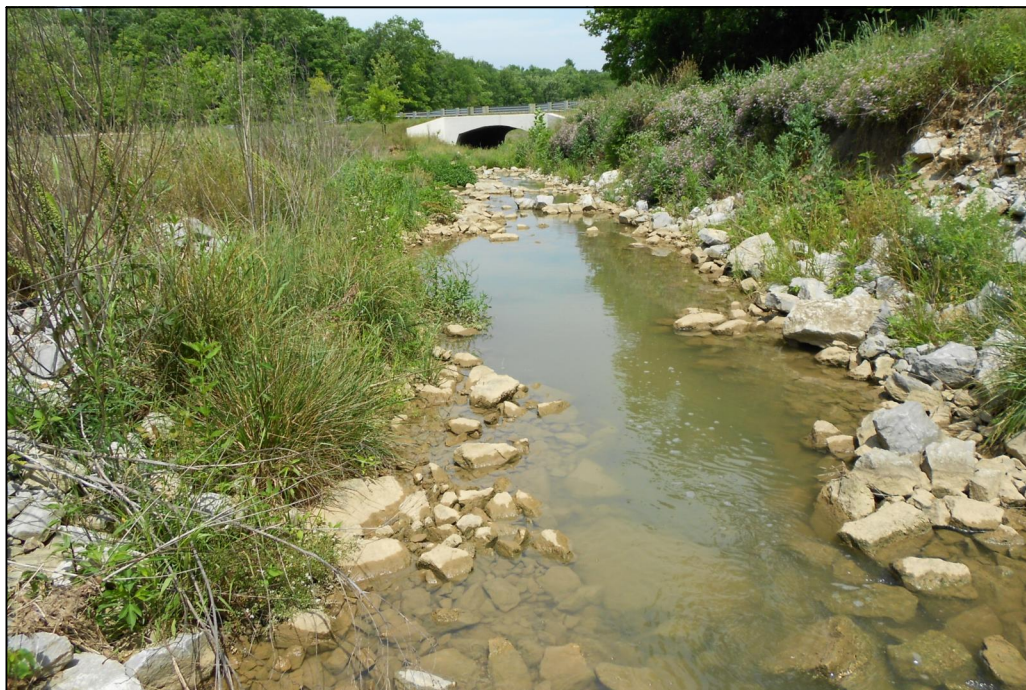
PHOTO 7: LOCATION 4 - LOOKING NORTHWEST (DOWNSTREAM)

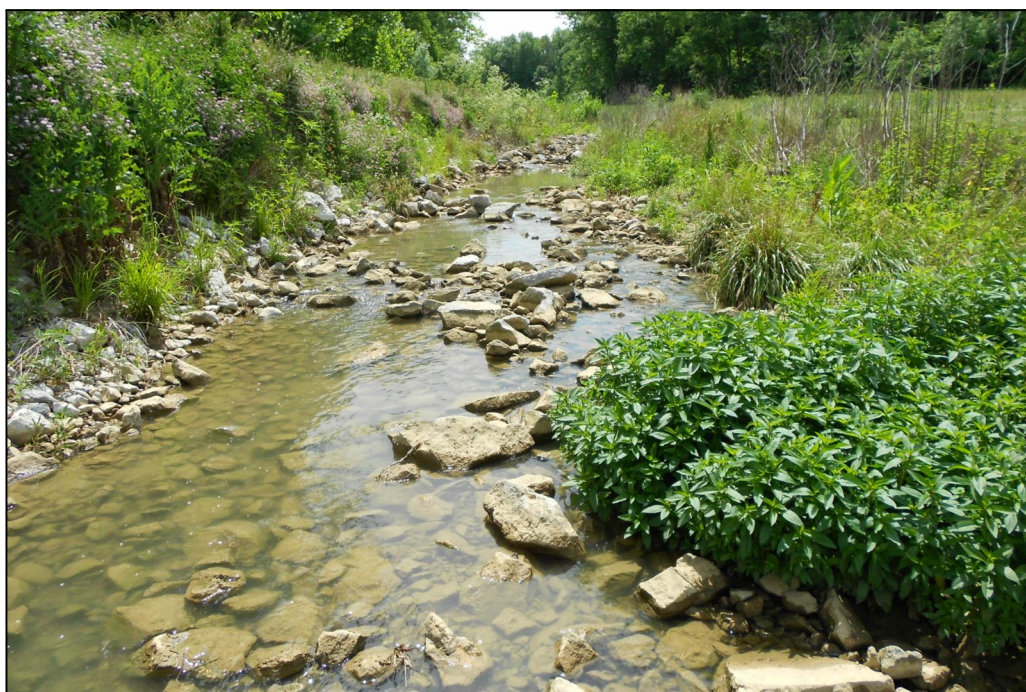
PHOTO 8: LOCATION 5 - LOOKING SOUTHEAST (UPSTREAM)

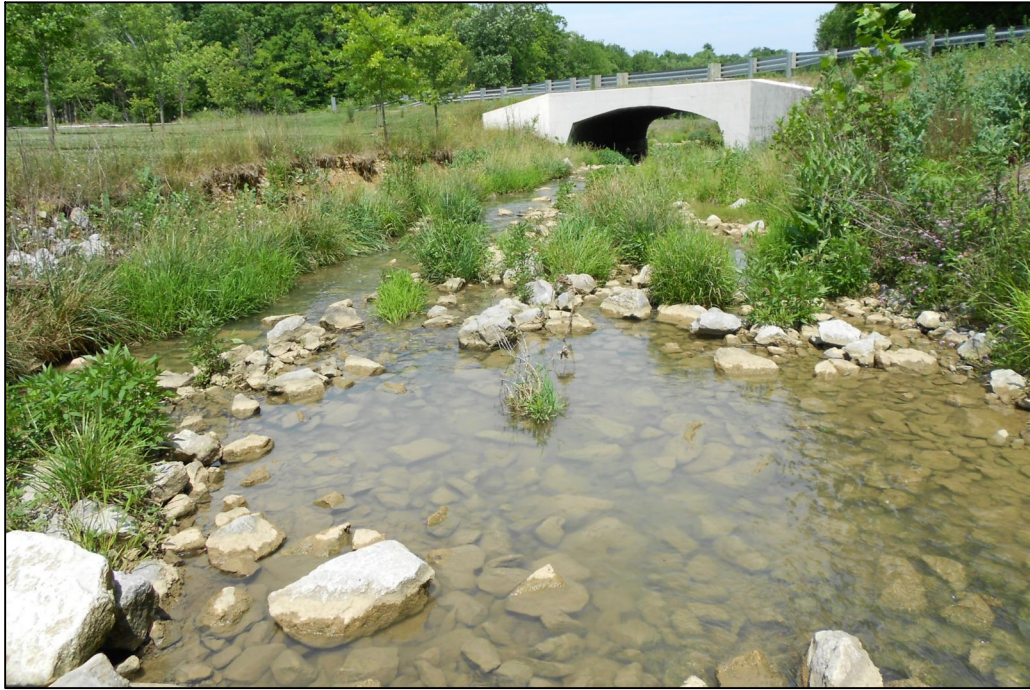
PHOTO 9: LOCATION 5 - LOOKING NORTHWEST (DOWNSTREAM)

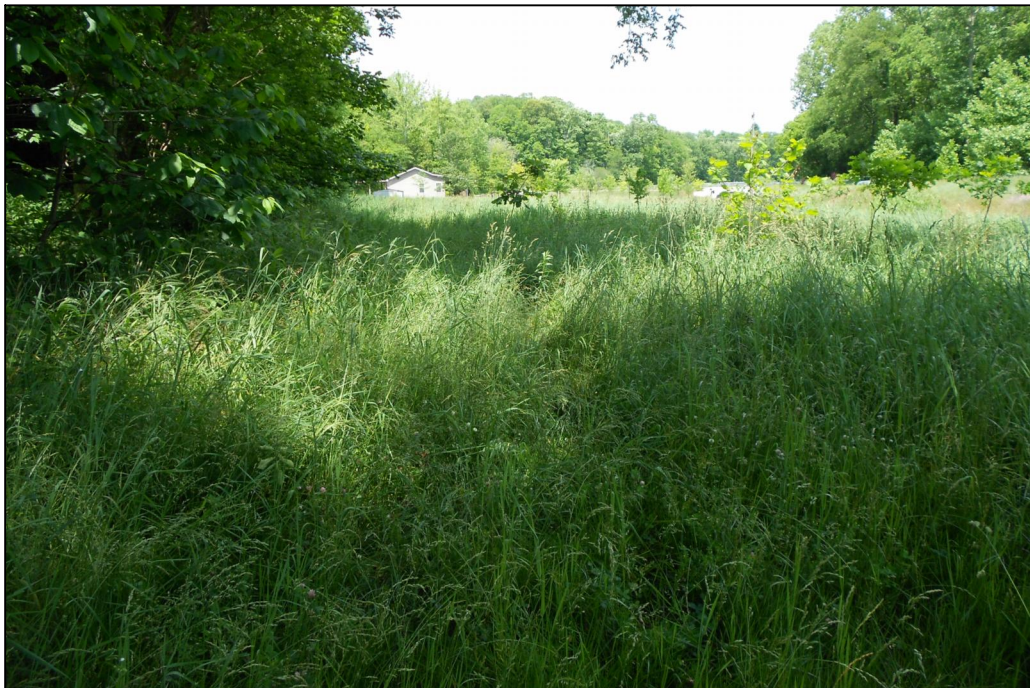
PHOTO 10: LOCATION 6 - LOOKING NORTHWEST

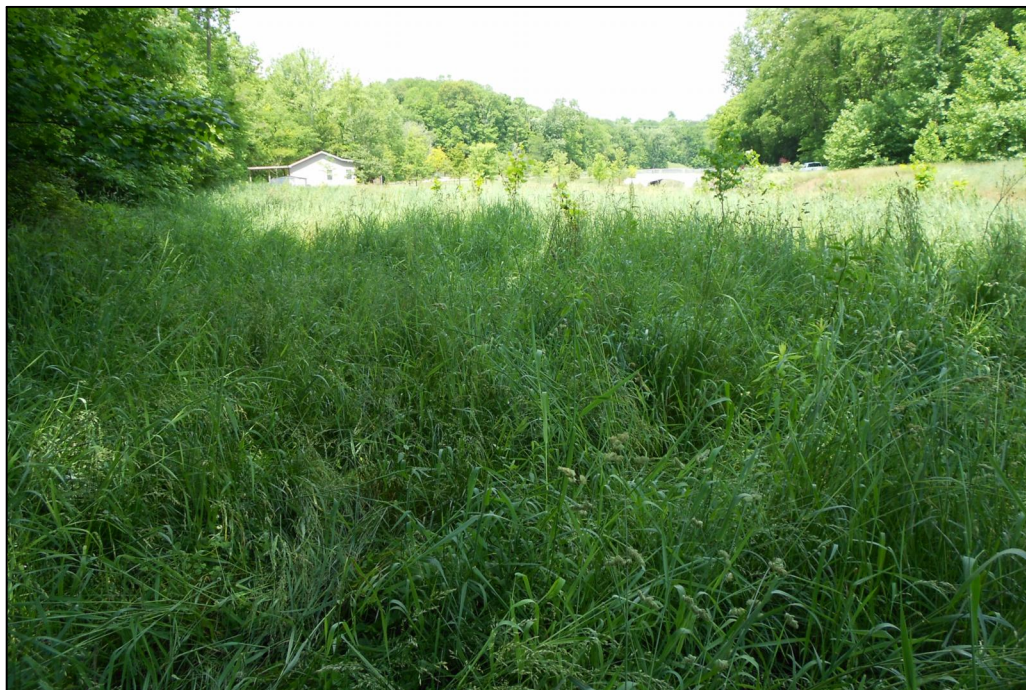
PHOTO 11: LOCATION 7 - LOOKING NORTHWEST

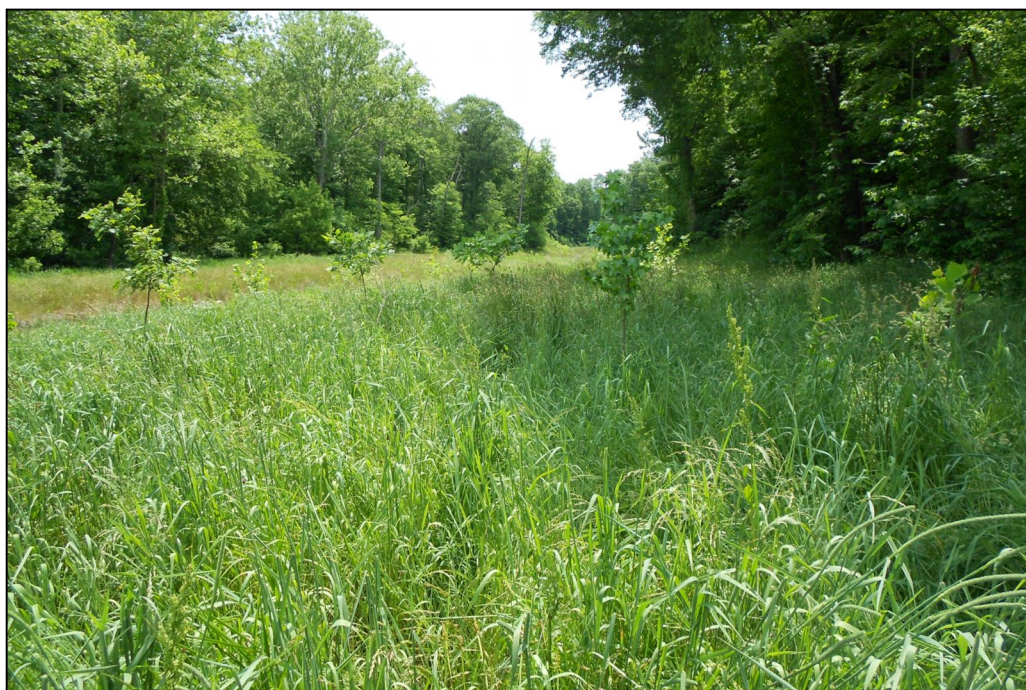
PHOTO 12: LOCATION 8 - LOOKING SOUTHEAST

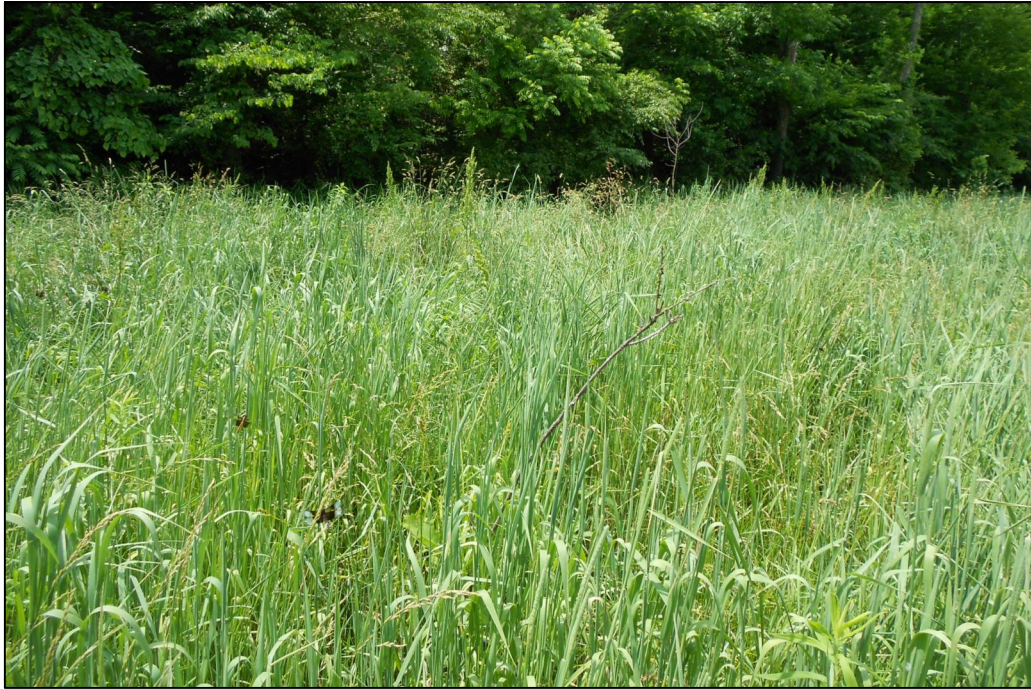
PHOTO 13: LOCATION 9 - LOOKING SOUTHWEST

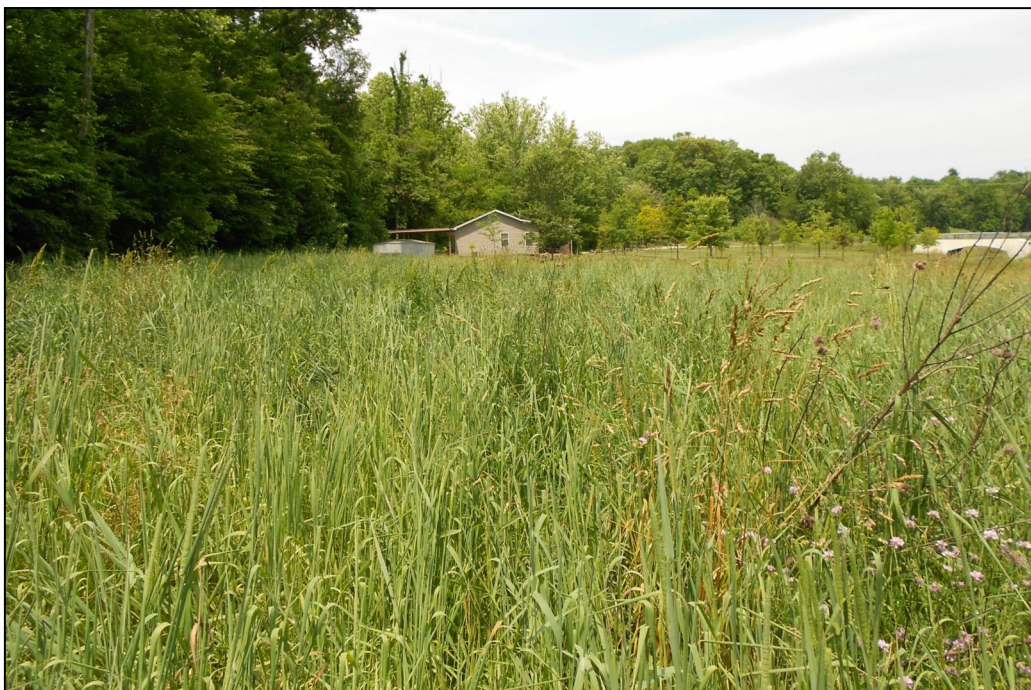
PHOTO 14: LOCATION 10 - LOOKING NORTHWEST

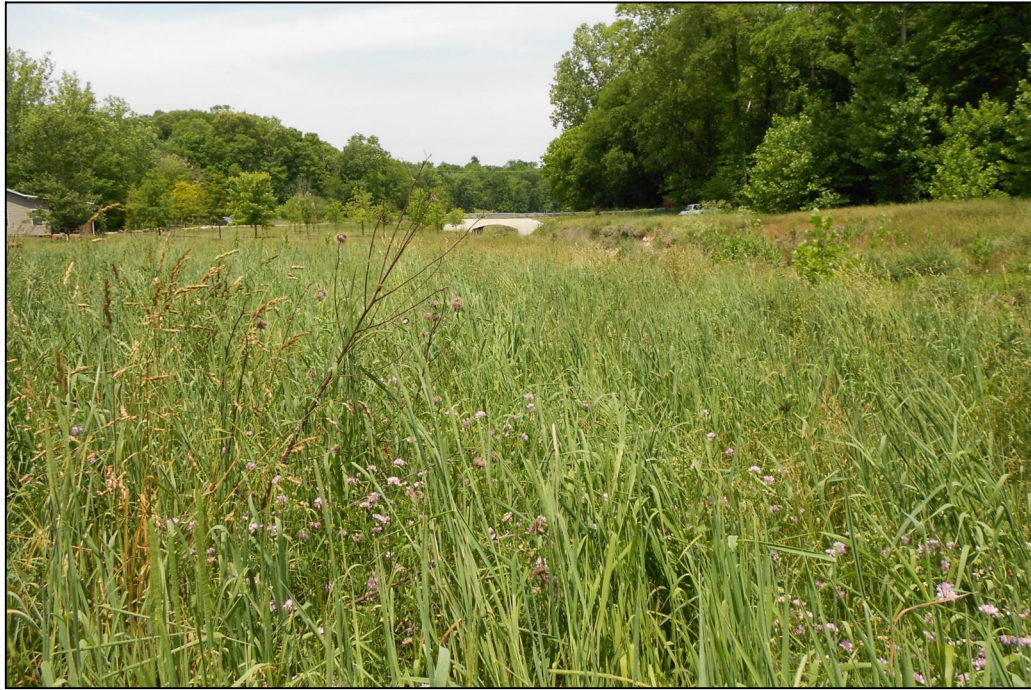
PHOTO 15: LOCATION 11 - LOOKING NORTHWEST

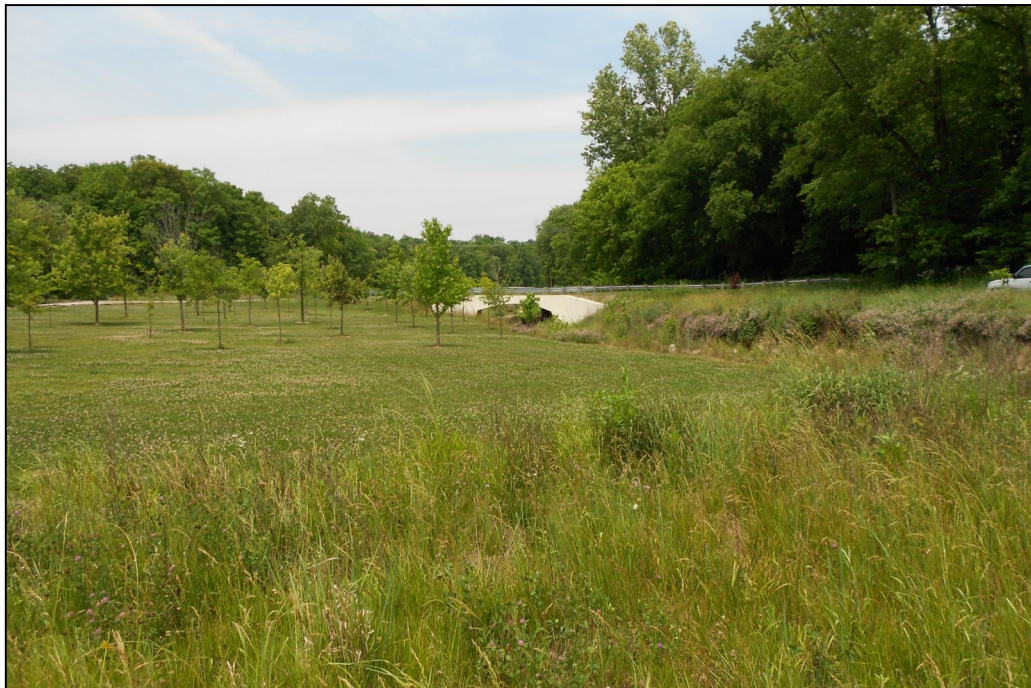
PHOTO 16: LOCATION 12 - LOOKING NORTHWEST

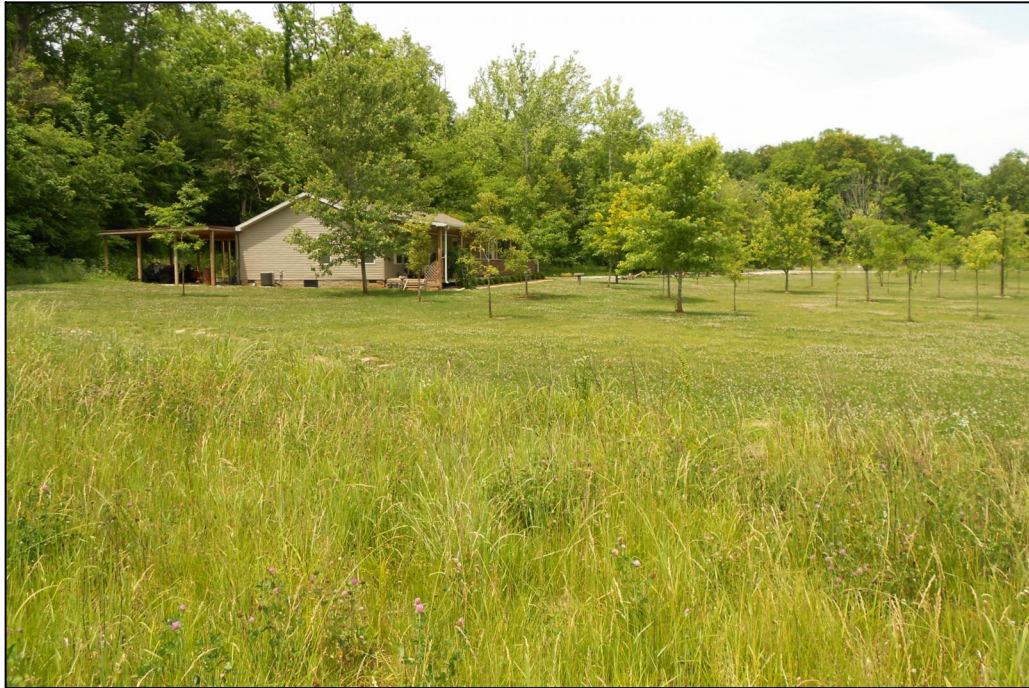
PHOTO 17: LOCATION 13 - LOOKING WEST

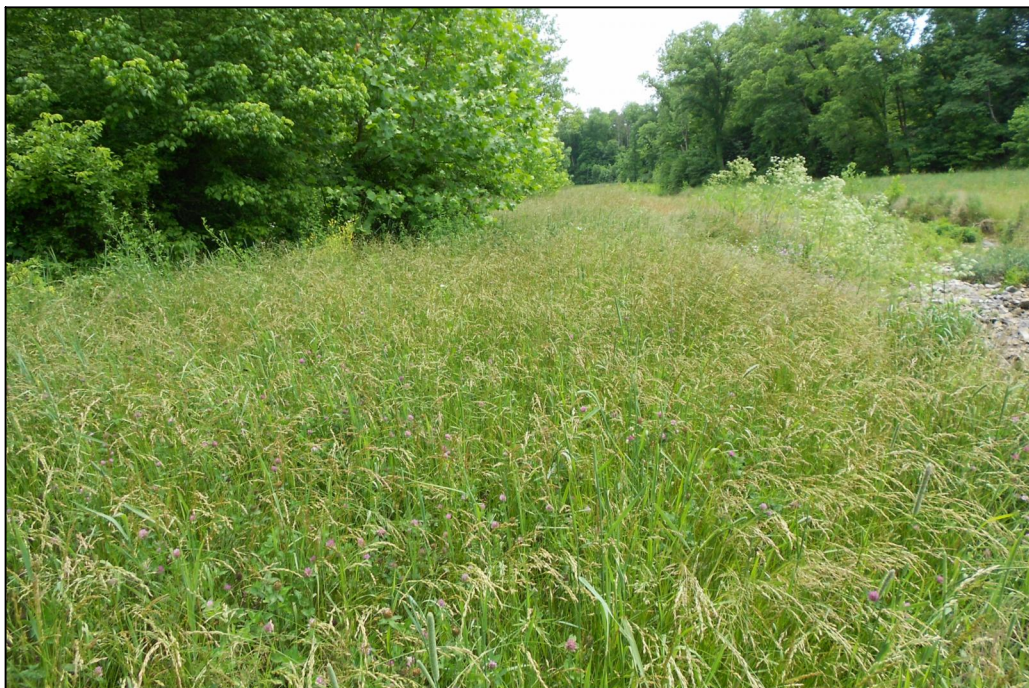
PHOTO 18: LOCATION 14 - LOOKING SOUTHEAST

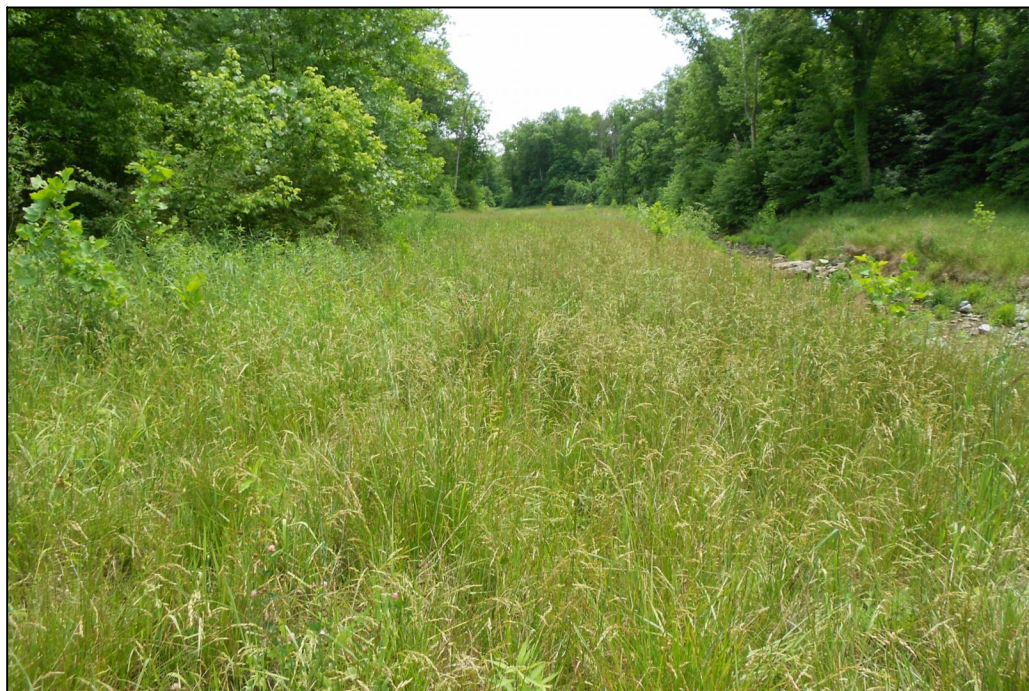
PHOTO 19: LOCATION 15 - LOOKING SOUTHEAST
