Re: RCRA Corrective Action Administrative Order on Consent (AOC)  
Progress Report 66, Third Quarter 2017  
GM GPS – Bedford Facility, IND 006036099, Docket No. RCRA 05-2014-0011  
Bedford, Indiana

## **Third Quarter 2017 Progress Report 66**

GM GPS – Bedford Facility  
105 GM Drive  
Bedford, Indiana  
EPA ID# IND006036099  
AOC Docket No. RCRA 05 2014 0011

## **Third Quarter 2017 Cover System Inspection: Field Logs, Transect Figures, and Photograph Log**

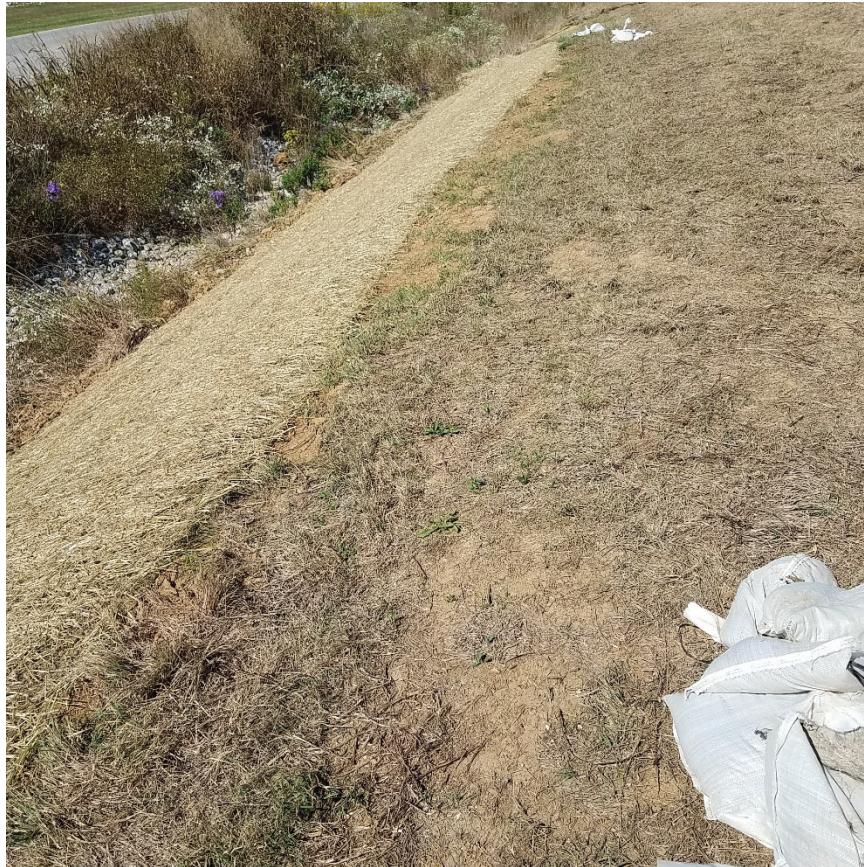
Photo 1: EV1 Vault Cover System west slope erosion area filled, seeded and straw placed.

| ITEM | TYPES OF PROBLEMS | CHECKED | | DETAILED ACTIONS REQUIRED | NOTES | DATE AND NATURE OF ACTIONS COMPLETED |
|---|---|---|---|---|---|---|
| | - EROSION | ✓ | | | filled, seeded, straw | 9/22/17 |

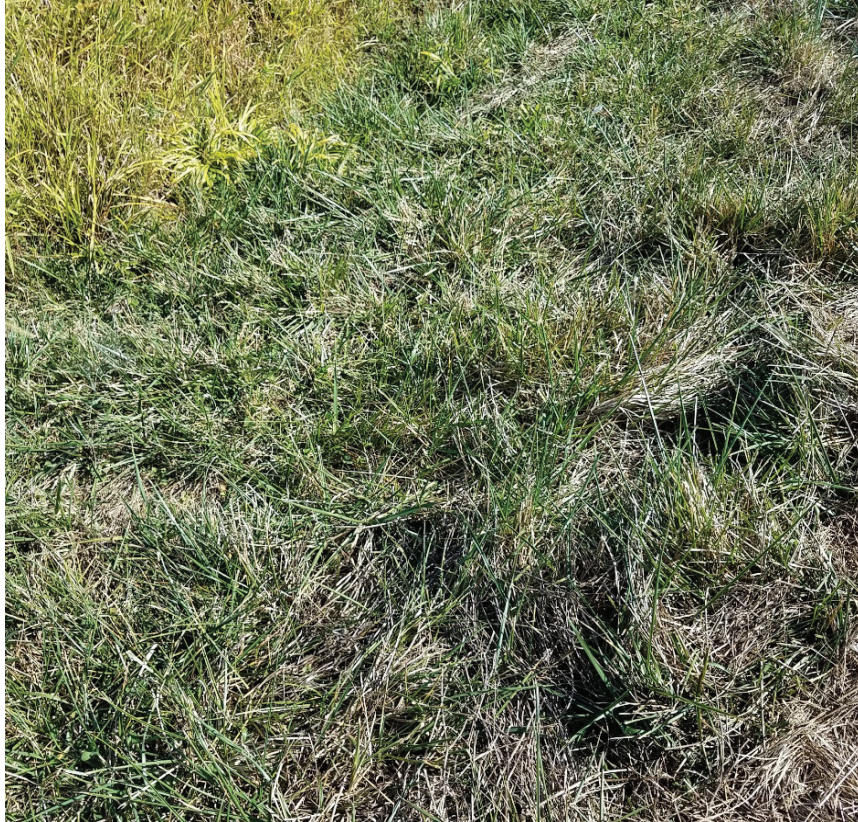
| ITEM | TYPES OF PROBLEMS | CHECKED | | DETAILED ACTIONS REQUIRED | NOTES | DATE AND NATURE OF ACTIONS COMPLETED |
|---|---|---|---|---|---|---|
| Transect EV1 | - QUALITY OF VEGETATIVE COVER | ✓ | | | heavy weed growth | |

Photo 2: EV1 Vault Cover facing northeast toward pond

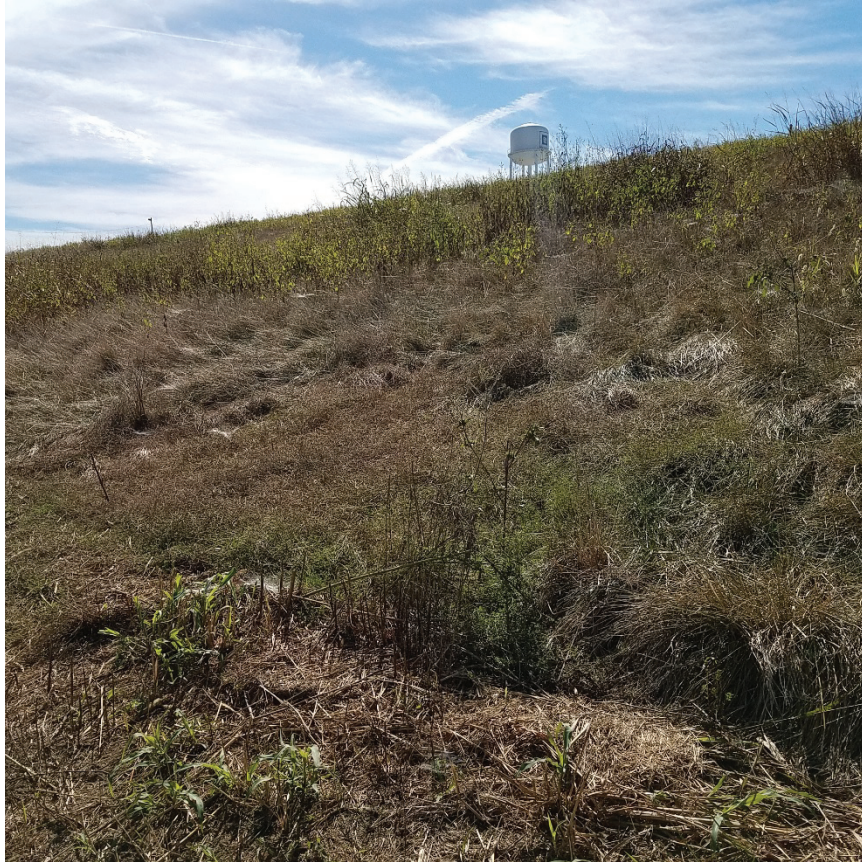
Photo 3: Vegetation at ES1 facing southwest.

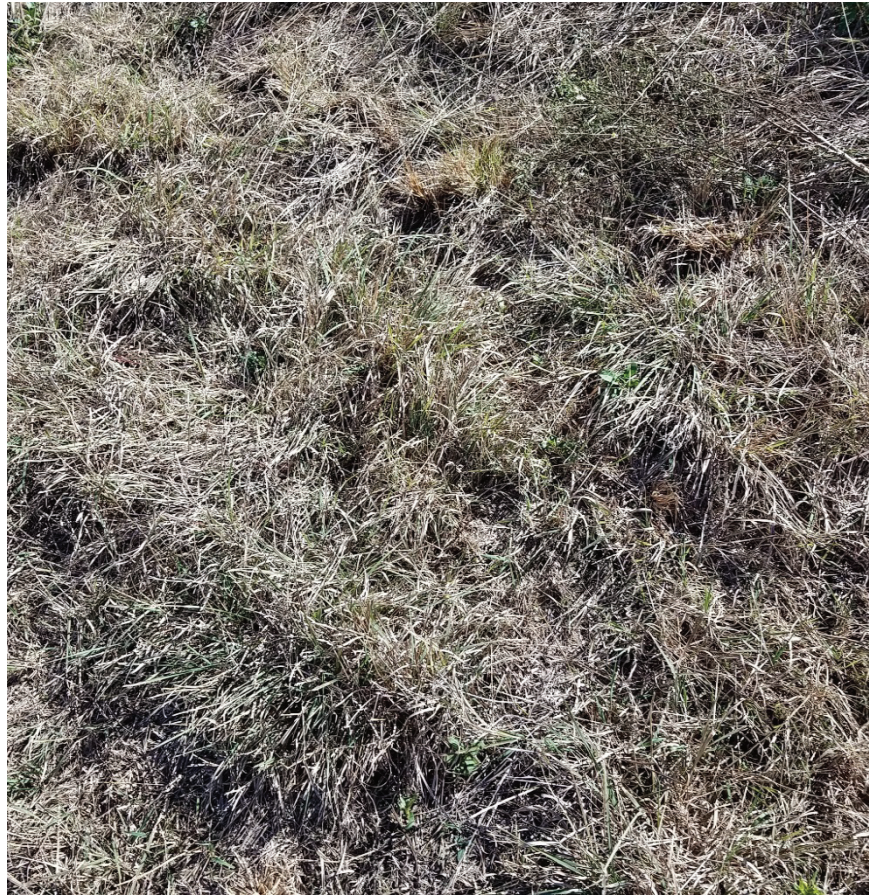
| ITEM | TYPES OF PROBLEMS | CHECKED | | DETAILED ACTIONS REQUIRED | NOTES | DATE AND NATURE OF ACTIONS COMPLETED |
|---|---|---|---|---|---|---|
| Transect EV2 | - QUALITY OF VEGETATIVE COVER | ✓ | | | heavy weed growth | |

Photo 4: Vegetation growth at EV2

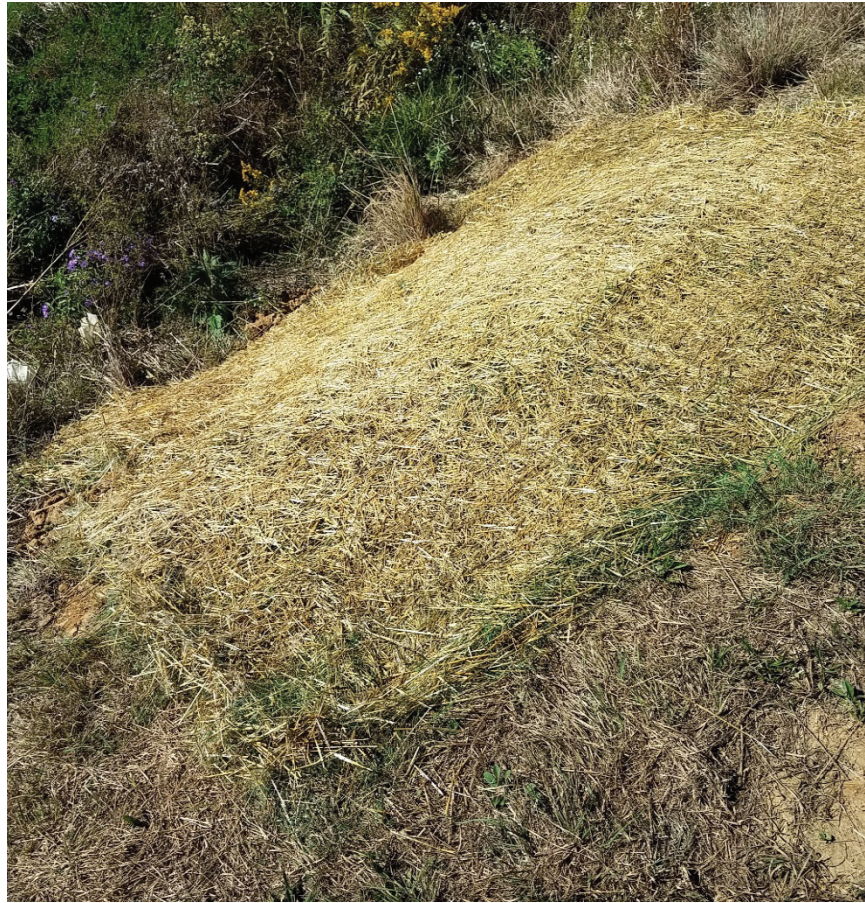
Photo 5: Erosion filled, seeded and straw placed at ES3.

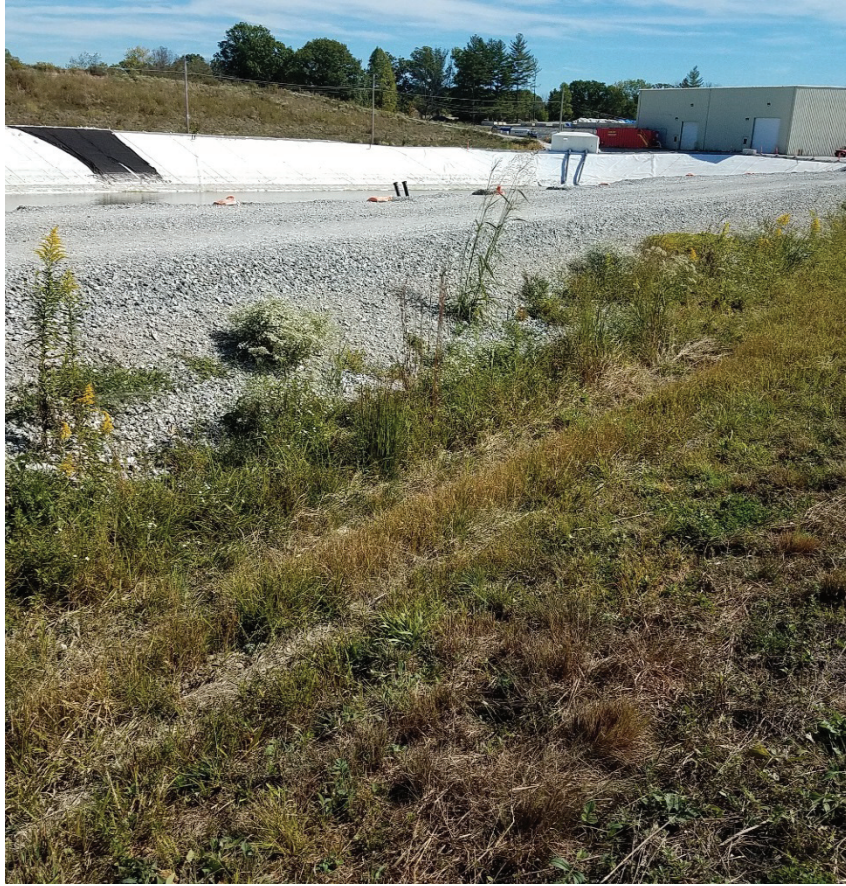
Photo 6: EV2 East Plant Area Cover facing southeast towards pond

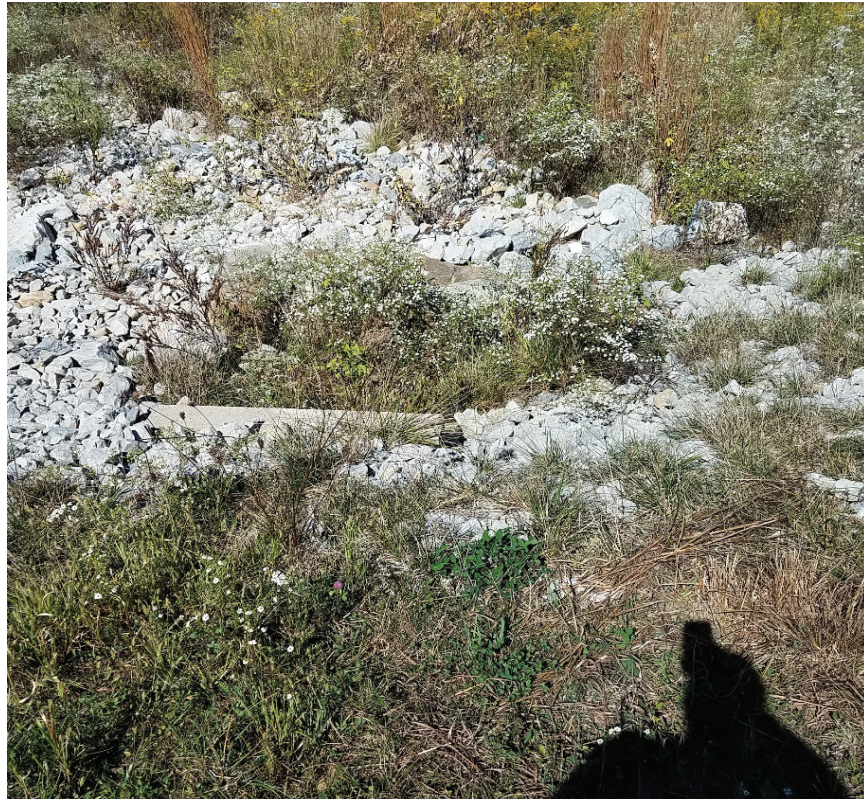
Photo 7: Drainage channel at ES6 East Plant Area Cover facing northeast.

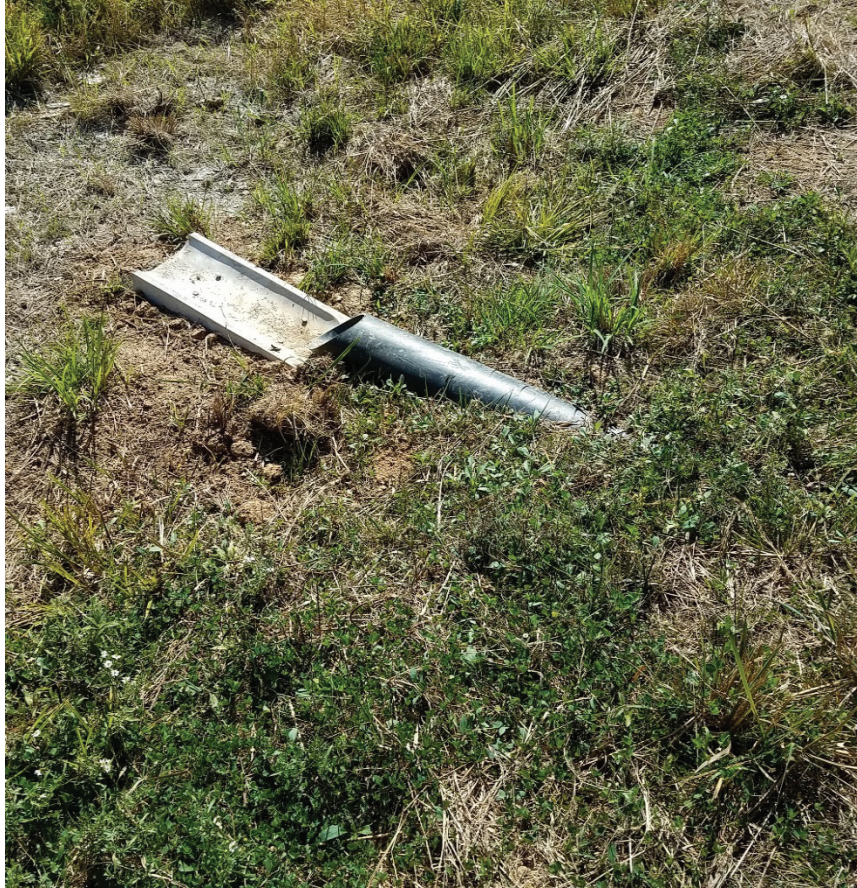
Photo 8: Drainage pipe along EV3 East Plant Area Cover.

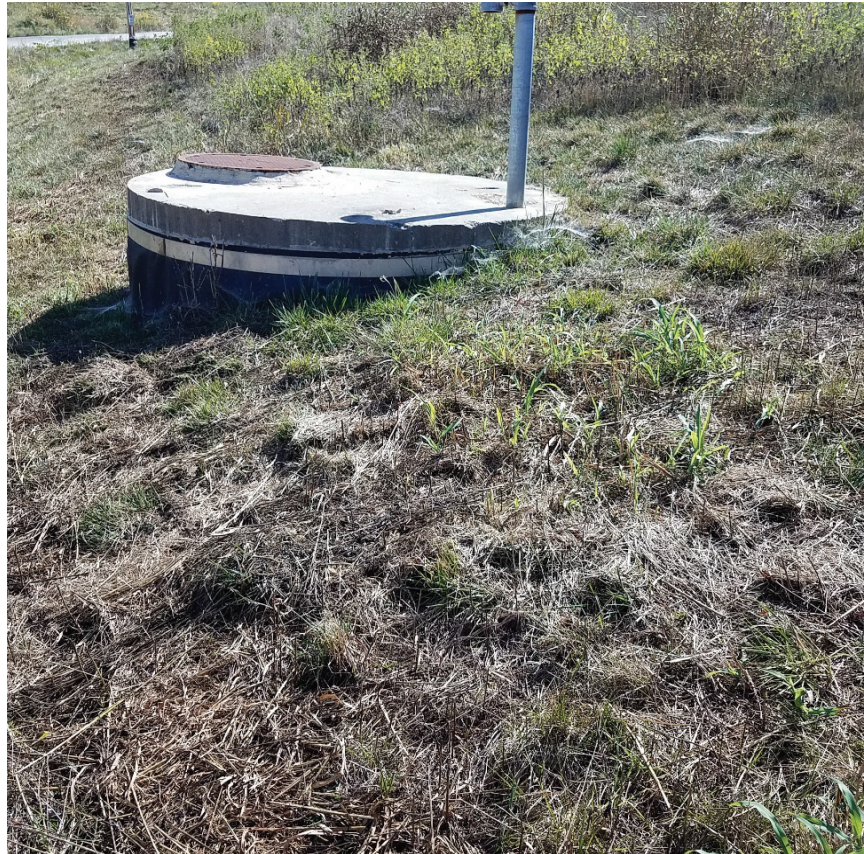
Photo 9: Vegetation on ES1 East Plant Area Cover at south end of Pond.

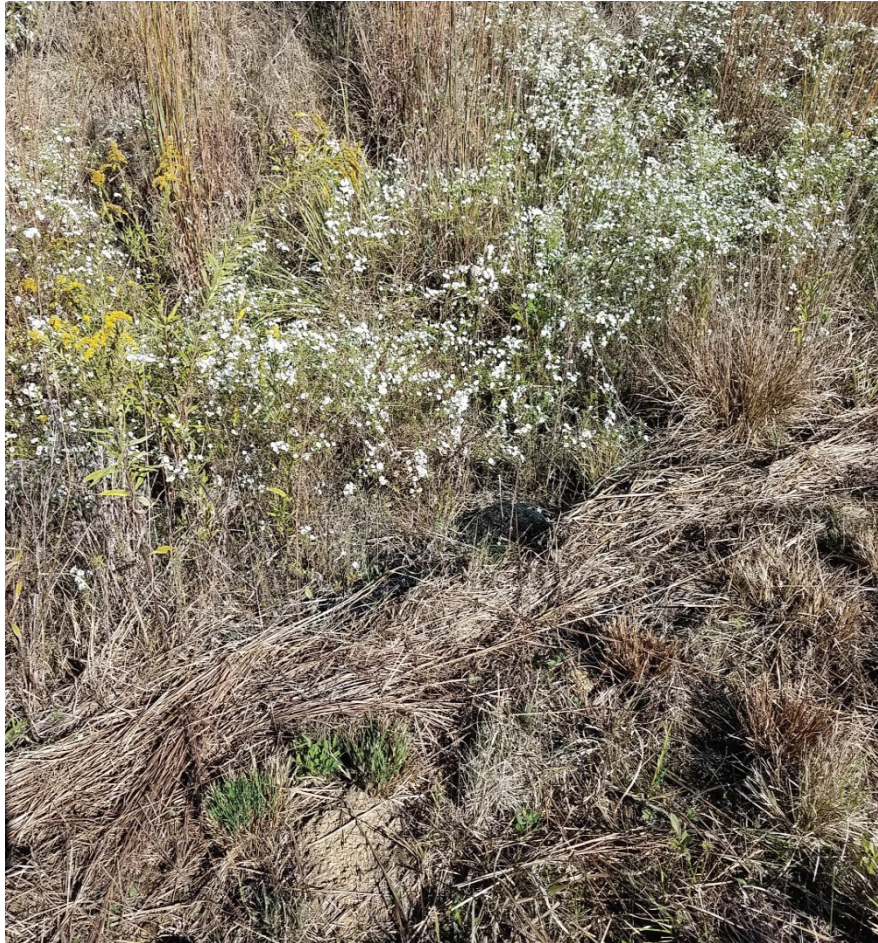
Photo 10: Vegetation along ES6 East Plant Area Cover

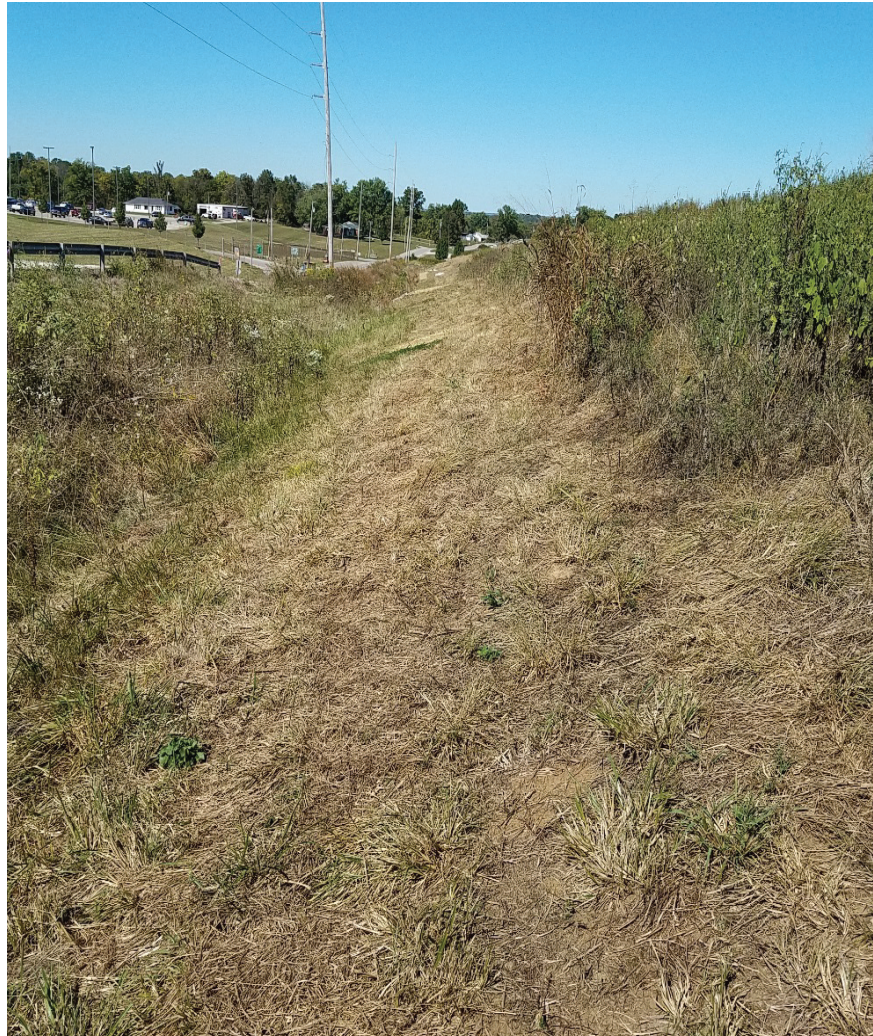
Photo 11: South of EV1 East Plant Cover System facing north

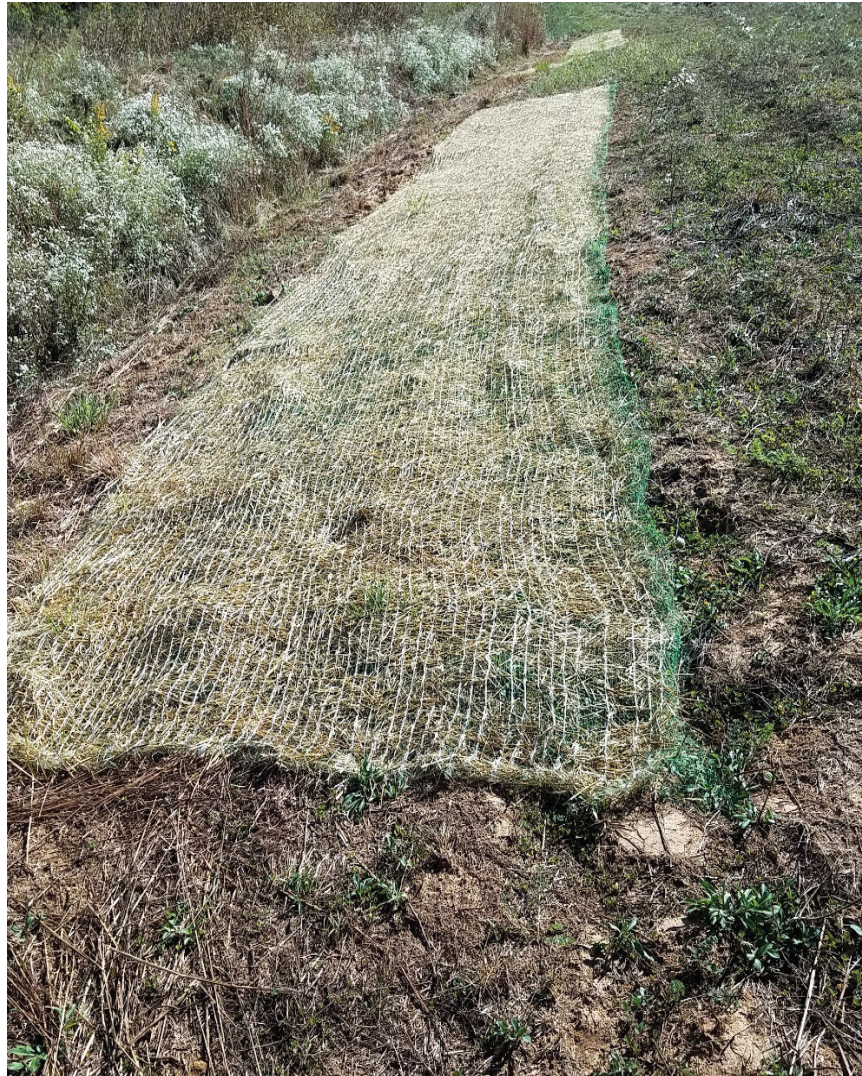
Photo 12: EV4 East Plant Area Cover vegetation filled, seeded and straw placed.

| ITEM | TYPES OF PROBLEMS | CHECKED | | DETAILED ACTIONS REQUIRED | NOTES | DATE AND NATURE OF ACTIONS COMPLETED |
|---|---|---|---|---|---|---|
| | - EROSION | ✓ | | | filled, seeded, straw | 9/22/17 |

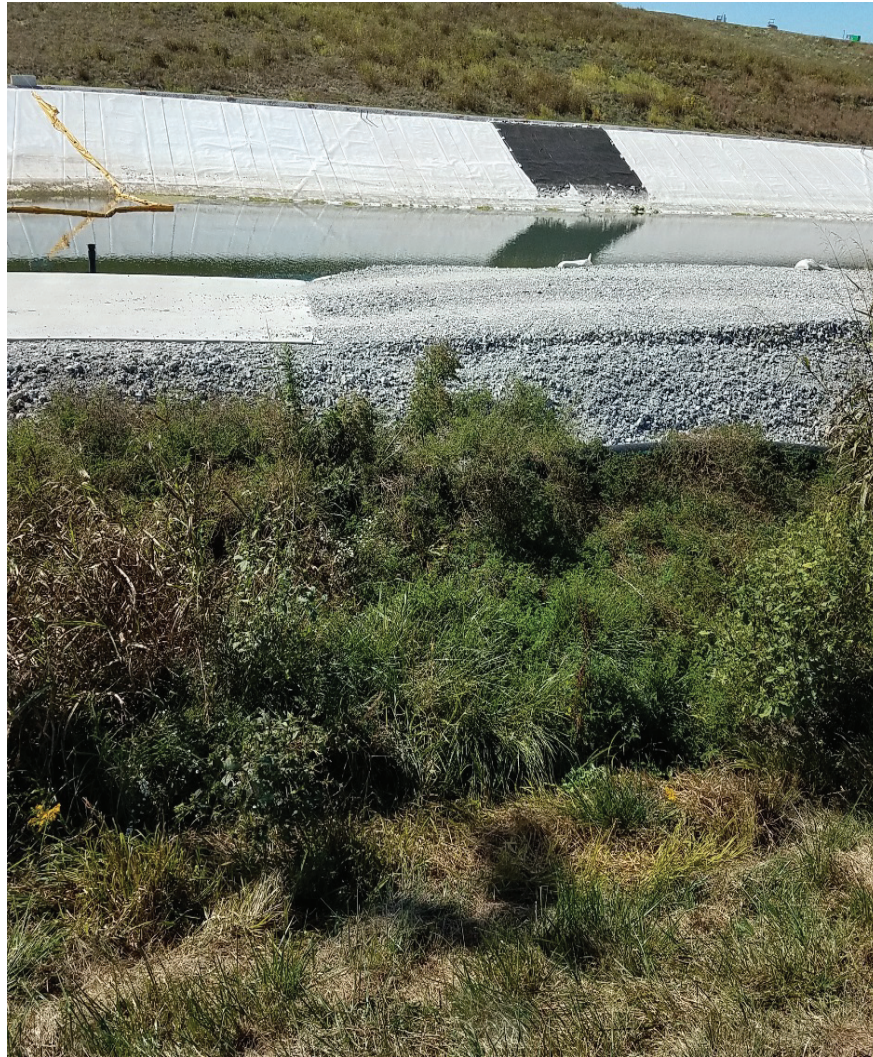
Photo 13: Vegetation south of EV5, facing pond

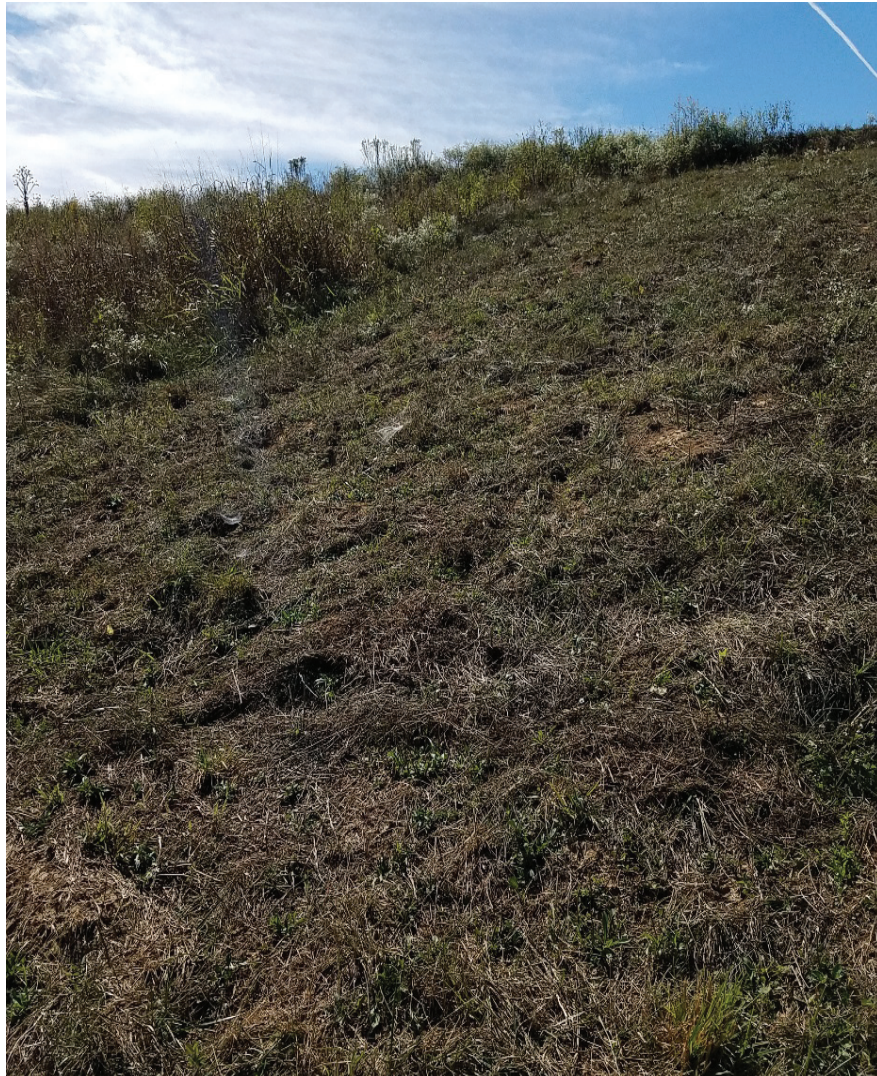
Photo 14: Vegetative growth along EV5 East Plant Area facing east, away from pond.

| ITEM | TYPES OF PROBLEMS | CHECKED | | DETAILED ACTIONS REQUIRED | NOTES | DATE AND NATURE OF ACTIONS COMPLETED |
|---|---|---|---|---|---|---|
| | - ROOTING OF TREES | ✓ | | | trees cut | 9/18/17 |

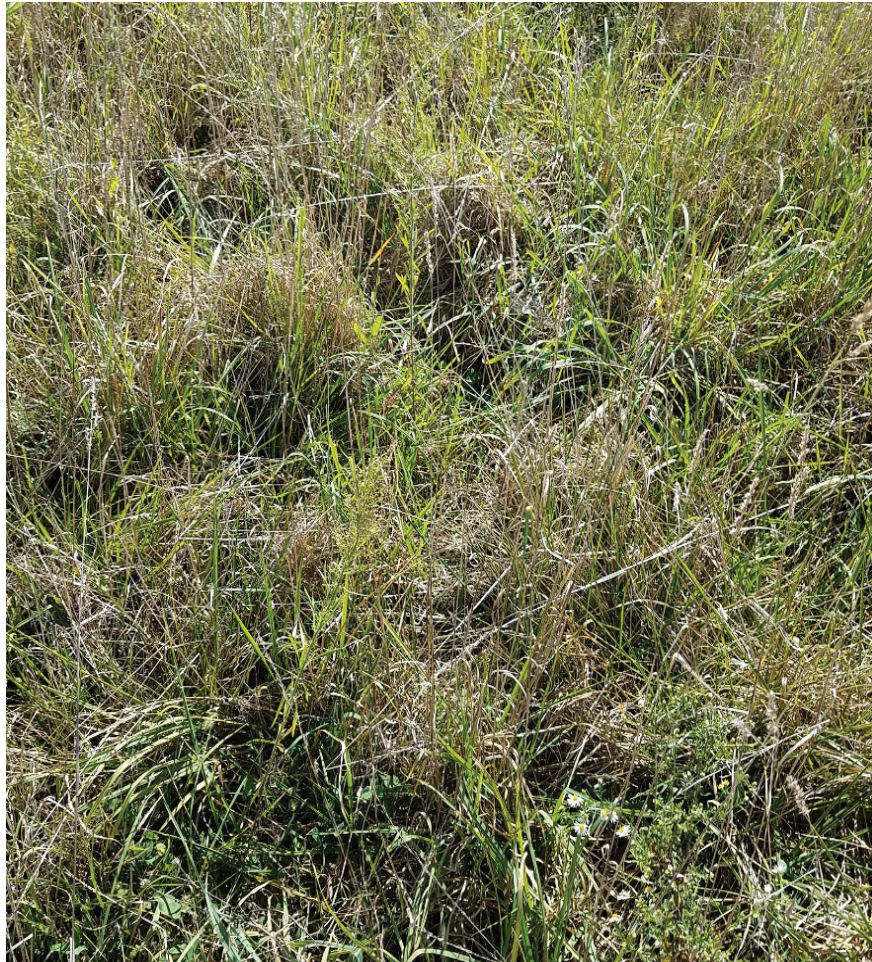
Photo 15: Vegetation growth at ES12 East Plant Area Cover.

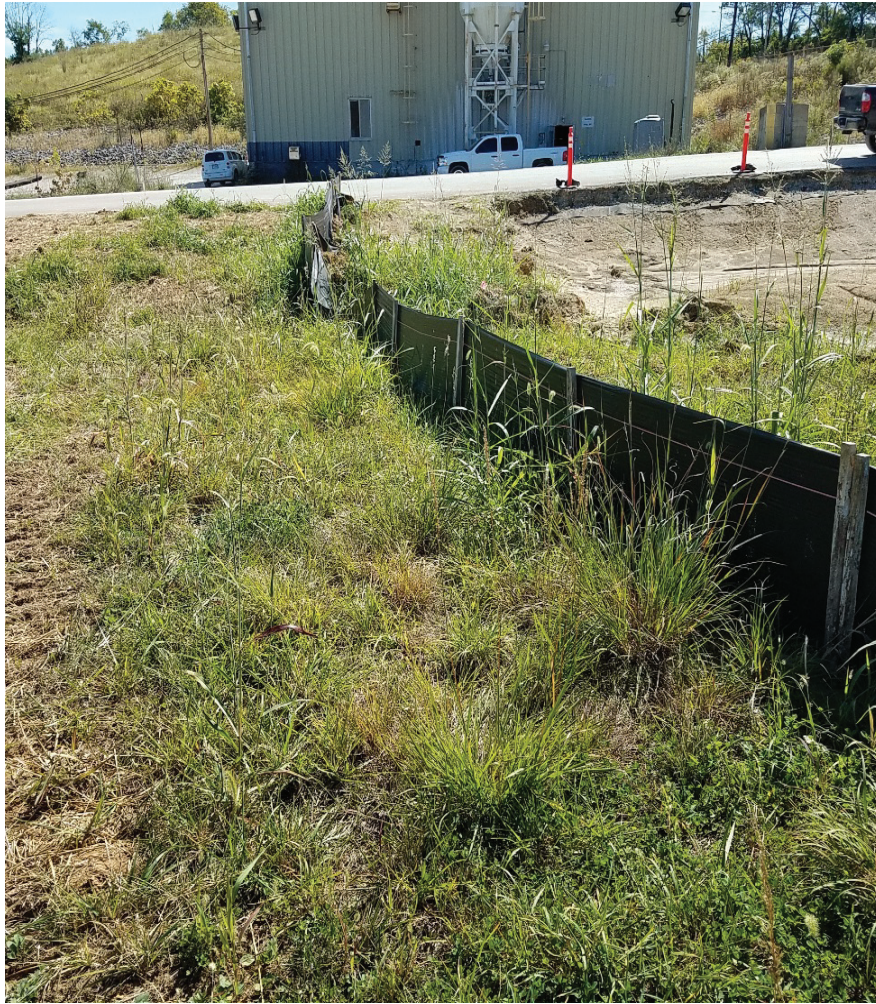
| ITEM | TYPES OF PROBLEMS | CHECKED | | DETAILED ACTIONS REQUIRED | NOTES | DATE AND NATURE OF ACTIONS COMPLETED |
|---|---|---|---|---|---|---|
| | - QUALITY OF VEGETATIVE COVER | ✓ | | | heavy weed growth | |

Photo 16: Facing east along EV7 East Plant Cover.

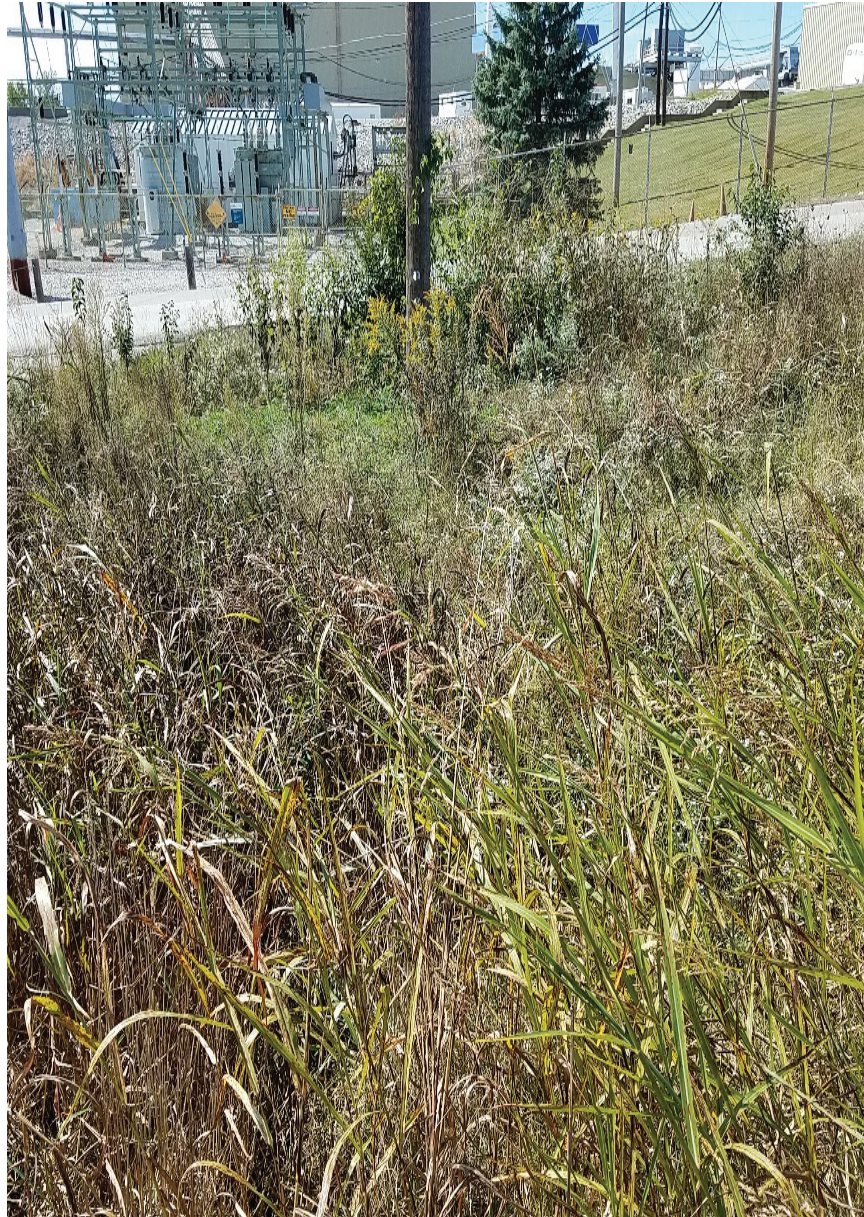
| ITEM | TYPES OF PROBLEMS | CHECKED | | DETAILED ACTIONS REQUIRED | NOTES | DATE AND NATURE OF ACTIONS COMPLETED |
|---|---|---|---|---|---|---|
| Transect EV6 | - QUALITY OF VEGETATIVE COVER | ✓ | | | heavy weed growth | |

Photo 17: East Plant Area Cover System along EV6, facing west.

| ITEM | TYPES OF PROBLEMS | CHECKED | | DETAILED ACTIONS REQUIRED | NOTES | DATE AND NATURE OF ACTIONS COMPLETED |
|---|---|---|---|---|---|---|
| | - EROSION | ✓ | | | filled, seeded, straw | 9/22/17 |

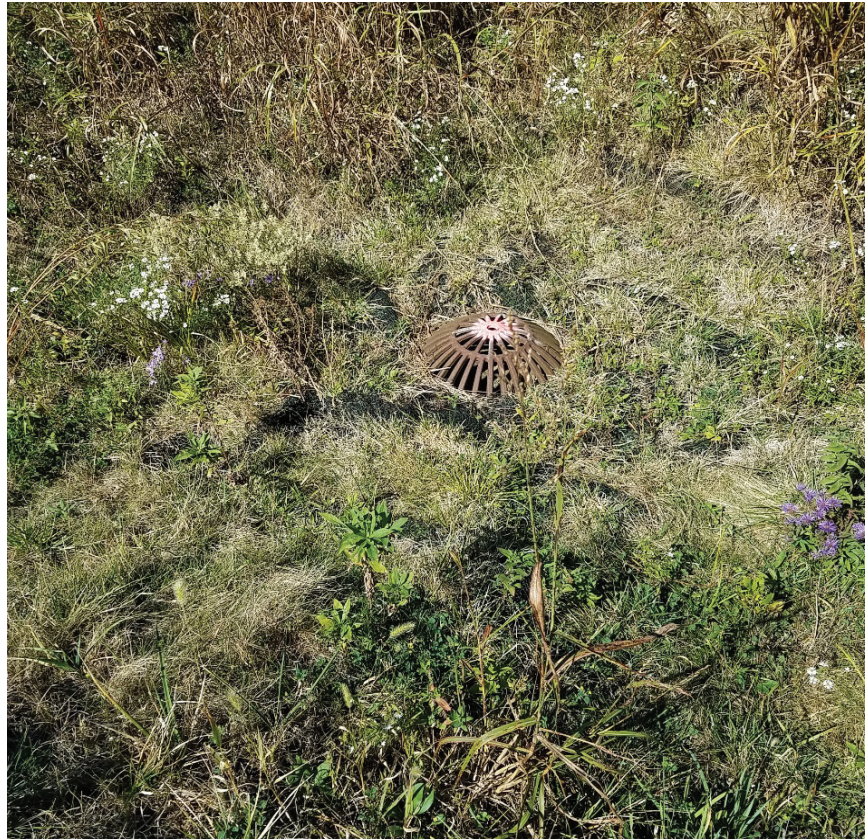
Photo 18: ES14 catch basin East Plant Area Cover.

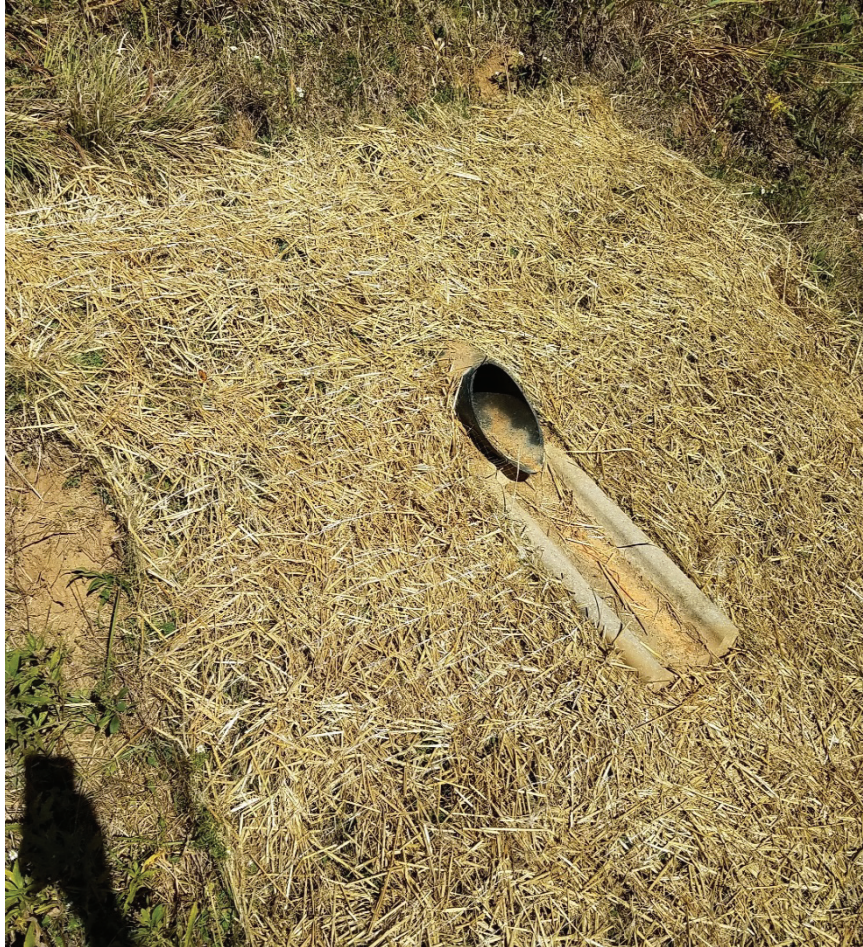
Photo 19: EV9 East Plant Area Cover erosion patch filled, seeded and straw placed.

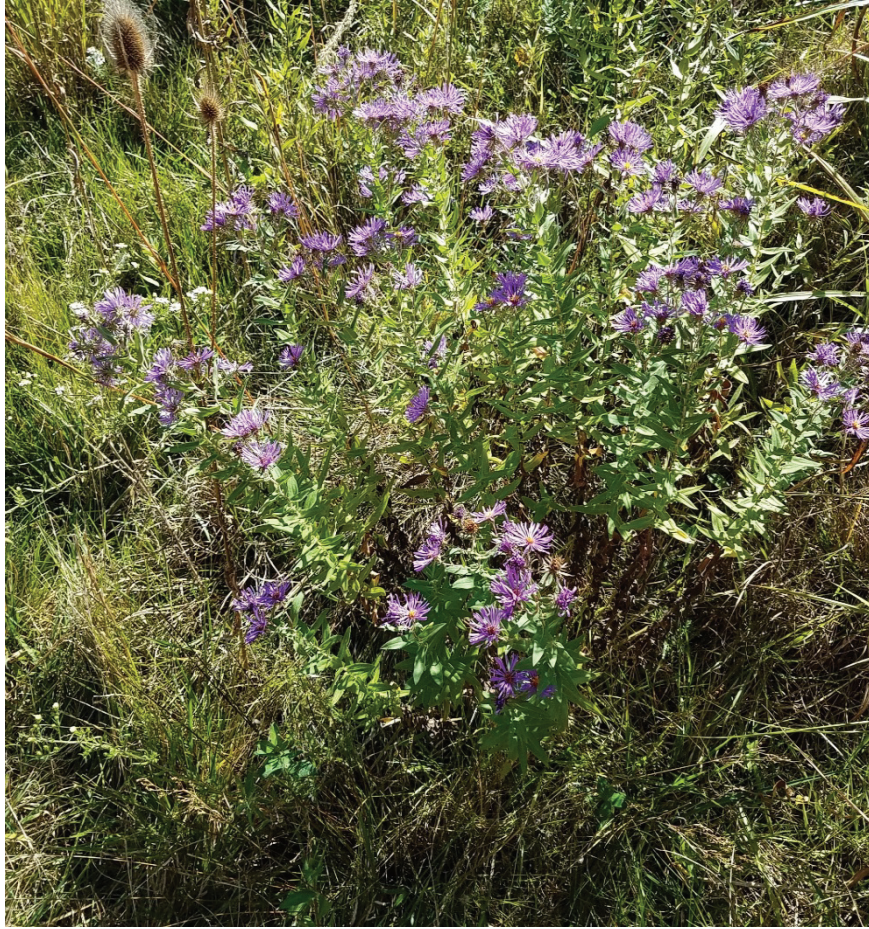
Photo 20: ES14 East Plant Area Cover vegetation growth.
