# East Plant Area TSCA Vault Annual Report Calendar Year 2015

GM CET Bedford Facility  
105 GM Drive  
Bedford, Indiana  
EPA ID# IND006036099

General Motors LLC

GHD | 651 Colby Drive Waterloo Ontario N2V 1C2  
031968 | Report No 391 Revision 1 | July 10 2017

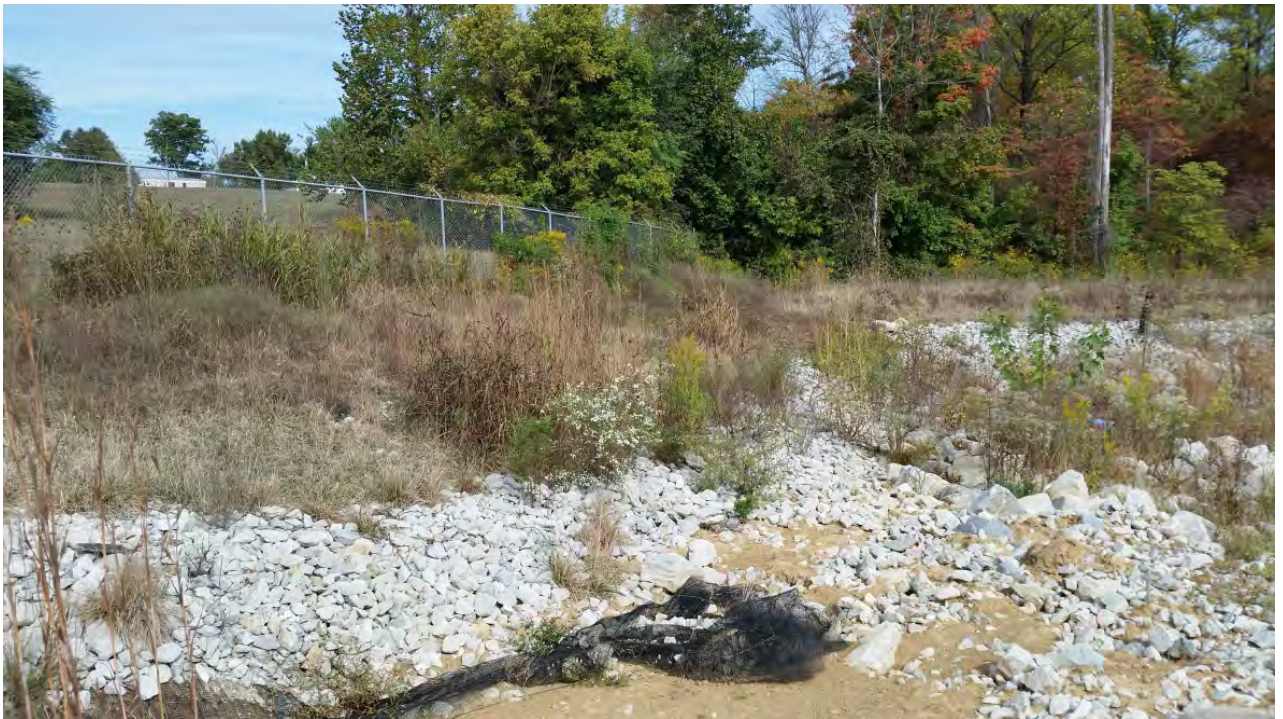
Photo 24: ES6 drainage swale facing west, channel erosion.

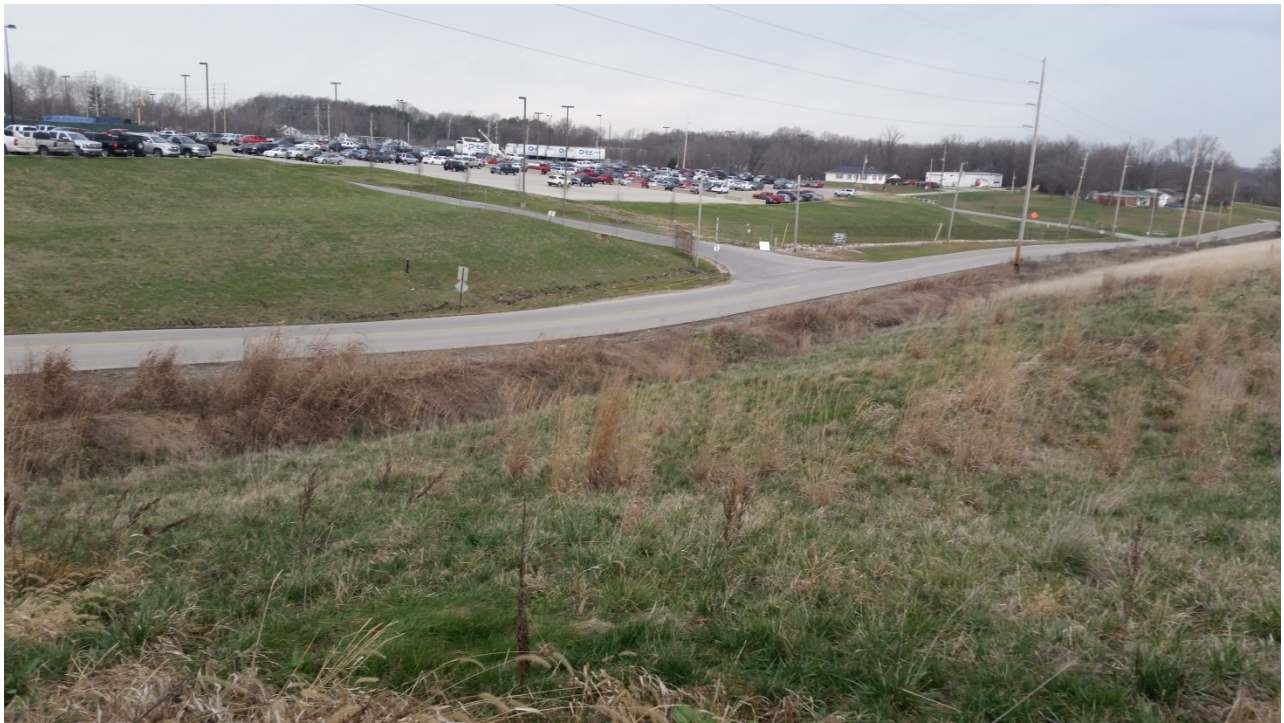
Photo 1: EV1 Vault cover facing northwest.

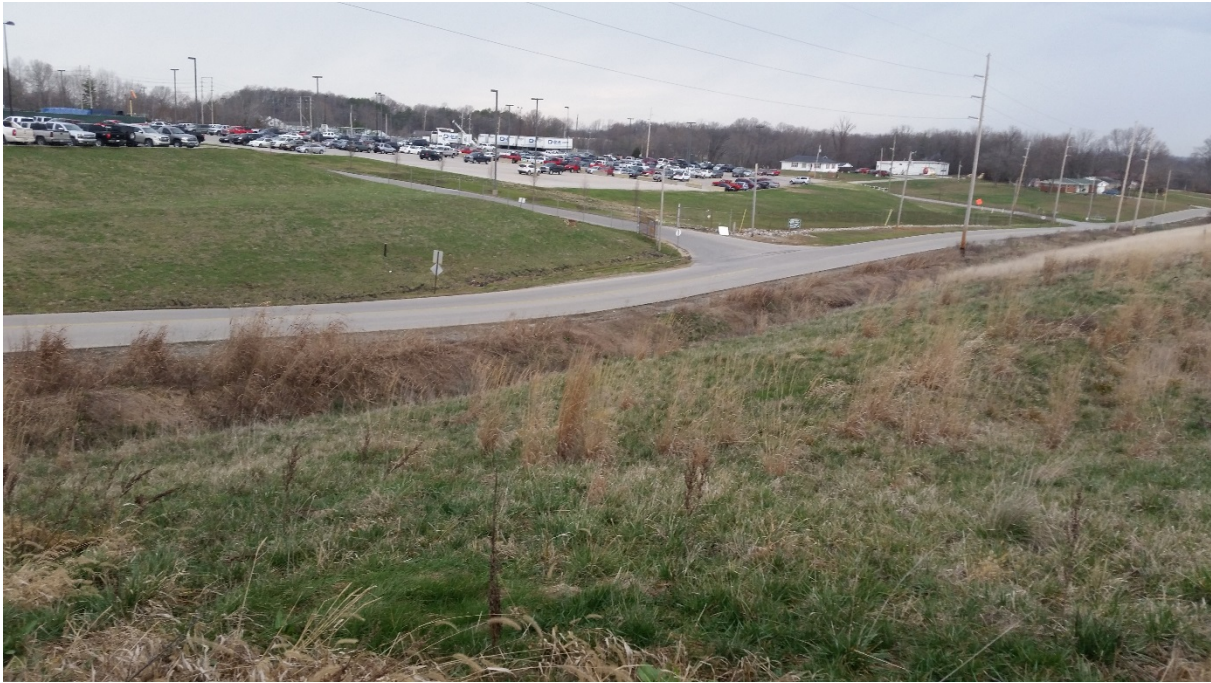
Photo 36: WV1 West Plant Area cover facing northwest.
