Re: RCRA Corrective Action Administrative Order on Consent (AOC)  
Progress Report 69, Second Quarter 2018  
GM GPS – Bedford Facility, IND 006036099, Docket No. RCRA 05 2014 0011  
Bedford, Indiana

## **Second Quarter 2018 Progress Report 69**

GM GPS – Bedford Facility  
105 GM Drive  
Bedford, Indiana  
EPA ID# IND006036099  
AOC Docket No. RCRA 05 2014 0011

## **Second Quarter 2018 Cover System Inspection: Photograph Log, Transect Figures, and Field Log**

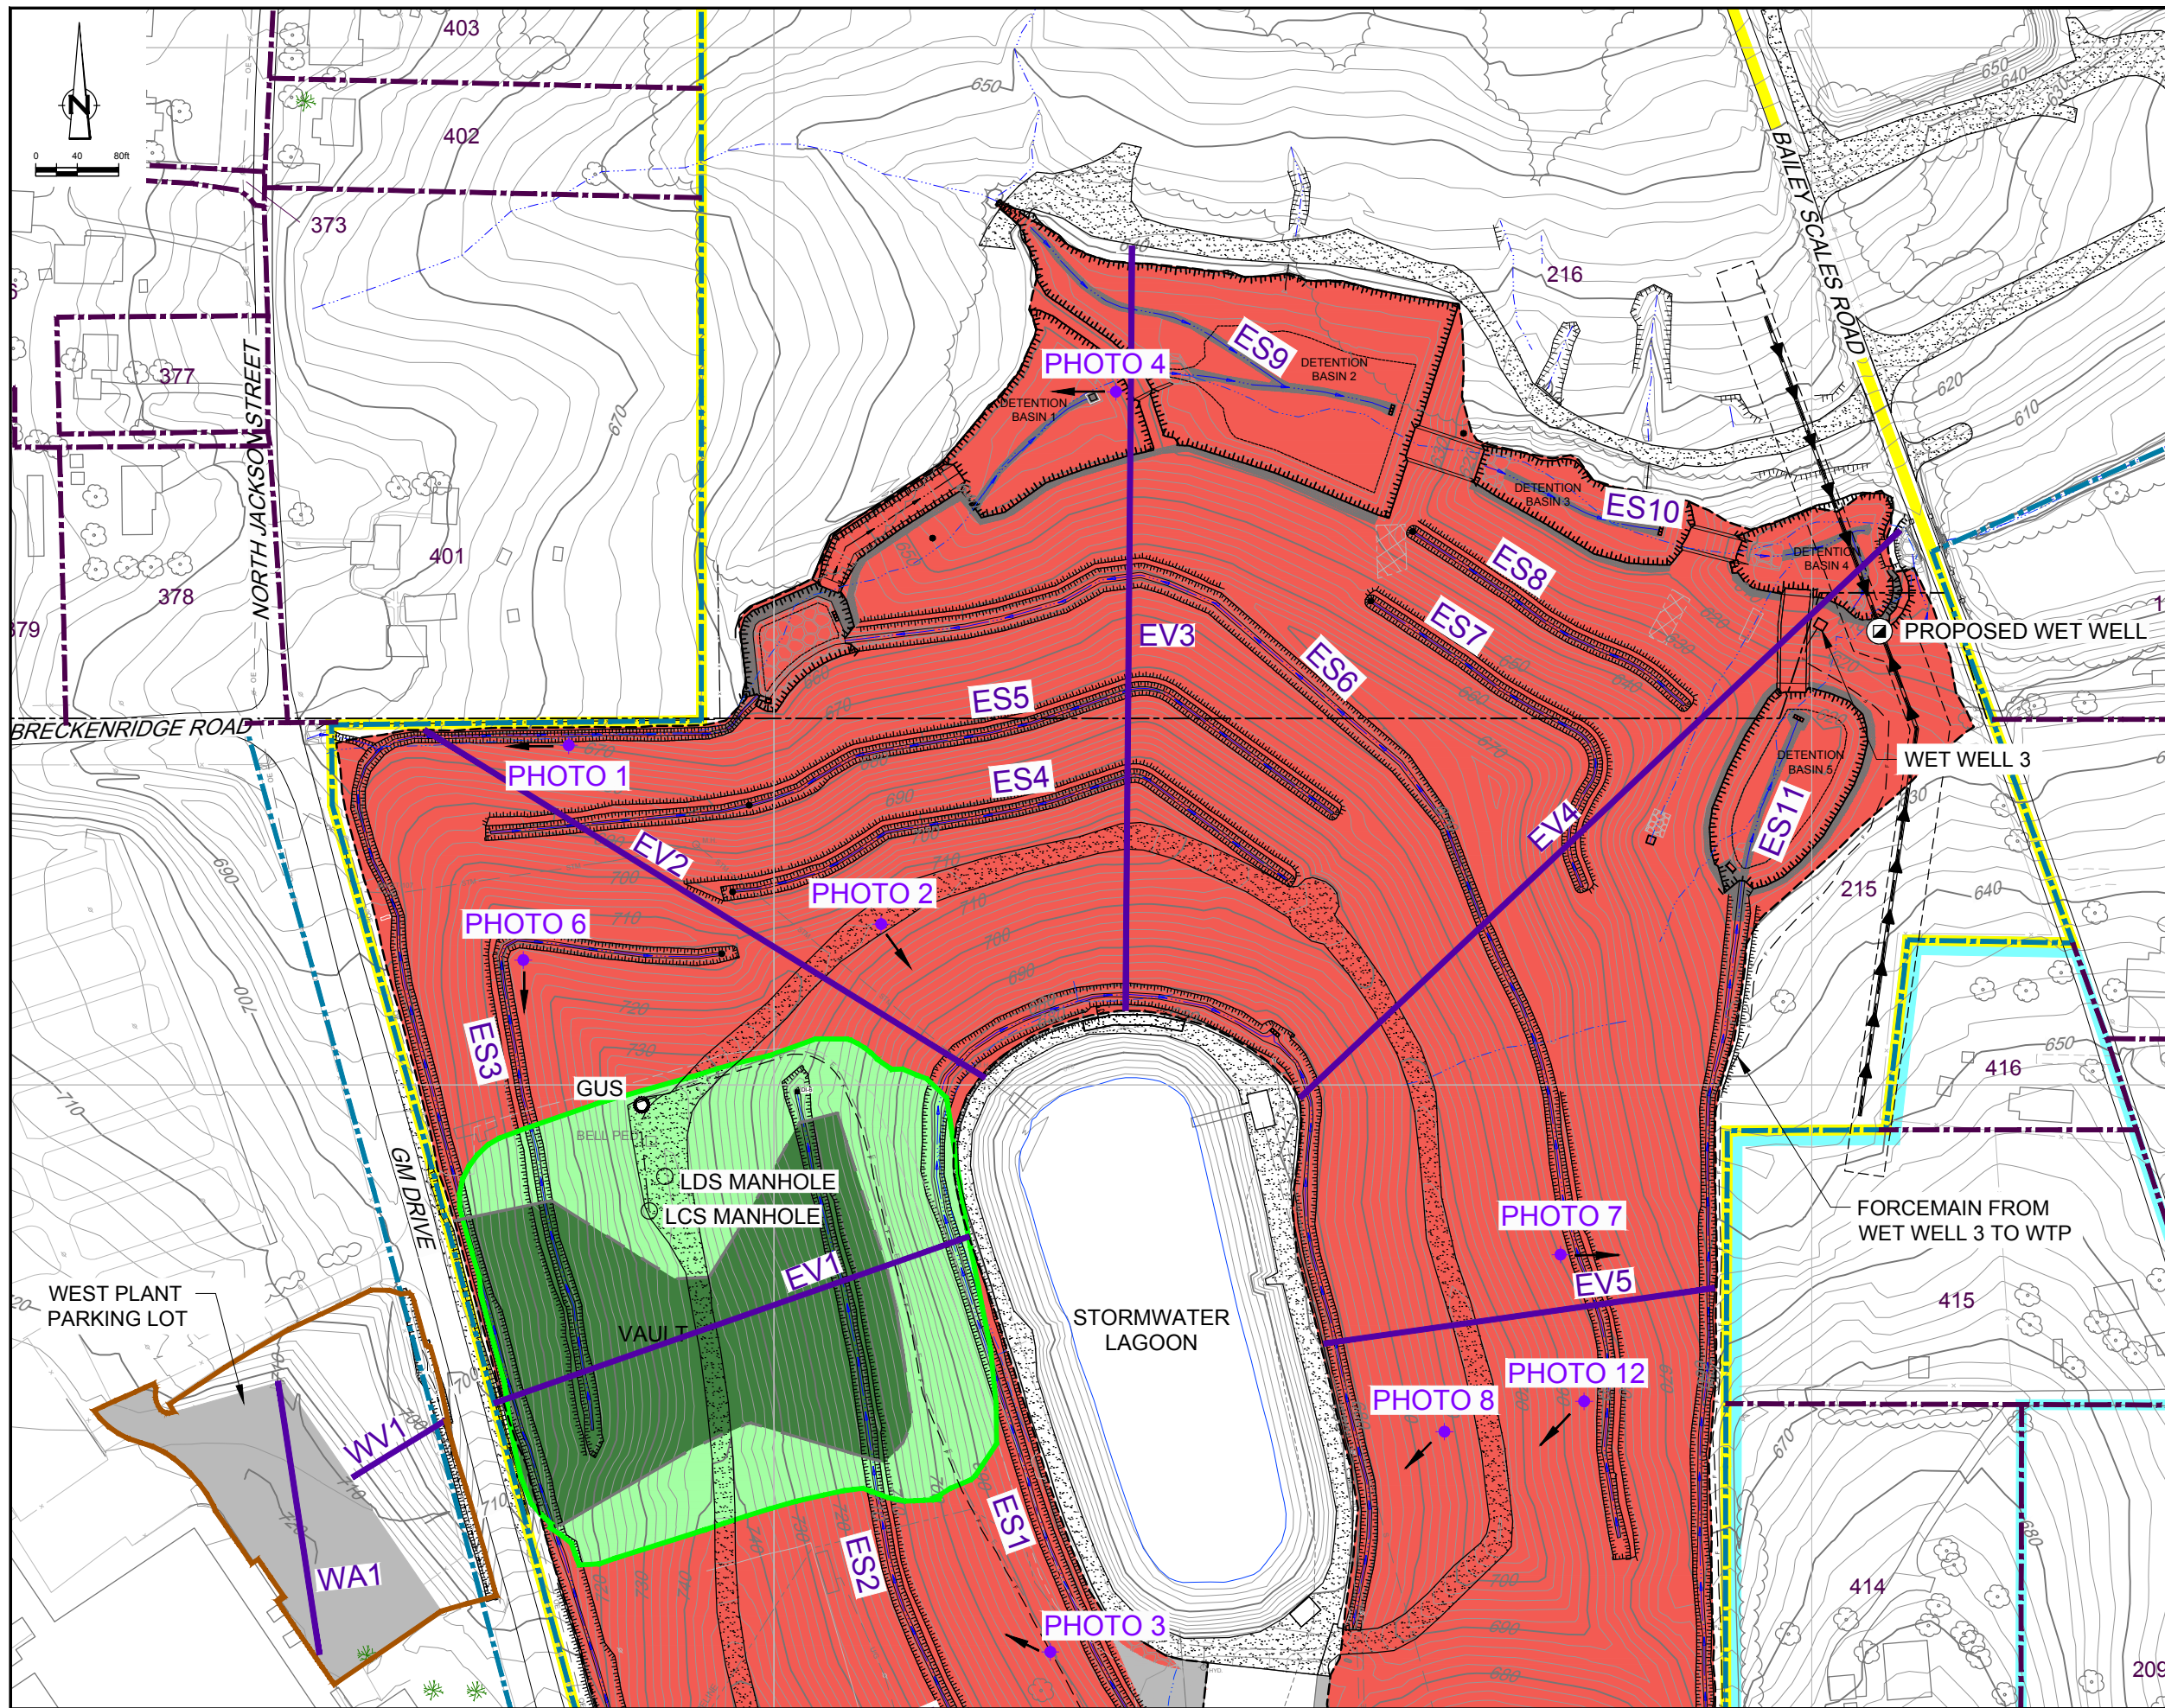
| | | Drawing N°:<br>figure A.1 |

1. Weeds or clover growth were noted at most Transects in the East Plant Area and the West Plant Area, which is also typically accompanied by some bare patches.
2. Weed growth and bare spots were identified at Transects EV1, EV2, EV3, EV4, EV5, EV6, EV7, EV8, EV9, WV1, ES1, ES2, ES3, ES4, ES5, ES6, ES7, ES8, ES9, ES10, ES11, ES12, and ES13.
3. Erosion reported at Transects EV4, EV5, and ES6.
  - Re-seeding in the eroded patches will be completed as necessary in early Fall 2018 to optimize germination.
