Re: RCRA Corrective Action Administrative Order on Consent (AOC)  
Progress Report 66, Third Quarter 2017  
GM GPS – Bedford Facility, IND 006036099, Docket No. RCRA 05-2014-0011  
Bedford, Indiana

## **Third Quarter 2017 Progress Report 66**

GM GPS – Bedford Facility  
105 GM Drive  
Bedford, Indiana  
EPA ID# IND006036099  
AOC Docket No. RCRA 05 2014 0011

## **Third Quarter 2017 Cover System Inspection: Field Logs, Transect Figures, and Photograph Log**

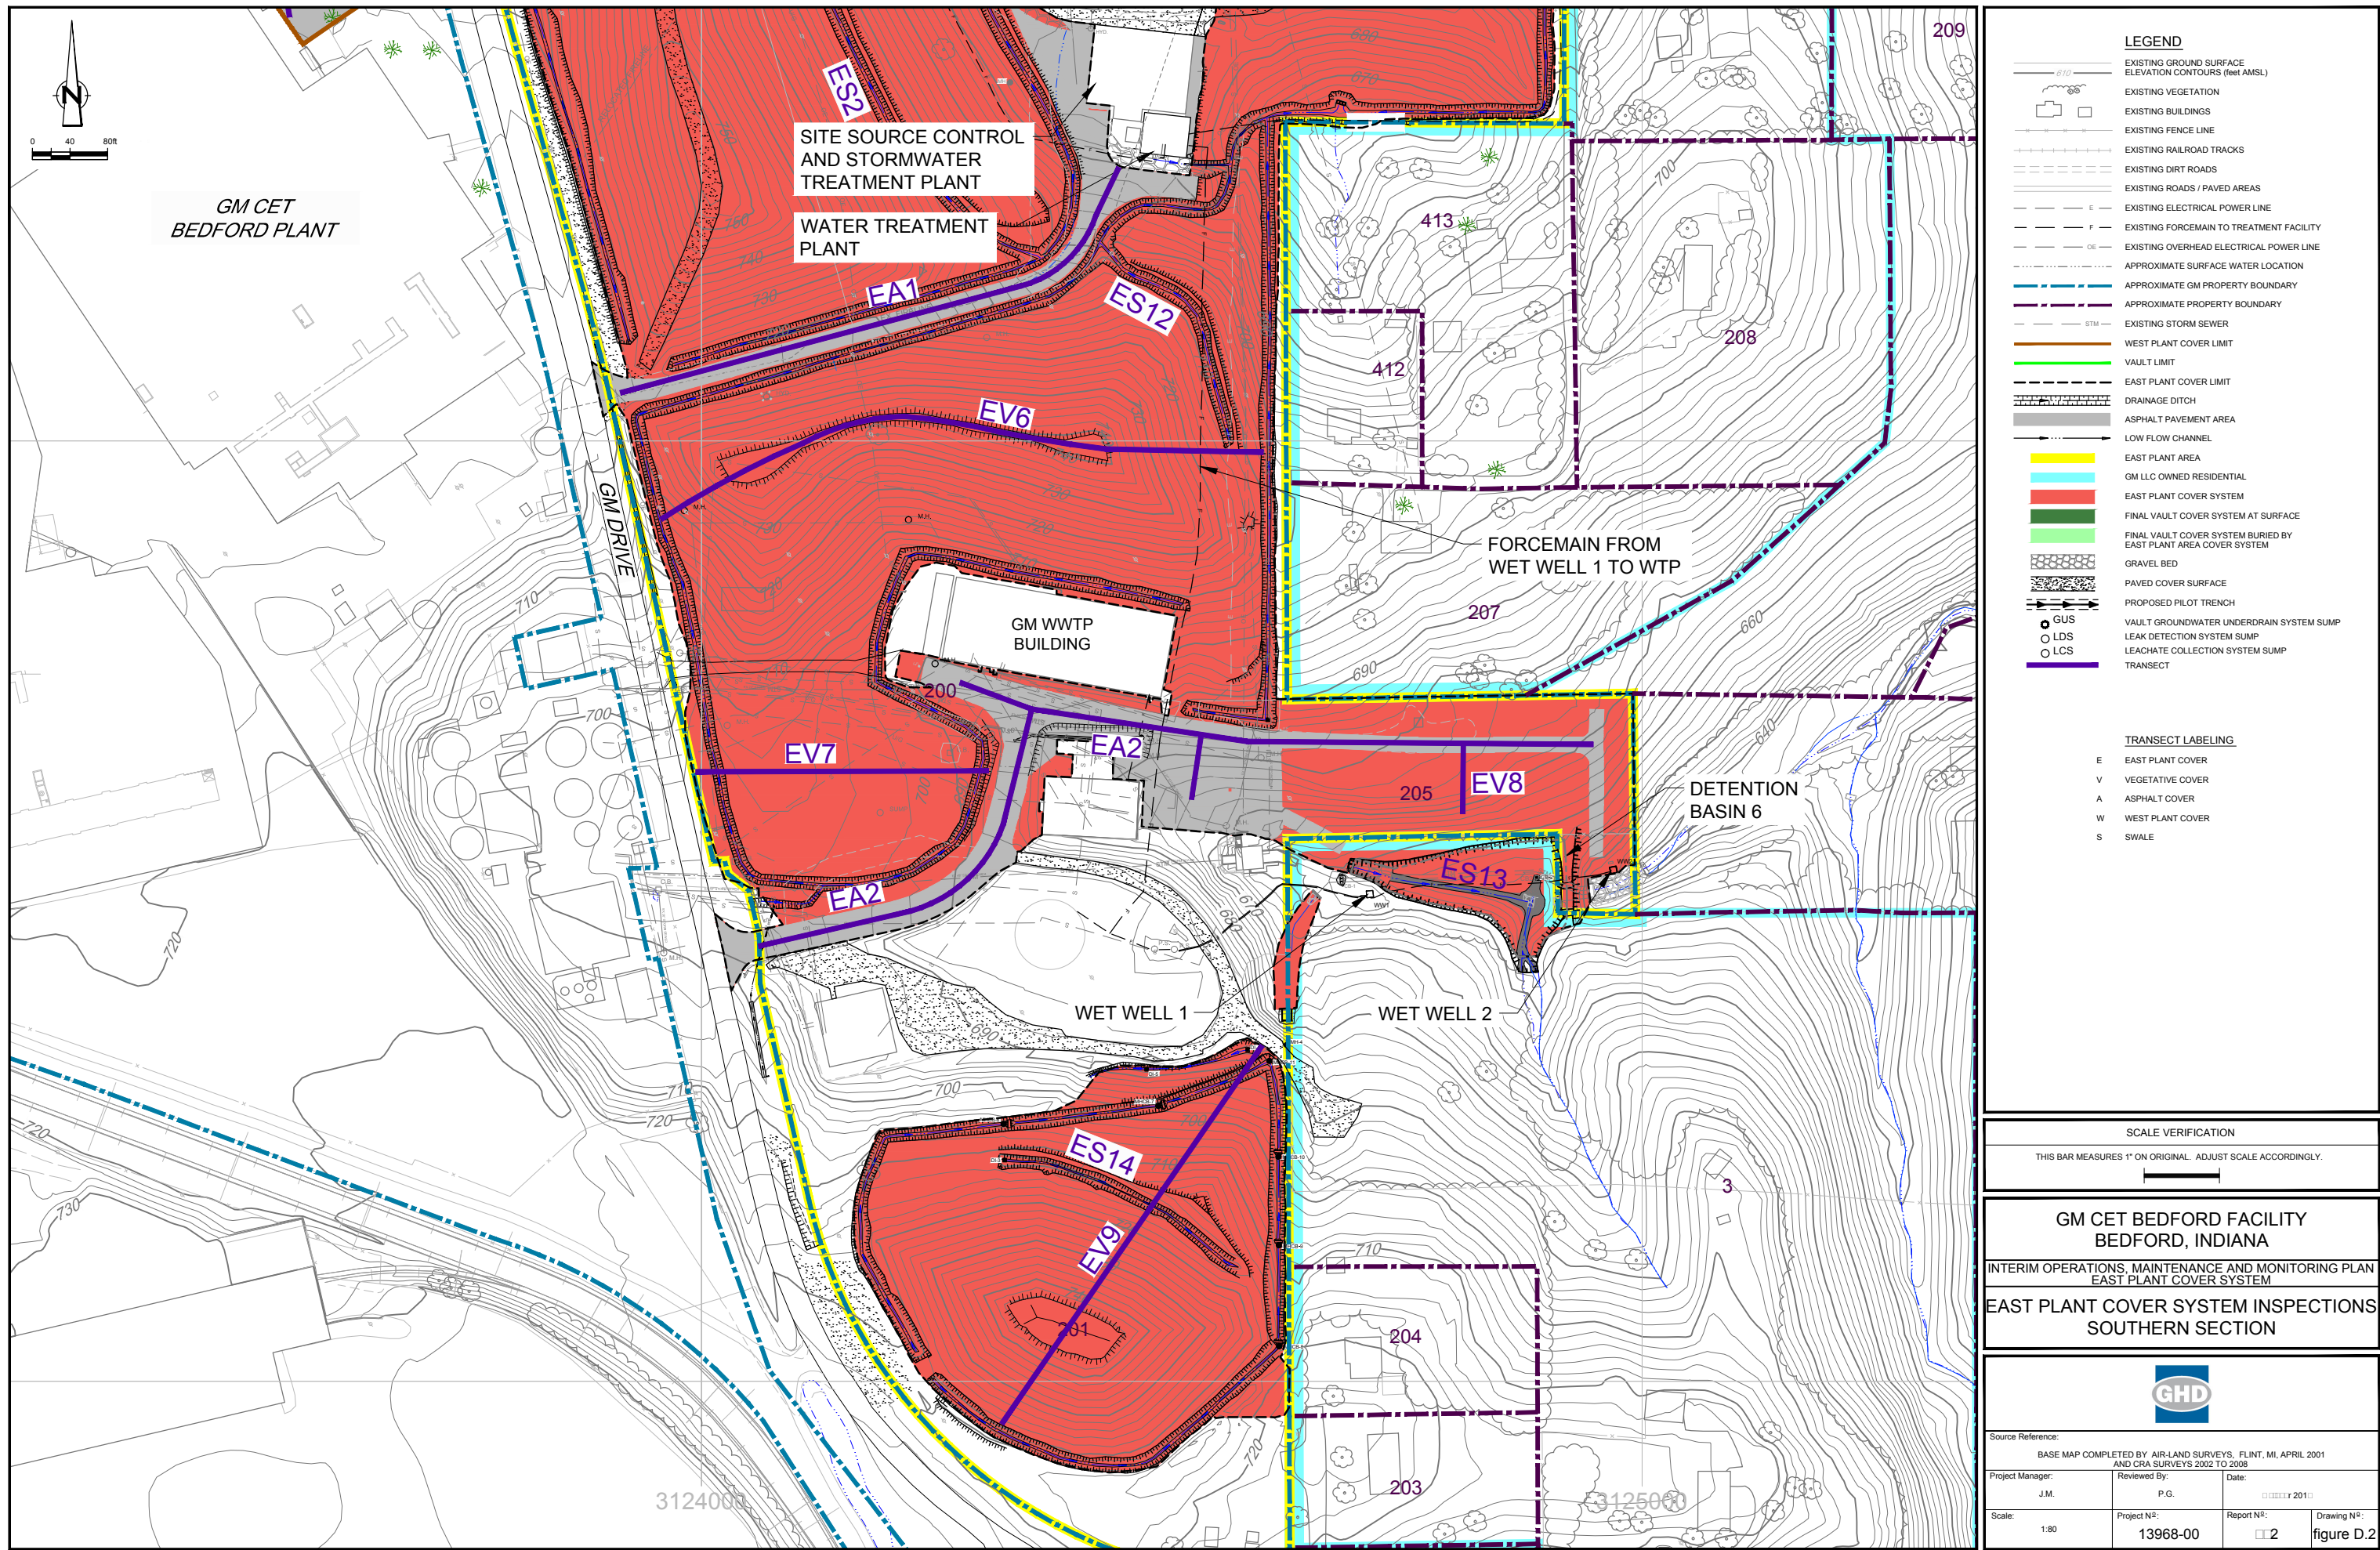
Photo 1: EV1 Vault Cover System west slope erosion area filled, seeded and straw placed.

3. Areas in EV1, EV2, EV3, EV4, EV5, EV6, EV7, EV8, EV9, ES1, ES2, ES3, ES7, ES8, ES9 and ES12 were filled in, re-seeded and had straw placed over the area.
  - Soil erosion repairs of the cover system were completed on September 22, 2017.
4. Saplings were cut on September 18, 2017 in Transects EV5, EV8, EV9 and ES12.
