# RCRA FACILITY INVESTIGATION (RFI) WORK PLAN ADDENDUM NO. 3

GM POWERTRAIN BEDFORD FACILITY 105 GM DRIVE BEDFORD, INDIANA

MARCH 2004 REF. NO. 13968 (68) This report is printed on recycled paper.

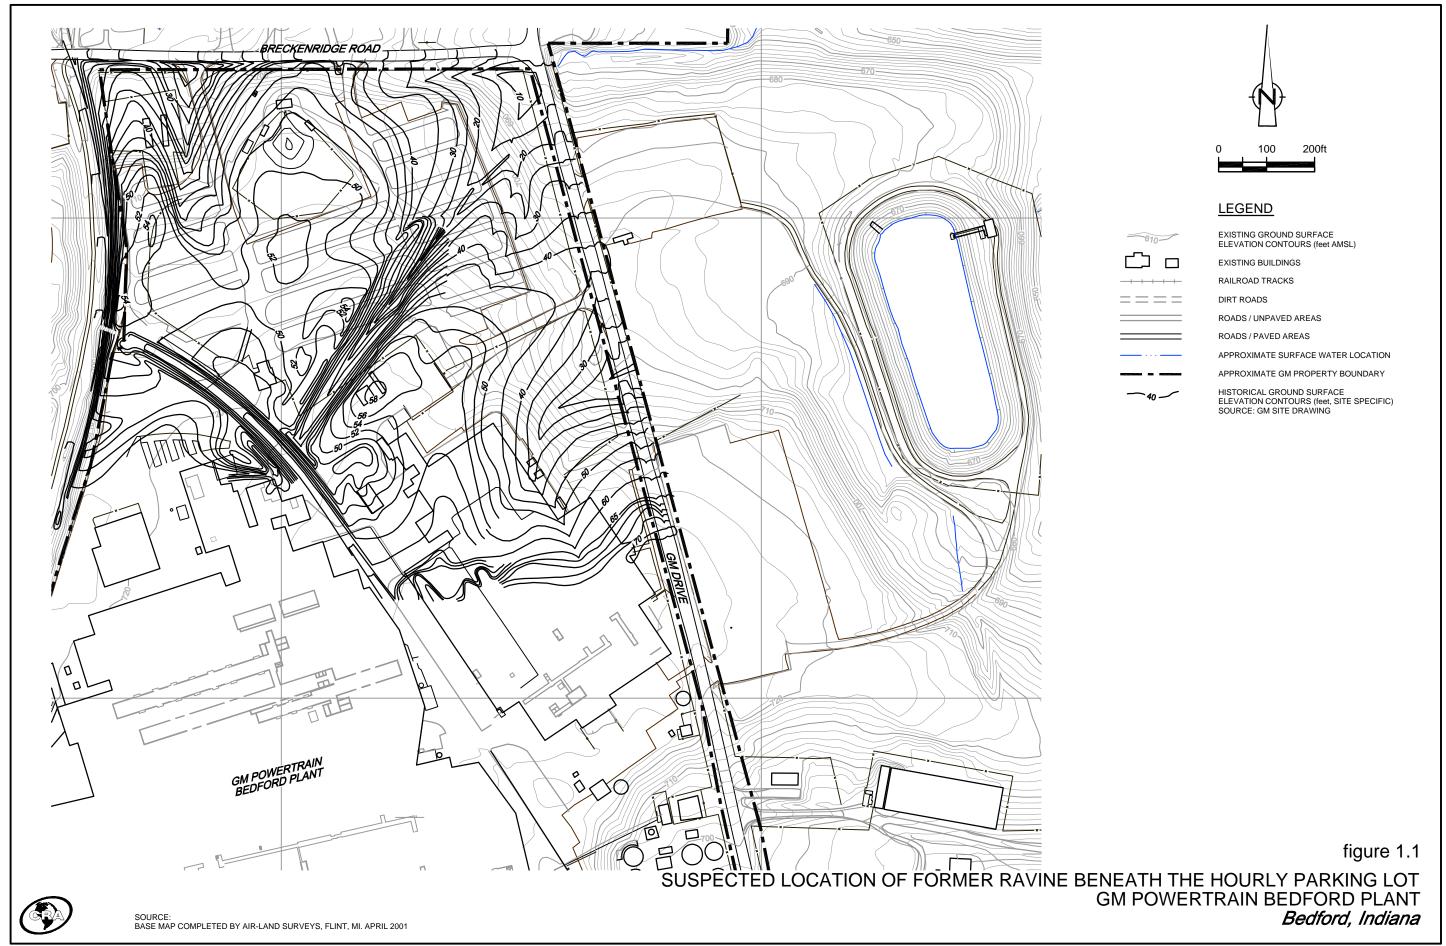
FIGURE 1.1	SUSPECTED LOCATION OF FORMER RAVINE BENEATH THE HOURLY
	PARKING LOT

The recently found drawings also indicated that there was a northern drainage feature along the extreme northwest portion of the property. It appears that this drainage was the start of the Northern Tributary to Bailey's Branch and was filled on both sides of Breckenridge Road (currently, much of the area where this drainage feature was located on the south side of Breckenridge Road is now the location of a substation, which is owned by Cynergy).

A third, smaller drainage feature could also be observed on these drawings. This feature appears to have directed surface water to the Former Stormwater Pond (AOI 7). This feature has also been filled.
