# East Plant Area TSCA Vault Annual Report Calendar Year 2015

GM CET Bedford Facility  
105 GM Drive  
Bedford, Indiana  
EPA ID# IND006036099

General Motors LLC

GHD | 651 Colby Drive Waterloo Ontario N2V 1C2  
031968 | Report No 391 Revision 1 | July 10 2017

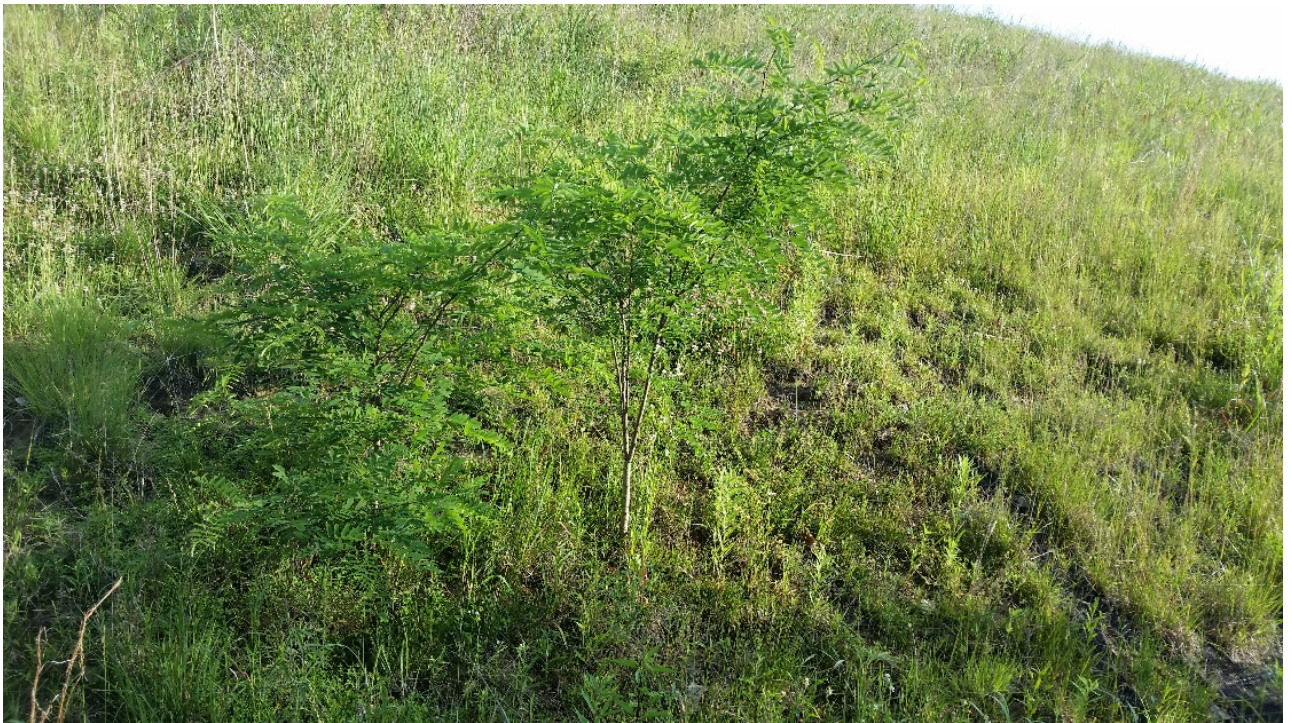
Photo 12: EV9 East Plant Area cover facing south (removed tree growth at time of inspection)

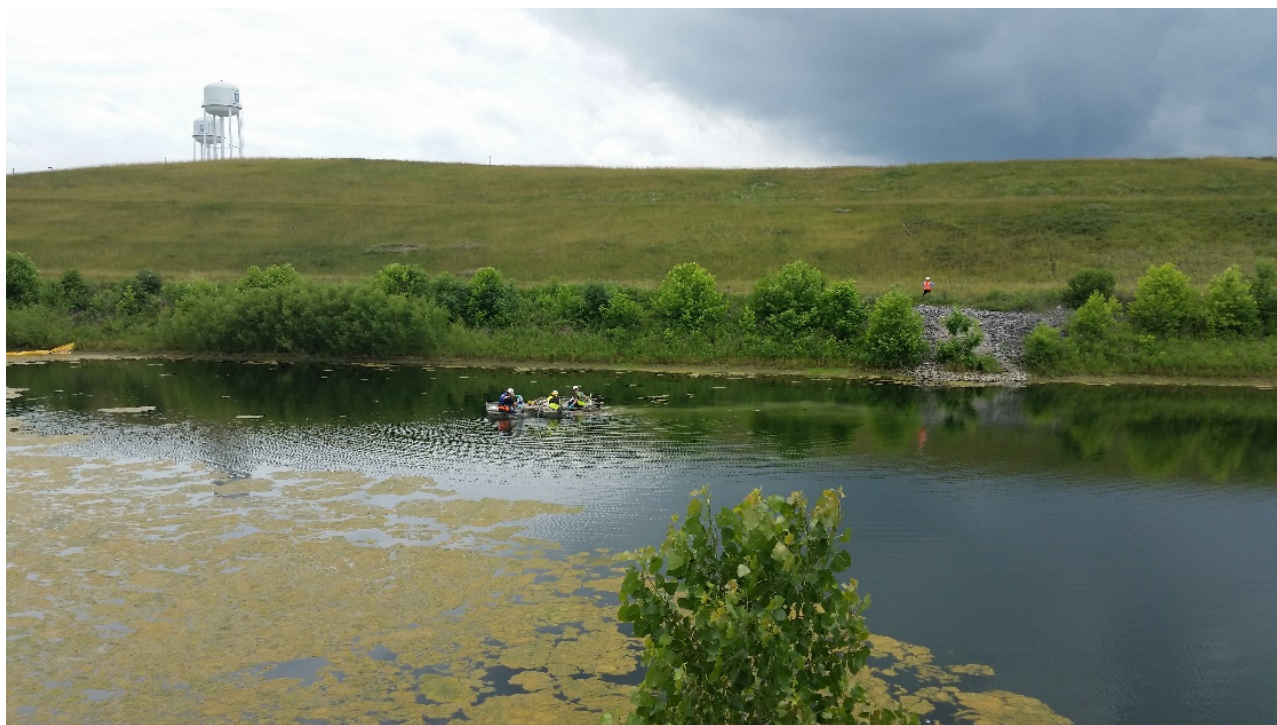
Photo 27: Phoslock Application in the stormwater pond facing southwest

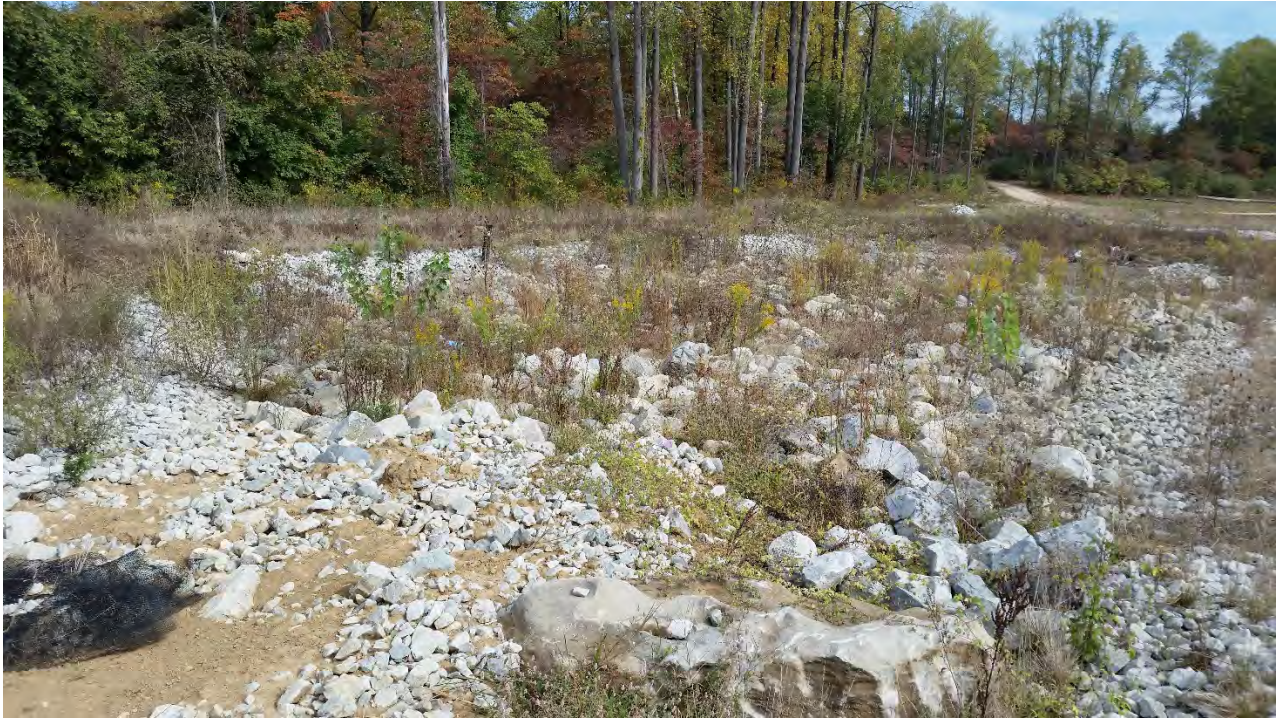
Photo 26: ES9 rip rap erosion at storm drain into detention basin #2 facing west

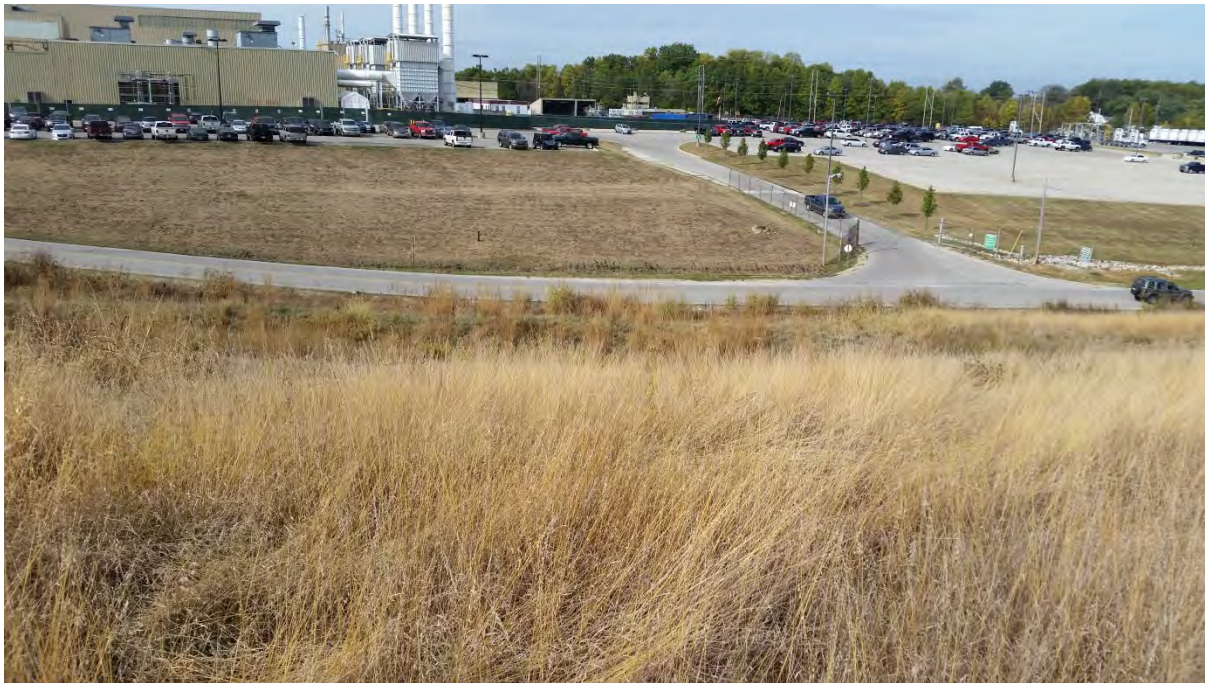
Photo 32: WV1 West Plant Area cover facing west

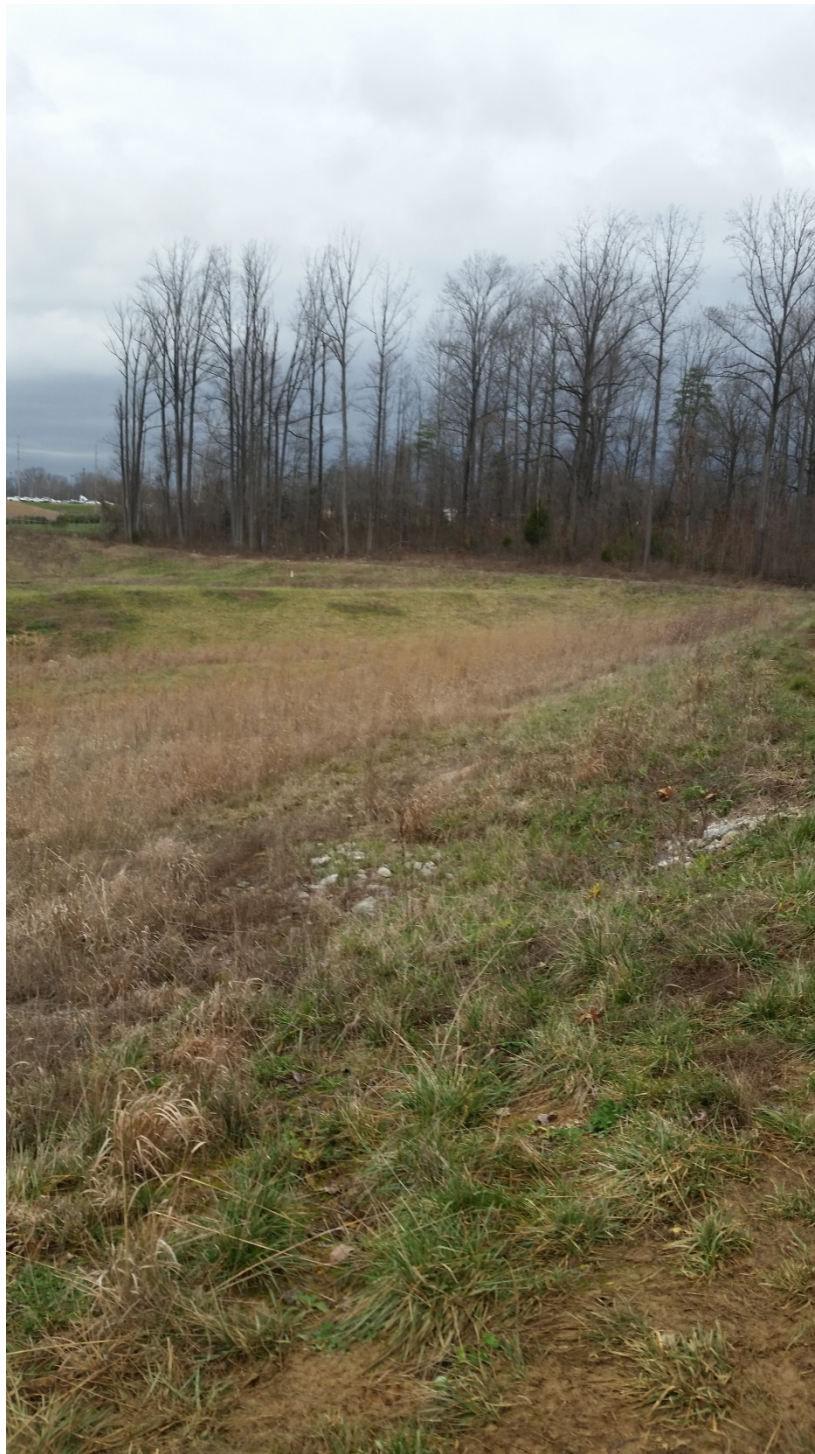
Photo 28: ES8 and ES10 facing west across detention basin 3.
